CK-2340

STAVE RIVER 16.1km

2015 Inspection

| Structure Class | Major Culvert |

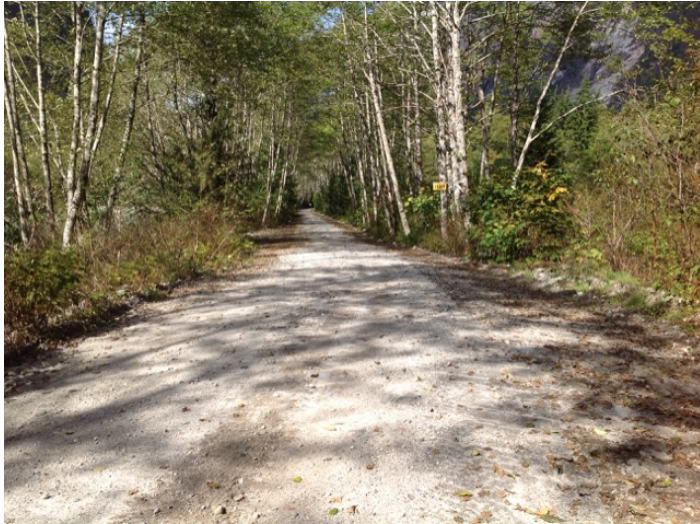
Approach from Left Bank when facing downstream

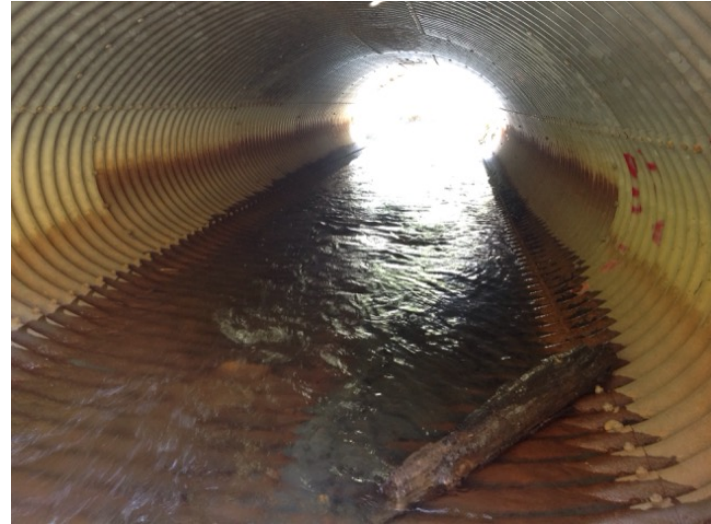
looking through

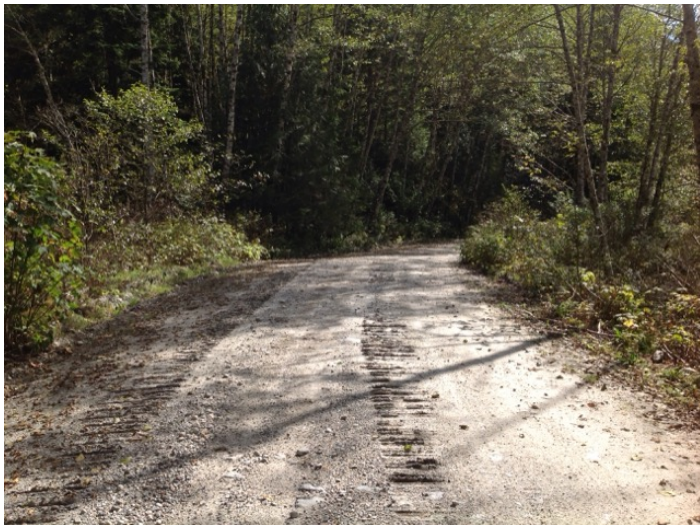
Approach from Right Bank when facing downstream

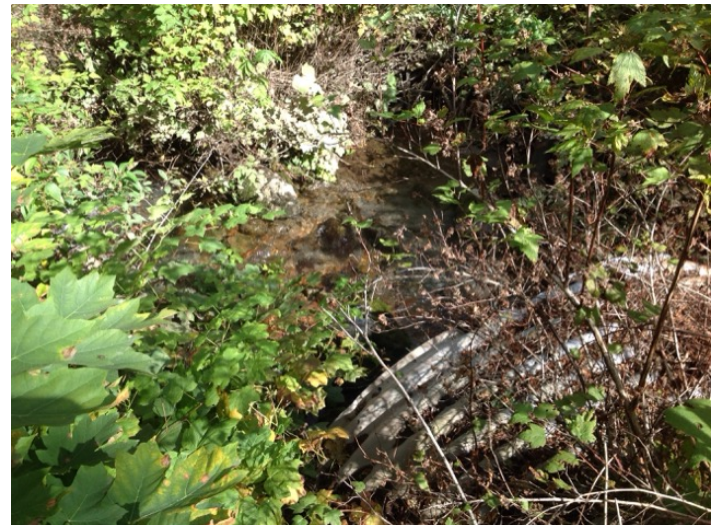
| Inlet | Fair | |

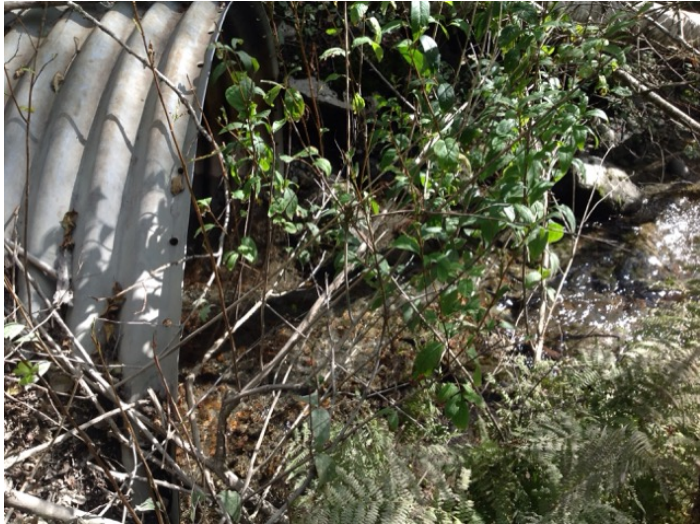
| Outlet | Good | |
