CK-2352

WINSLOW CREEK 1.4km

2015 Inspection

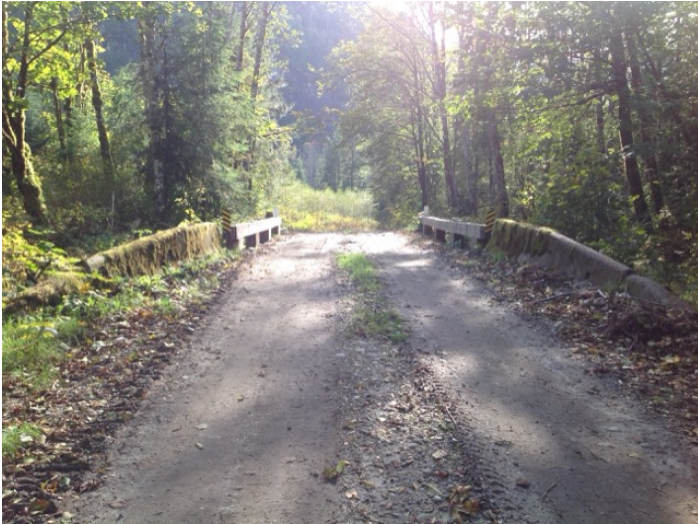
Approach from Right Bank when facing downstream

Alignment Fair

Road Surface Good

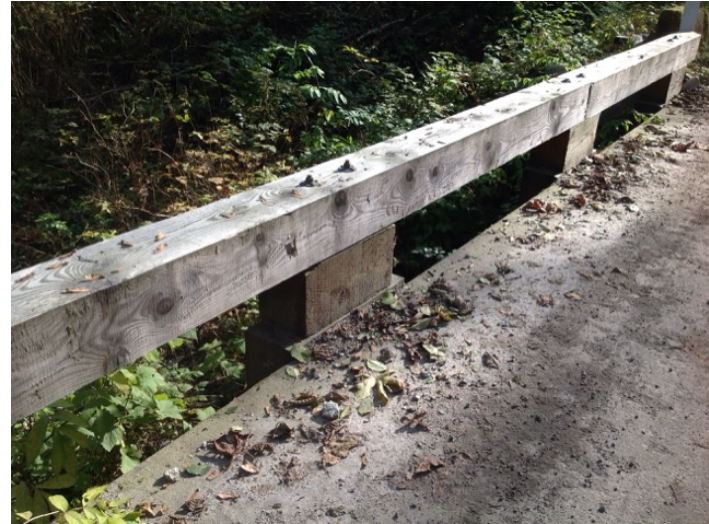
Guard Rail

Curb Rail/Blocks/Posts Excellent

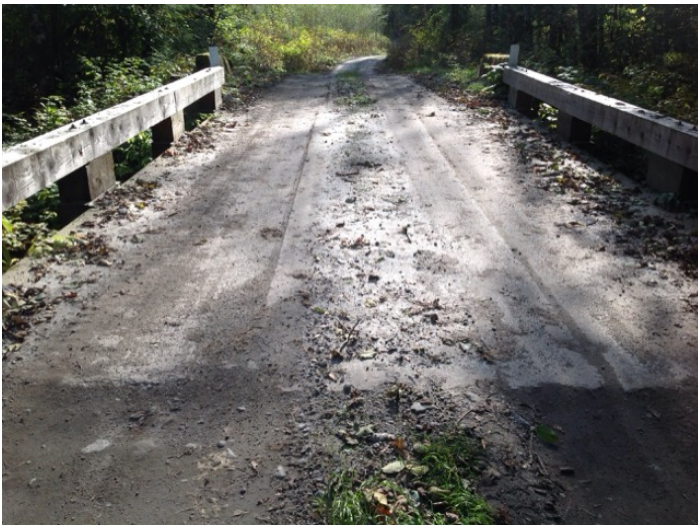
Running Surface Fair

Overall Deck Condition Excellent

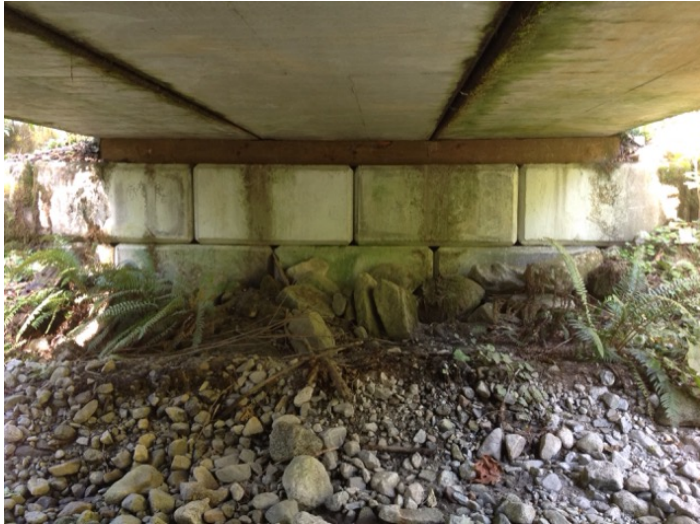
Right Bank Abutment when facing downstream

Concrete Good lock blocks -2 high both banks

Caps or Sills Excellent treated timbers

Riprap Fair
