CK-2354

HARRISON EAST 16.8km

2015 Inspection

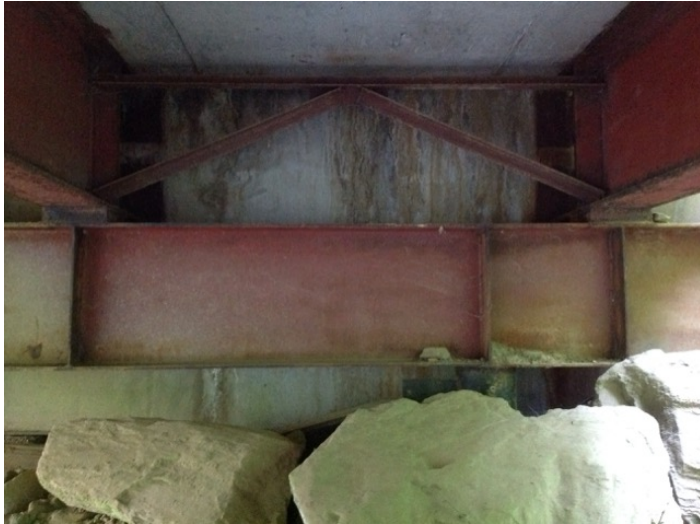
upstream girder set shimmed due to different deck thicknesses

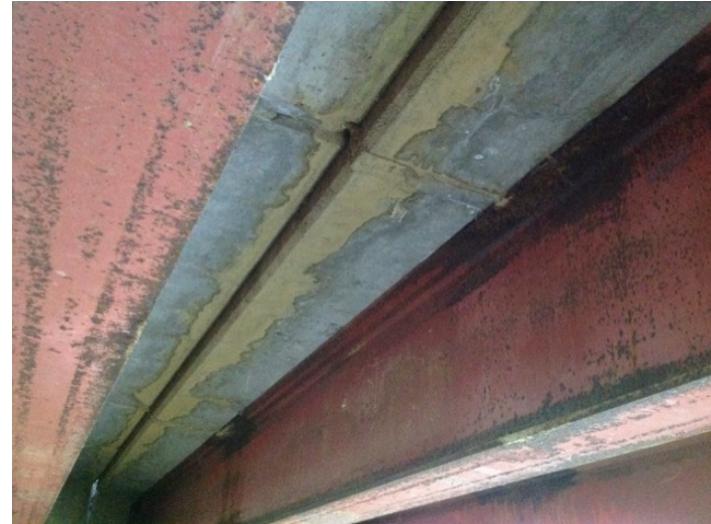
concrete deck thicknesses
