CK-2378

STAVE RIVER 8.8km

2015 Inspection

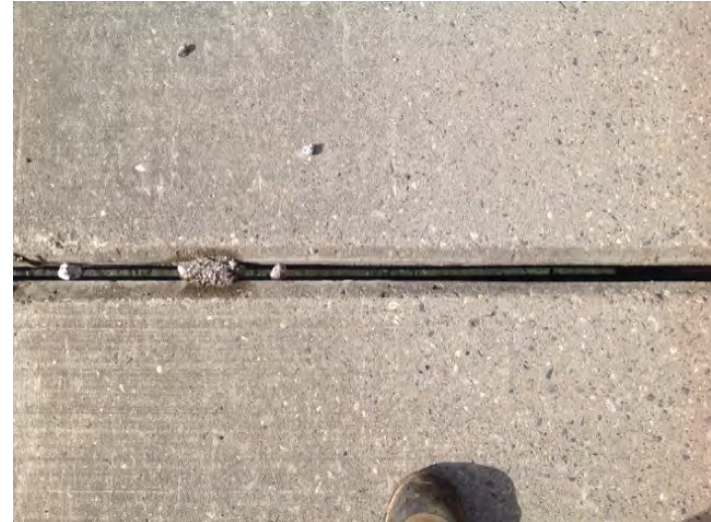
| Deck Joints | Fair | most deck seals have fallen out |

seals between deck panels missing

| Item | Priority | Repair Description |
|---|---|---|
| 2 | Medium | replace missing deck seals |

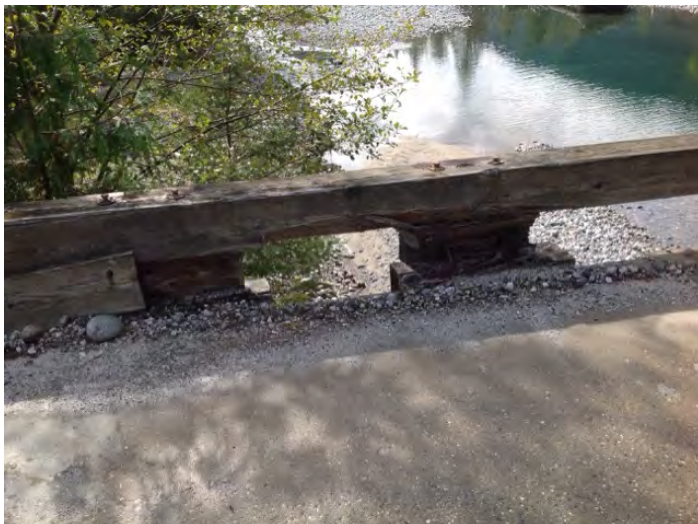
| Curb Rail/Blocks/Posts | Fair | some damaged risers that require replacement |

guardrail damage

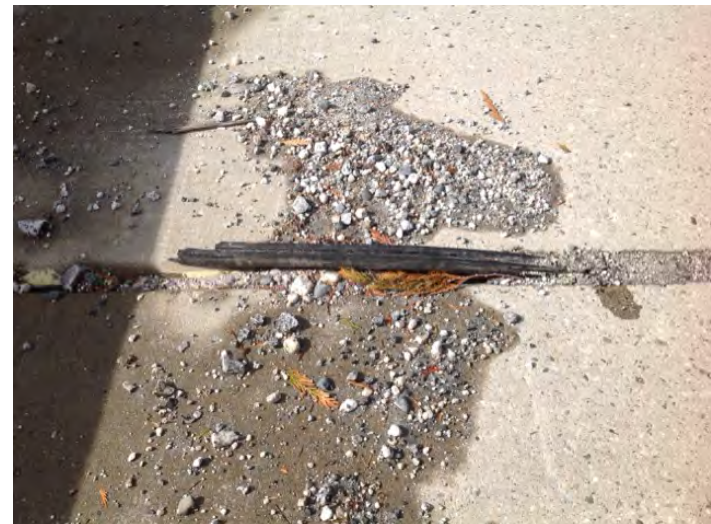
seal pushed out

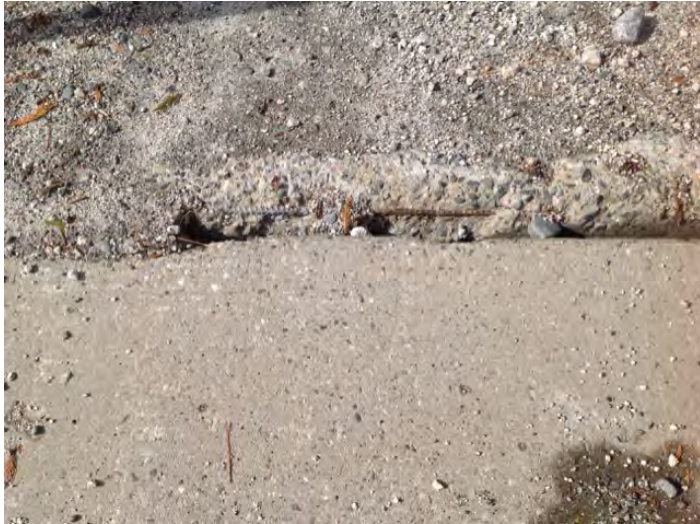
damage on right bank

ballast wall damage

| Item | Priority | Repair Description |
|---|---|---|
| 3 | Medium | repair exposed rebar on right bank ballast wall |

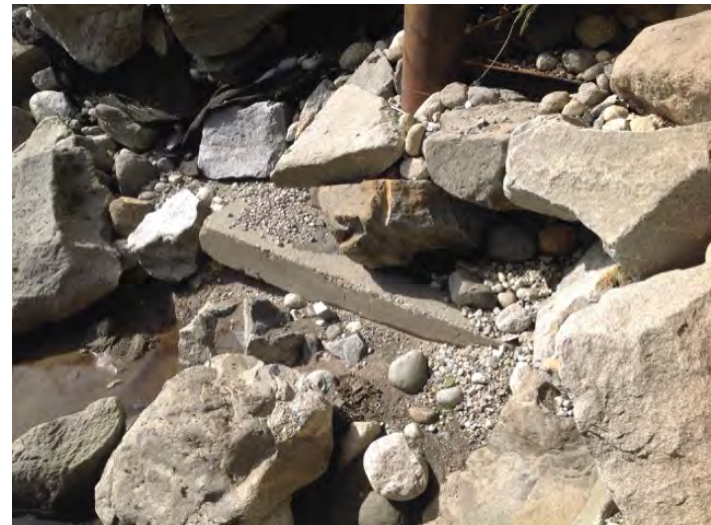
The right bank downstream footing is exposed and undermined. Replace the scoured material from underneath the precast pad and place riprap in front for protection. This abutment is subject to scour and is not the first time this has happened - monitor. Replace all the deck joint seals, post bridge ahead signs, replace the missing downstream concrete no post barriers and replace the damage risers. Repair the right bank ballast wall by cutting around all exposed rebar, remove all corrosion from the rebar and grouting over. The present load rating of L75 or 68 tonnes can continue provided there has been no further scour from under the exposed footing pad. If further scour has occurred please stop using the structure and contact the Coast Engineering Group for a repair plan.

Concrete **Poor**
 right bank downstream precast footing pad is  
exposed and slightly undermined

right bank - downstream footing exposed

| Item | Priority | Repair Description |
|---|---|---|
| 1 | High | place dam sacks under exposed footing pad and place riprap in front for protection |

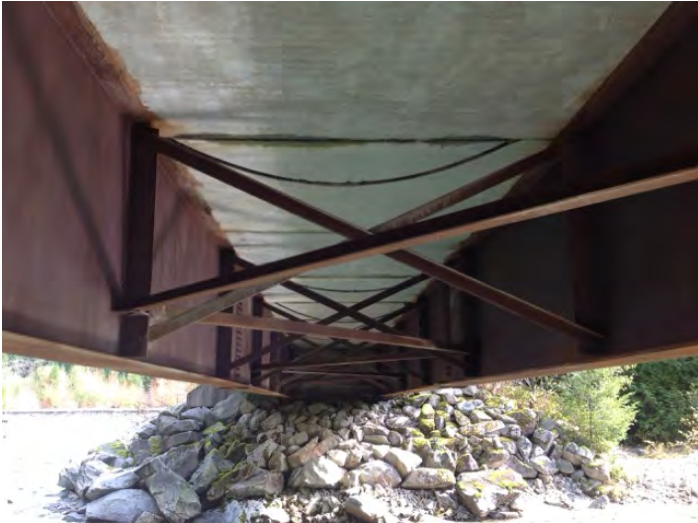
deck seals all pushed through

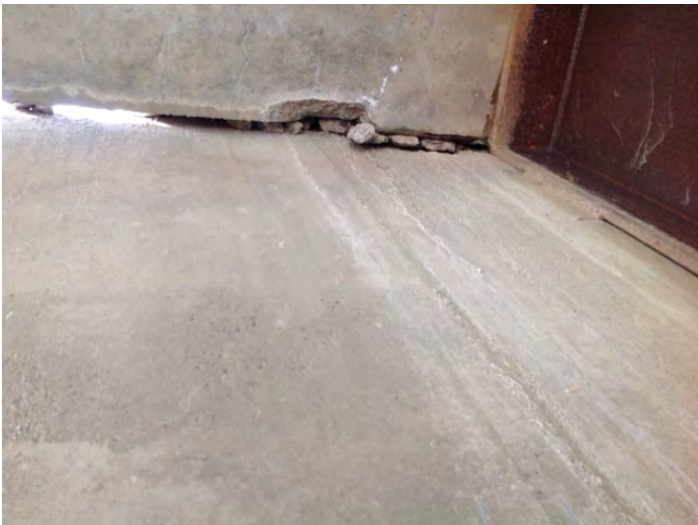
damaged deck panel

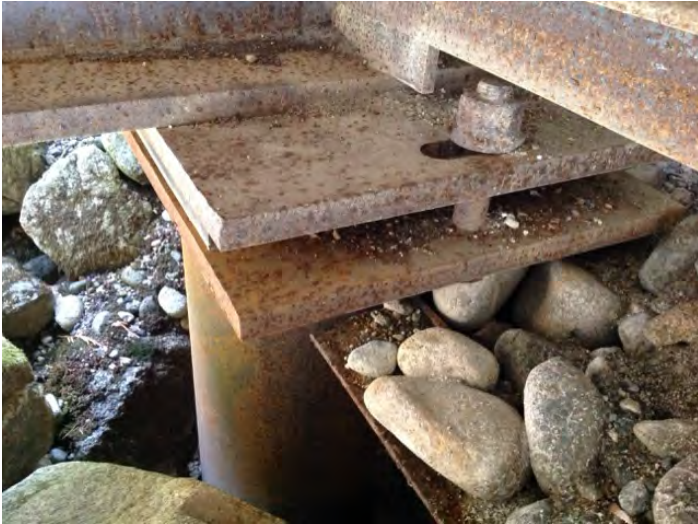
bearing bolts at full extent of slot
