CK-2379

LOST-LEASE 0.7km

2015 Inspection

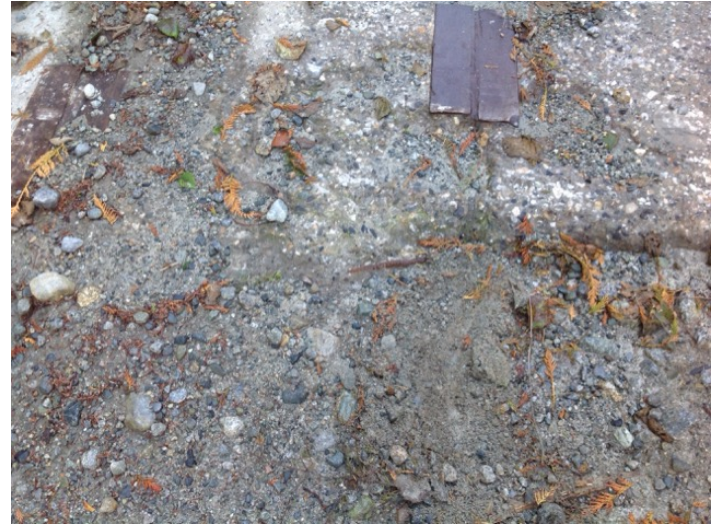
| 1 | spalling concrete on slabs | Routine Inspection |

exposed rebar on slabs

Repair damage on slabs with exposed rebar. Replace missing delineator. Present load rating of CL-625 or 63 tonnes to continue.

| 2 | High | repair exposed concrete slabs |

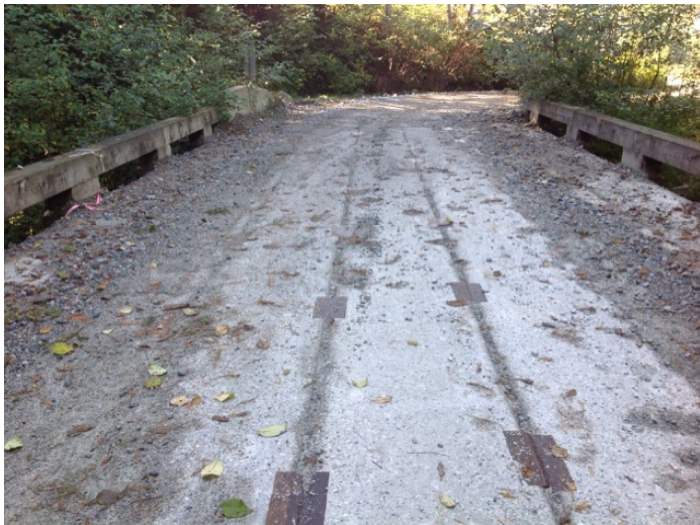
Concrete Deck Fair

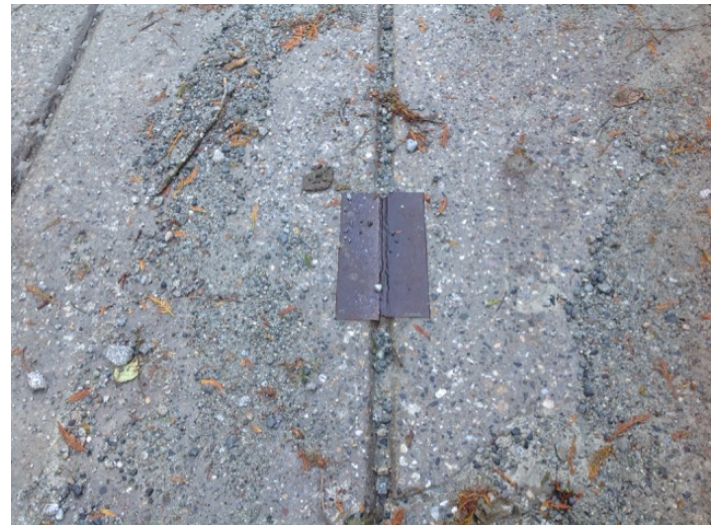
welded shear keys

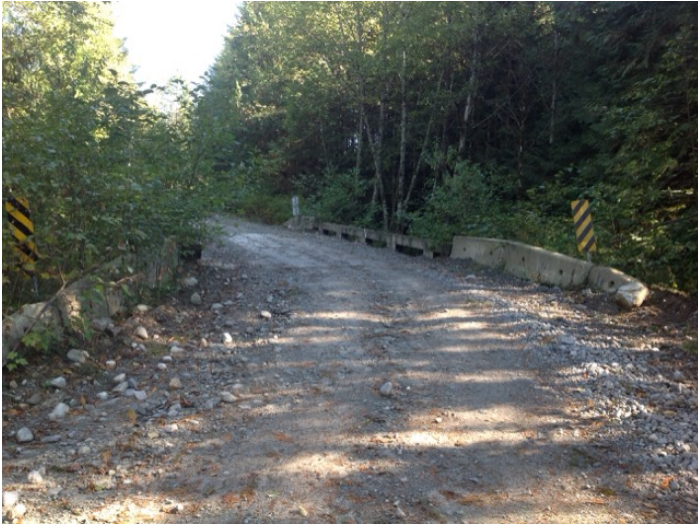
Approach from Left Bank when facing downstream

Delineator Missing  
Left ☐ 0 ☒ 1 ☐ 2

| 1 | Medium | replace missing delineator |

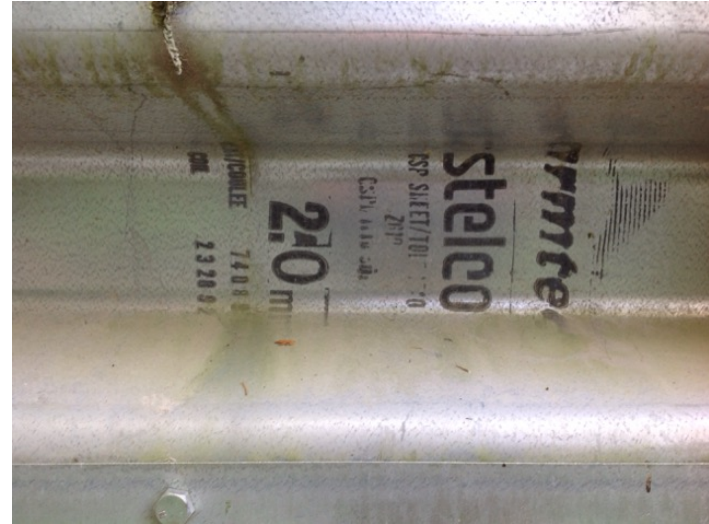
Bin Wall Fair some minor installation damage

bin wall info
