CK-2400

NESAKWATCH LAKE 1.07km

2015 Inspection

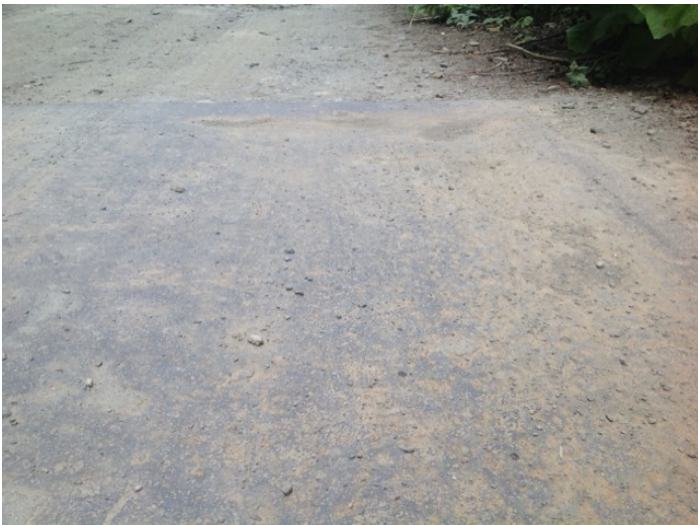
Steel Deck Plate Fair some localized damage

steel plate damage

Post bridge ahead signs and brush approaches. Monitor slight deck deformation. Present load rating of L75 or 68 tonnes to continue.

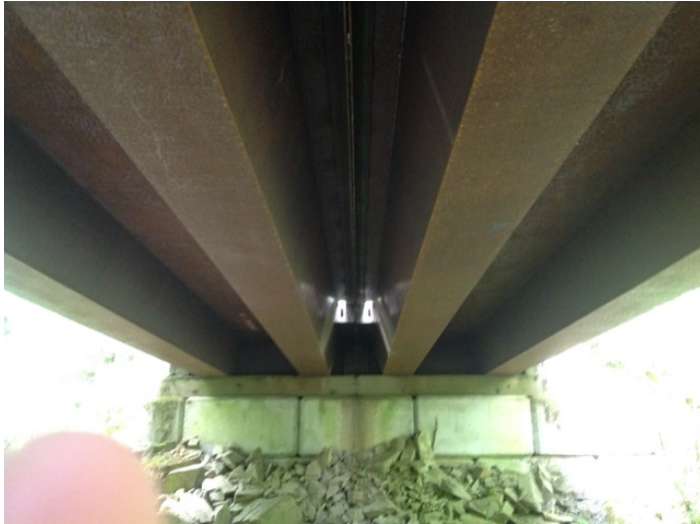
superstructure

Girders Fair Magnum style ASP
