CK-2401

NESAKWATCH LAKE 1.64km

2015 Inspection

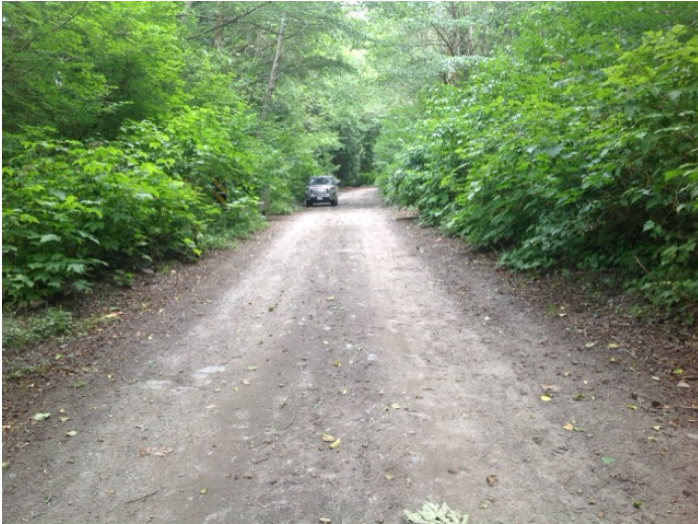
Approach from Left Bank when facing downstream

Road Surface Poor potholes; requires grading

Replace guardrail, risers and blocks. Post bridge ahead signs, grade and brush approaches. Present load rating of L75 or 68 tonnes to continue.

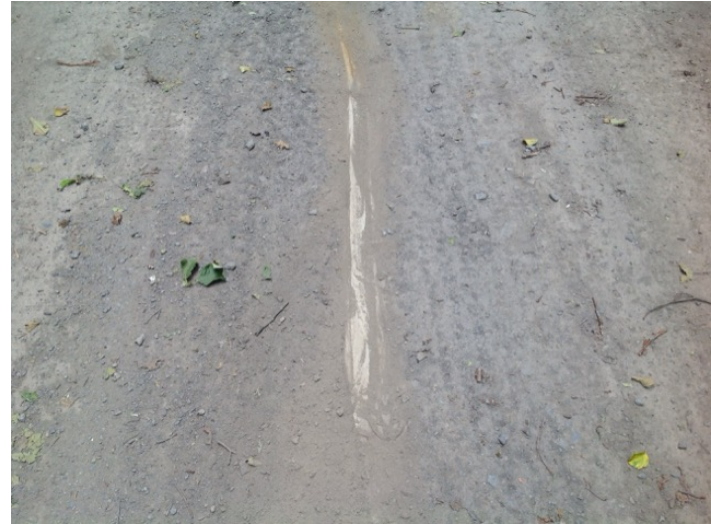
| Running Surface | Fair | potholes; requires grading |
| Curb Rail/Blocks/Posts | Poor | rotting risers and blocks |
| Overall Deck Condition | Poor | due to rotten guardrail system |

| Repair Item | Priority | Repair Description |
|---|---|---|
| 1 | Medium | replace guardrail system prior to industrial activity |
