CK-2441

DEWDNEY WEST 1.5km

2015 Inspection

| Crossing Name | Fifteen Mile Creek |

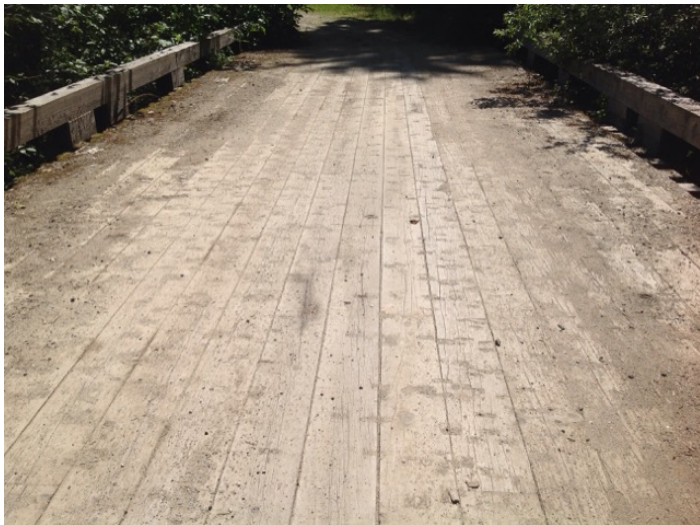
Overall Deck Condition Fair

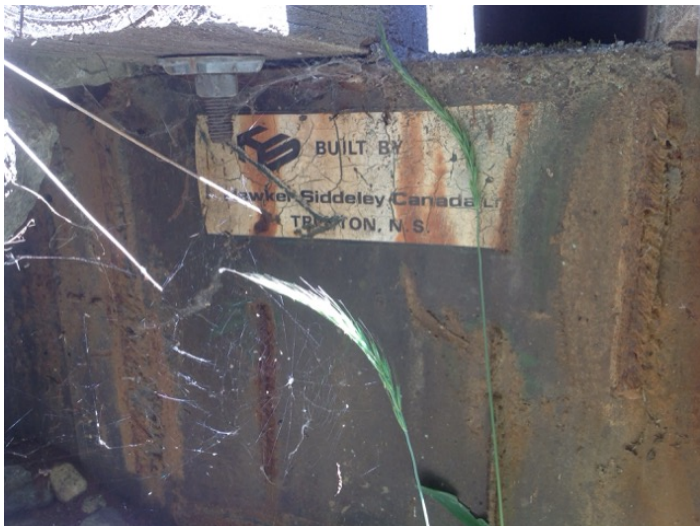
hawker siddeley

Girders Fair
