CK-2444

NORRISH CREEK 12.9km

2015 Inspection

| Crossing Name | Cyr Creek |

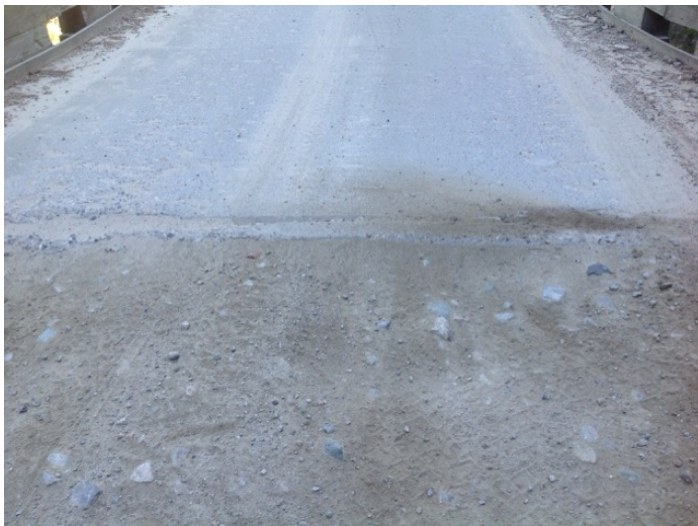
Ballast Wall Fair

Concrete Deck Fair

ballast wall and deck damage on both approaches

Repair damaged panel. Present load rating of L100 or 91 tonnes to continue.

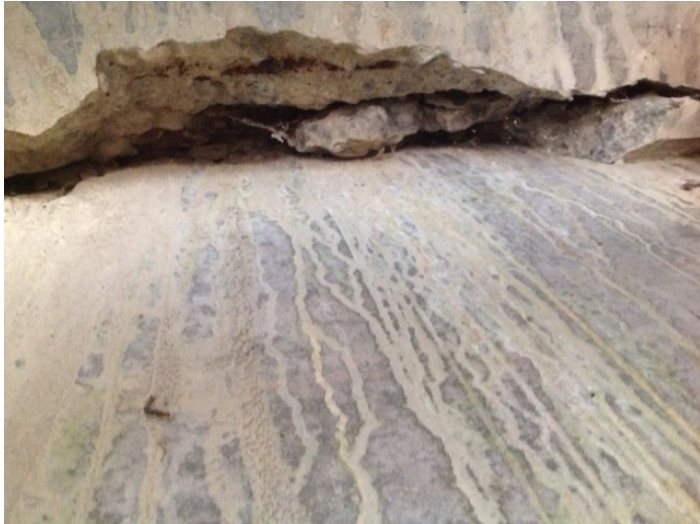
| Item | Monitor Description | Frequency |
|---|---|---|
| 1 | panel damage and rebar corrosion | Routine Inspection |

panel damage under right approach

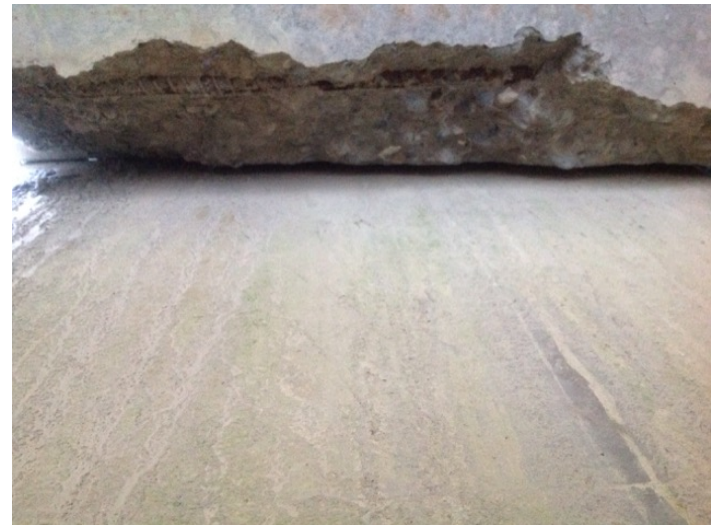
panel damage under left approach
