CK-2445

NORRISH CREEK 16.1km

2015 Inspection

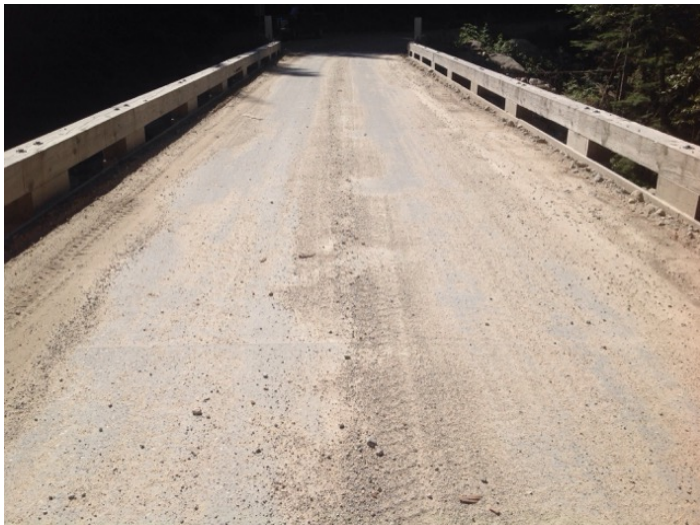
Concrete Deck Fair

Overall Deck Condition Fair
