CK-2447

NORRISH CREEK 18km

2015 Inspection

| Crossing Name | Tom Creek |

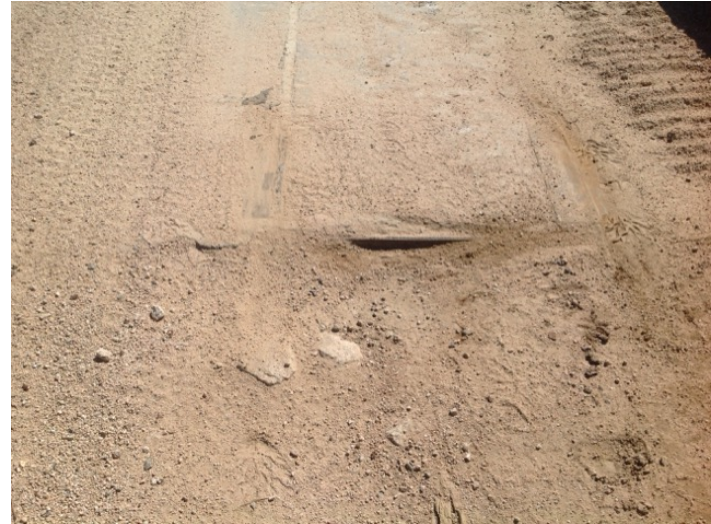
slab damage and rebar exposed

Brush approaches and monitdamage to slab. Present load rating of L165 or 150 tonnes to continue.

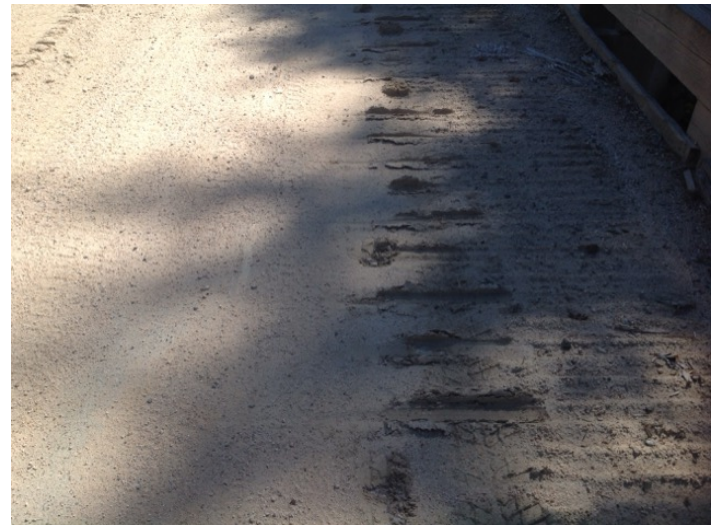
tracked machines recently walked across structure

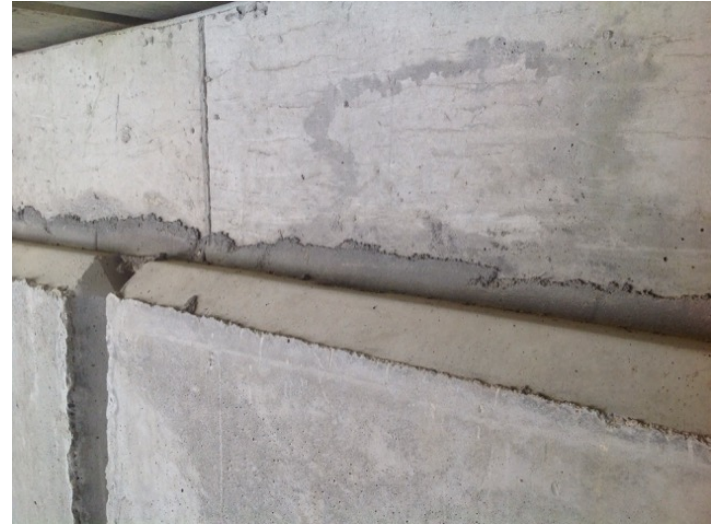
concrete cap grouted to lock blocks
