CK-2448

NORRISH CREEK 1.8km

2015 Inspection

| Crossing Name | Sally Creek | | |

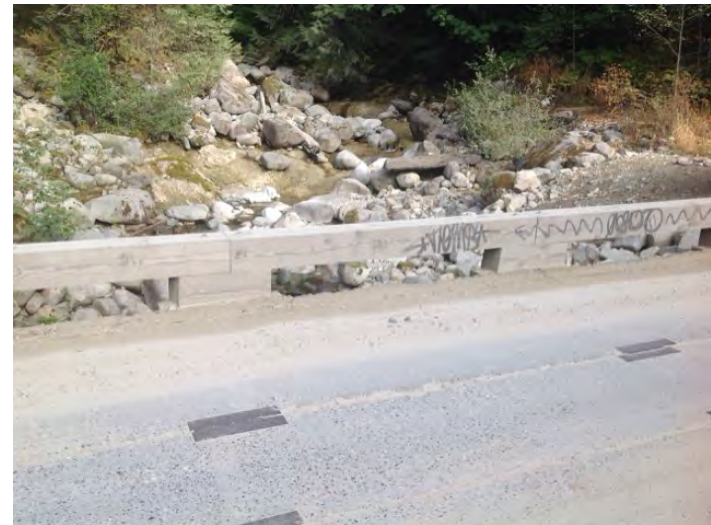
upstream guardrail new

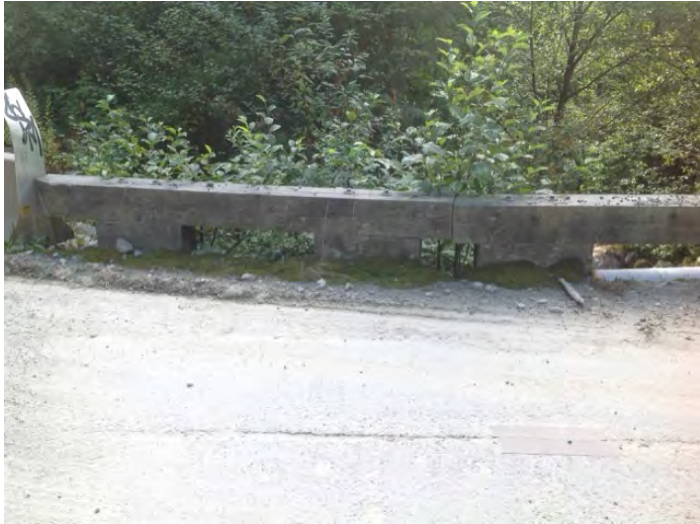
| Curb Rail/Blocks/Posts | Fair | downstream blocks and risers rotting |

downstream guardrail old

| Repair Item | Priority | Repair Description |
|---|---|---|
| 1 | Medium | replace downstream guardrail, risers and blocks |

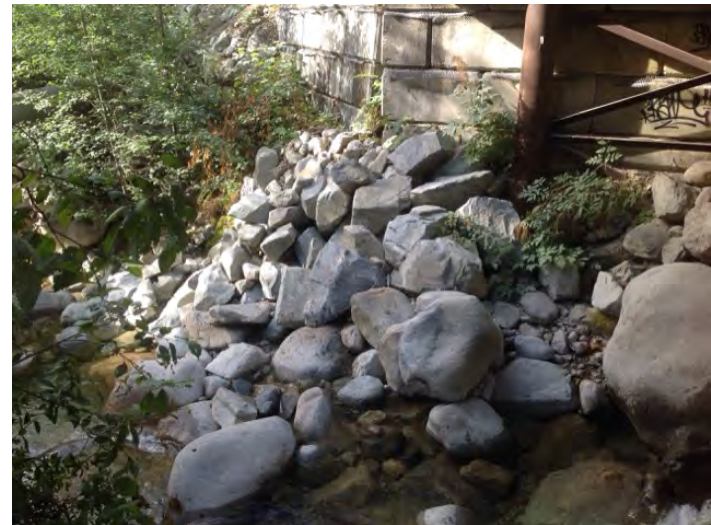
lock blocks downstream right abutment

right downstream abutment

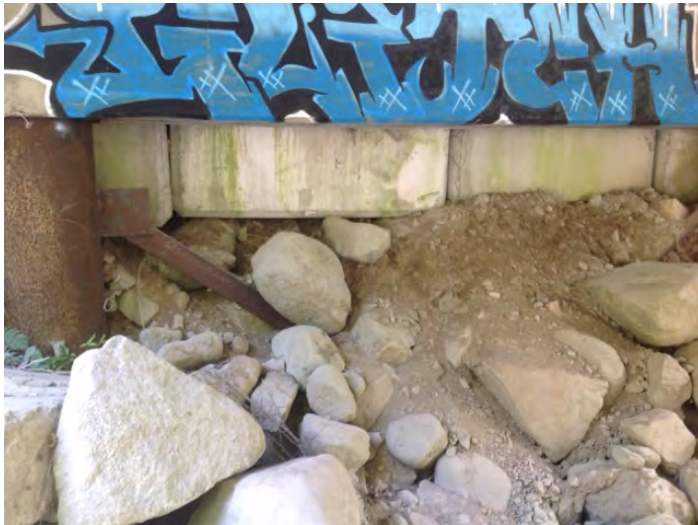
lock blocks under left cap differential settling

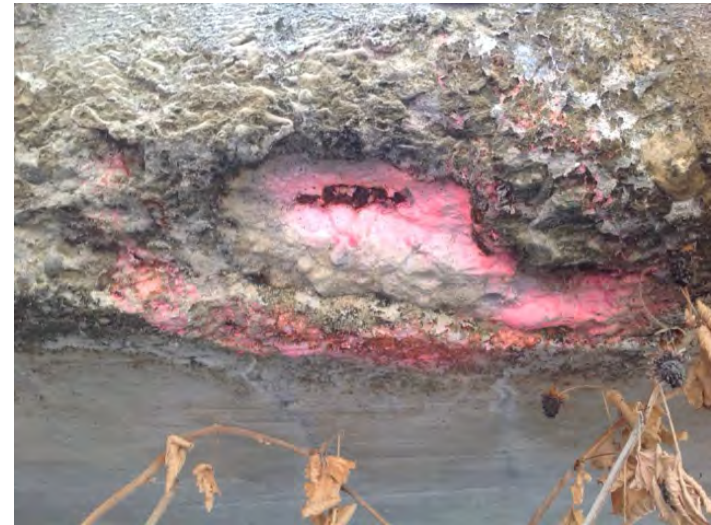
spalling concrete and corroding rebar

Replace the right hand delineators that are posted on the left sides with proper left hand delineators. Replace the downstream guardrail, risers and blocks. The riprap in front of the pipe risers is rounded and slightly scoured - monitor for future scour especially given the water line located immediately downstream. Repair the spalling concrete and rusting rebar. Present load rating of L150 or 136 tonnes to continue.

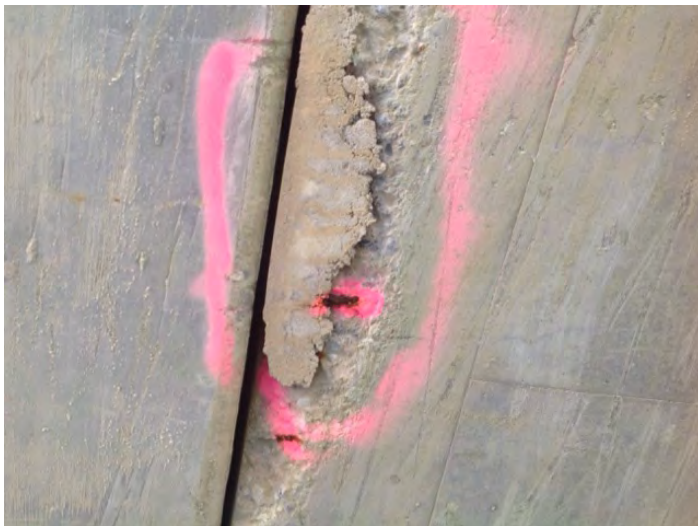
spalling concrete and corroding rebar
