CK-2450

NORRISH CREEK 5.2km

2015 Inspection

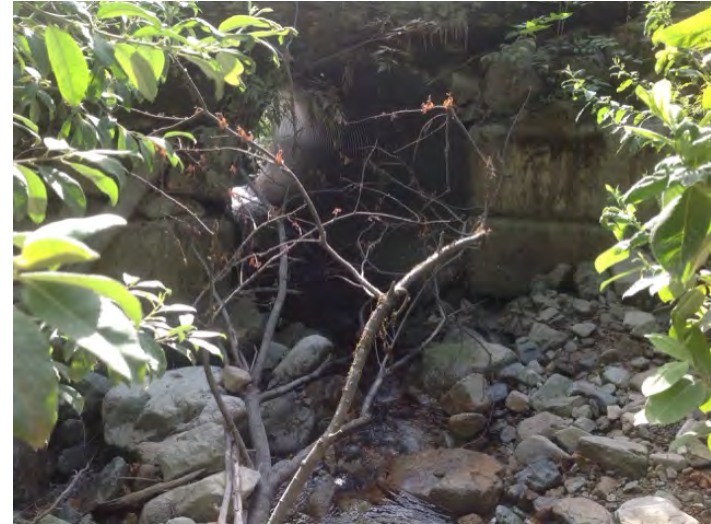
| Inlet | Fair | debris starting accumulate |

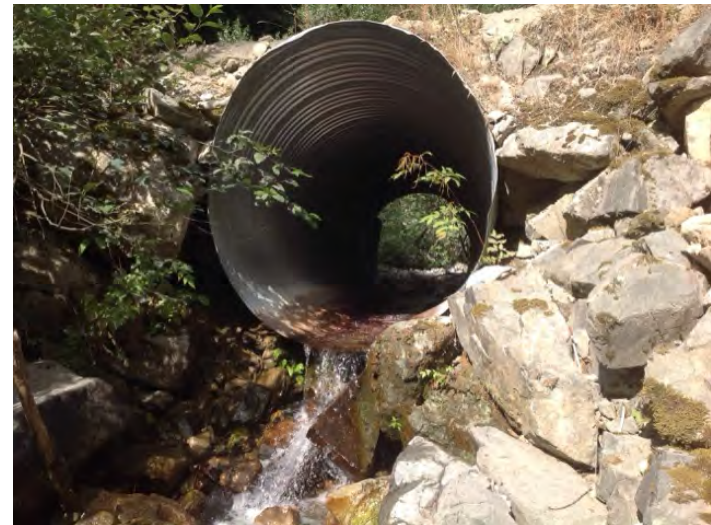
| Outlet | Fair | 0.5 meter drop |

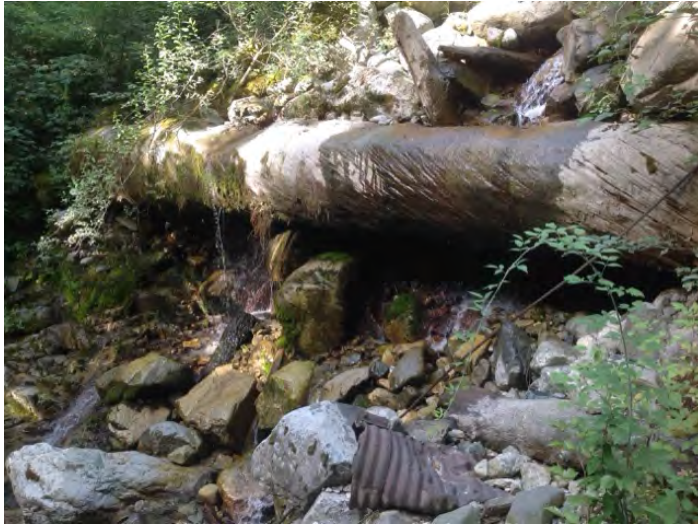
| Comments | monitor fill retaining log on fillslope | | | | |

log retaining fill on fillslope

Add 200mm gravel fill over the culvert and blend into the existing grade. The approach fills are erodible and require monitoring. There does not appear to be any movement of the large log retaining fill at the outlet of the culvert; however it needs to be monitored especially during/after heavy rainfall events. Consider removing this log and replacing with well keyed riprap. Present load rating of BCL-625 or 63 tonnes to continue.

1 fill retaining log on fillslope

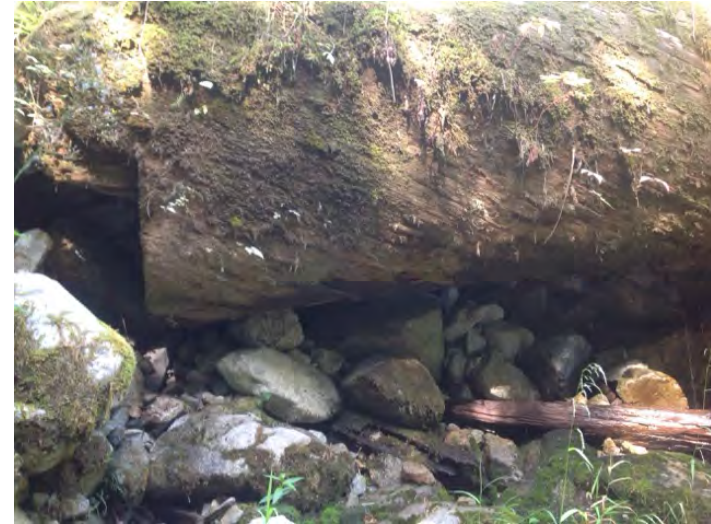
right bank of fill retaining log - not tied in very well

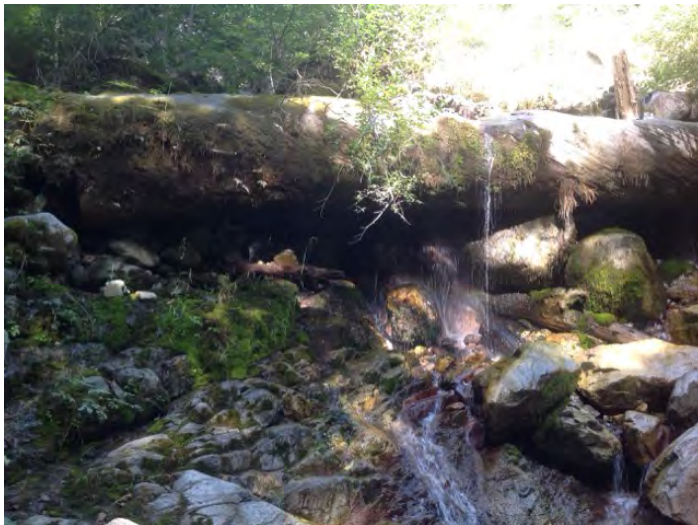
log retaining fill on fillslope

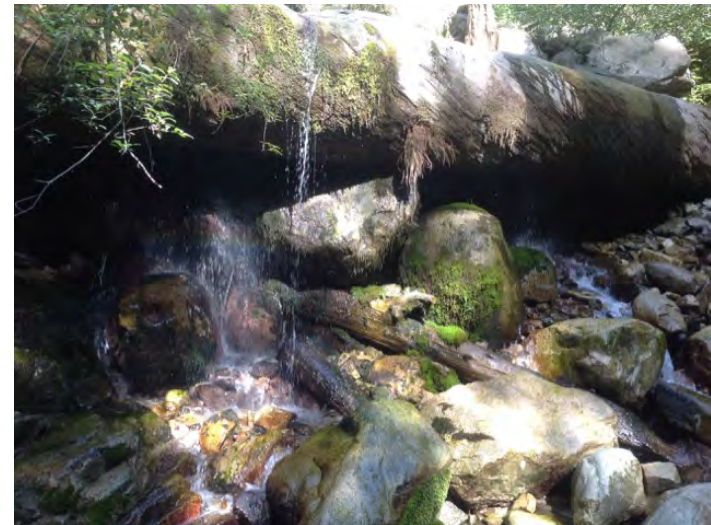
approx middle of fill retaining log - bearing on large rounded rock that sits on a smaller log

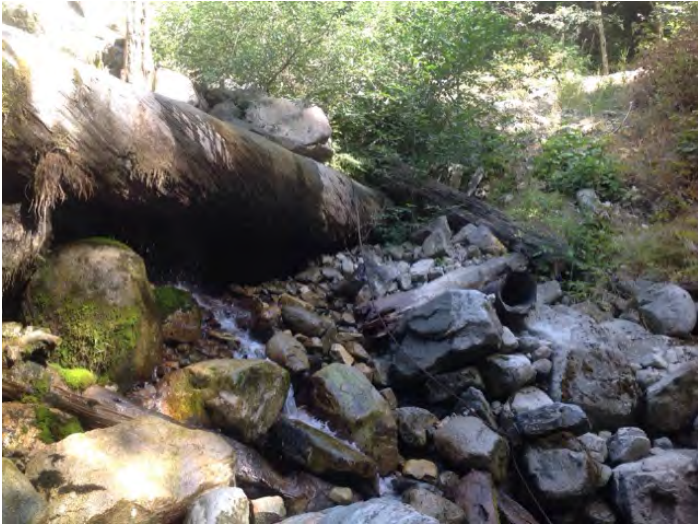
left bank of fill retaining log - tied into bank
