CK-2452

NORRISH CREEK 7.1km

2015 Inspection

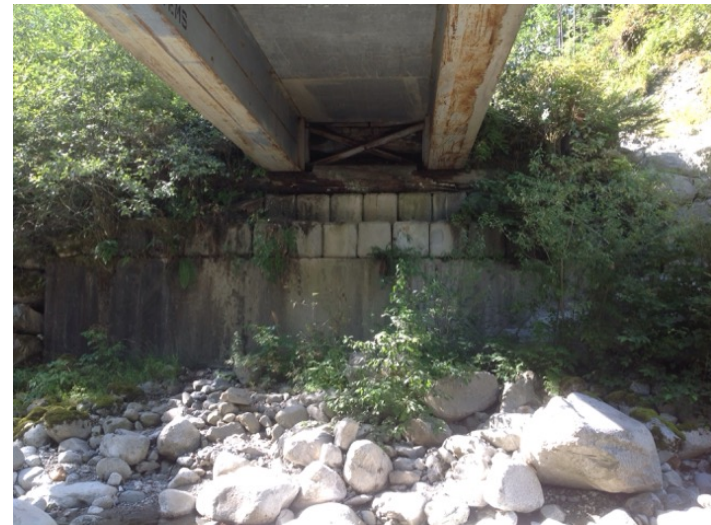
Right Bank Abutment when facing downstream

Concrete Fair CIP on both ends, right has lock blocks on top of CIP

Caps or Sills Fair log sill on right bank on top of CIP and lock blocks
