CK-2457

NORRISH CREEK 13.6km

2015 Inspection

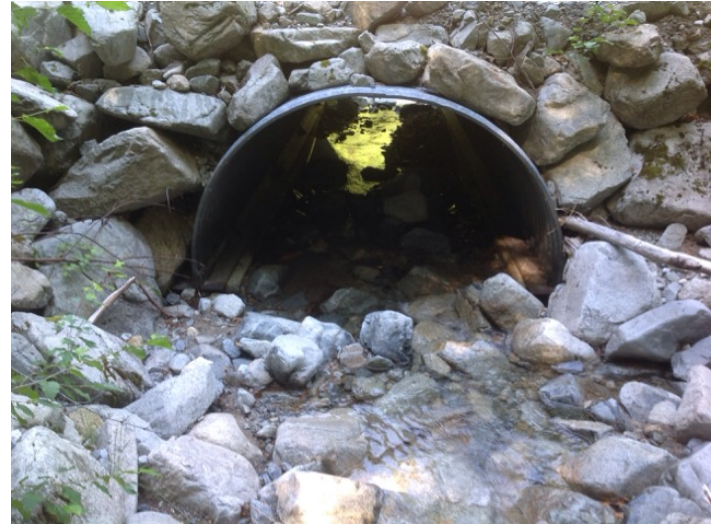
| Inlet | Fair | steep stream coming into culvert |

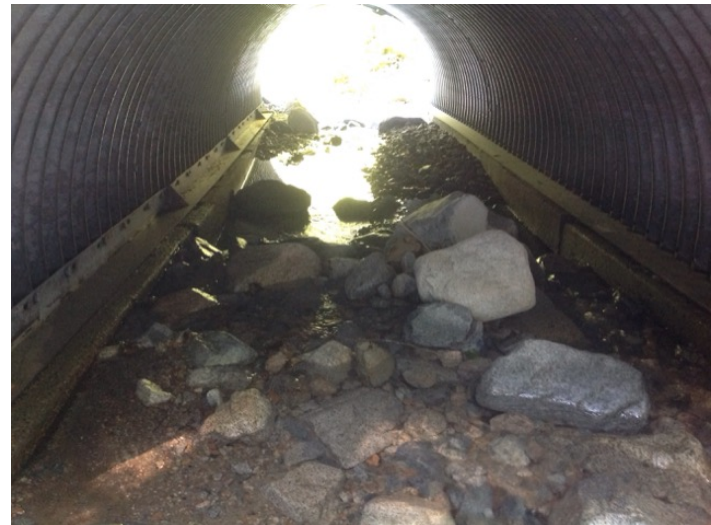
looking through culvert from inlet

| Footing | Fair | concrete footing exposed and slightly scoured in localized areas |

1 footing scour

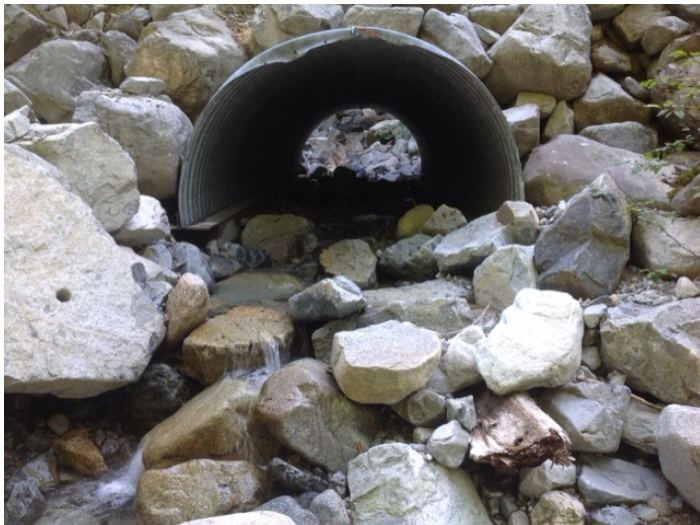
Streambed material eroding approximately 3 meters from the outlet of the culvert - requires monitoring. Material under some portions of the concrete footings still eroding - requires monitoring. The structure should be continually inspected especially during/after periods of heavy rainfall. If the streambed material continues to erode and undermine the footings additional repair work will be required. The site may require a different structure installed. Present load rating of BCL-625 or 63 tonnes to continue.

| Outlet | Fair | steep drop 3 meters from outlet |
