CK-2468

HARRISON EAST 18.3km

2015 Inspection

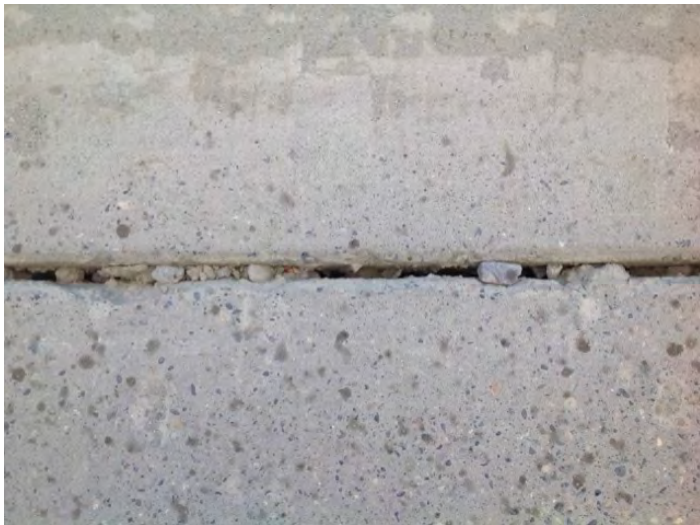
| Concrete Deck | Fair | sealant missing between slabs and gravel wedged in |

sealant missing and gravel getting between the slabs

Replace sealant between slabs. Present load rating of L75 or 68 tonnes to continue.

| Repair Item | Priority | Repair Description |
|---|---|---|
| 1 | Medium | replace sealant between panels |

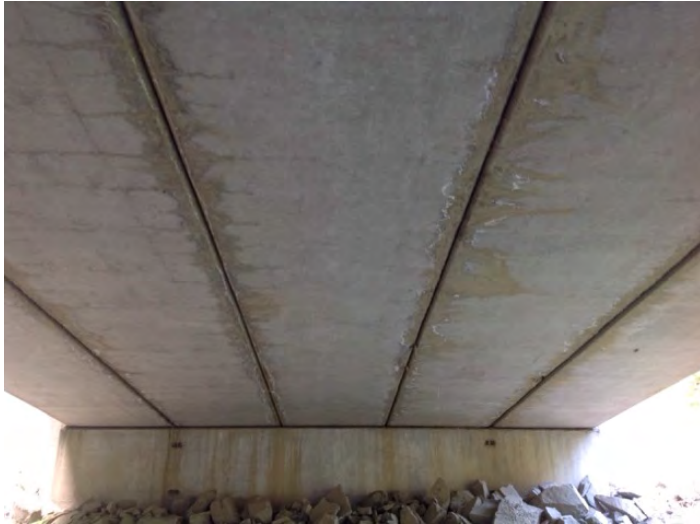
slabs

5 individual slabs, not connected to each other or to cap
