CK-2469

HARRISON EAST 31.3km

2015 Inspection

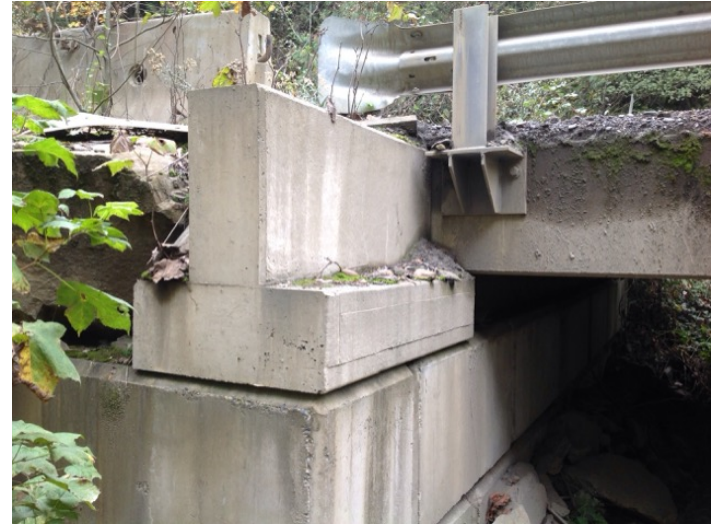
inverted T for ballast wall ends
