CK-2470

HARRISON EAST 22.5km

2015 Inspection

| Structure Class | Major Culvert |

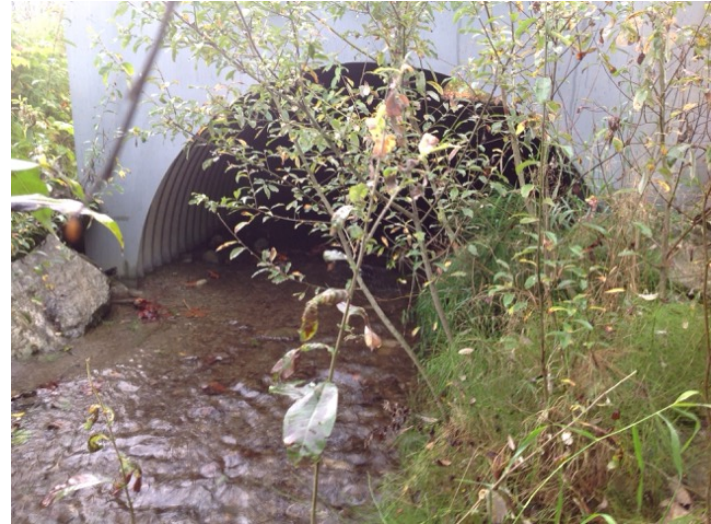
| Outlet | Good |

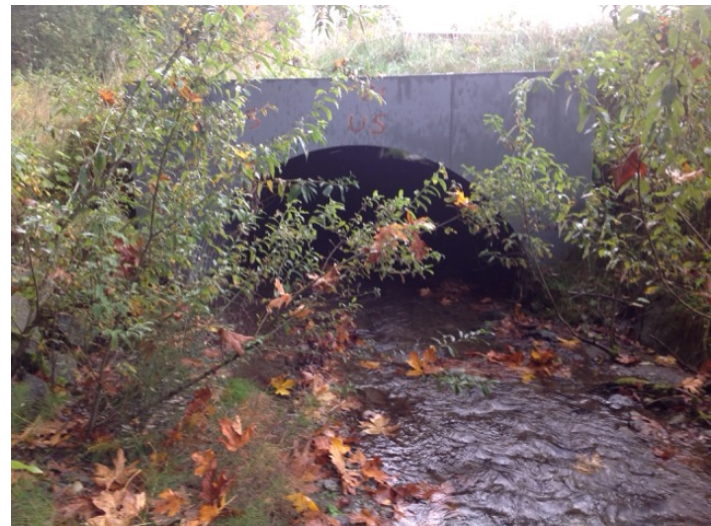
| Inlet | Good |
