CK-2473

NAHATLATCH 45km

2015 Inspection

| Crossing Name | Whistle Pig Creek |

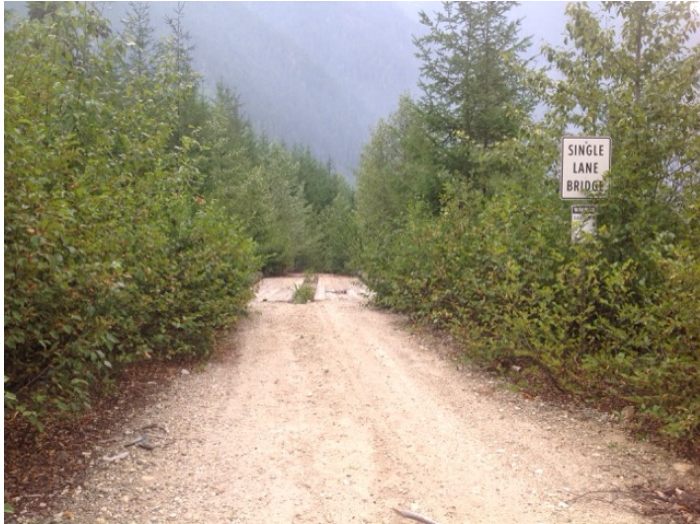
Approach from Right Bank when facing downstream

Road Surface Poor requires surfacing in many locations

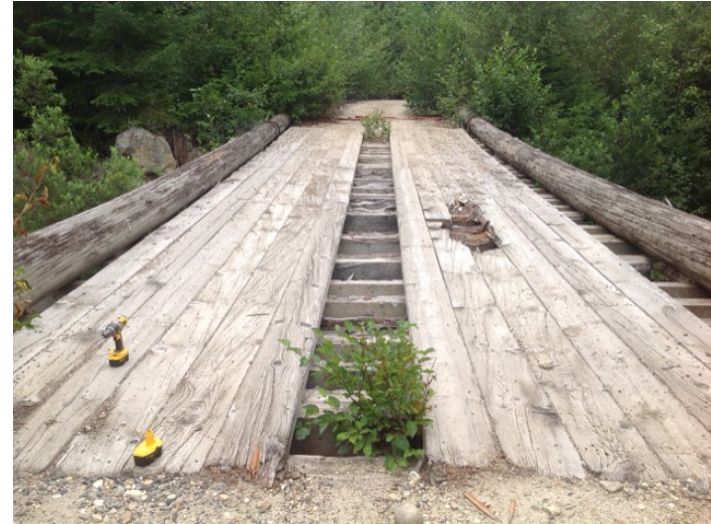
deck

| Running Planks | Poor | rotting |
| Overall Deck Condition | Poor | rotting |

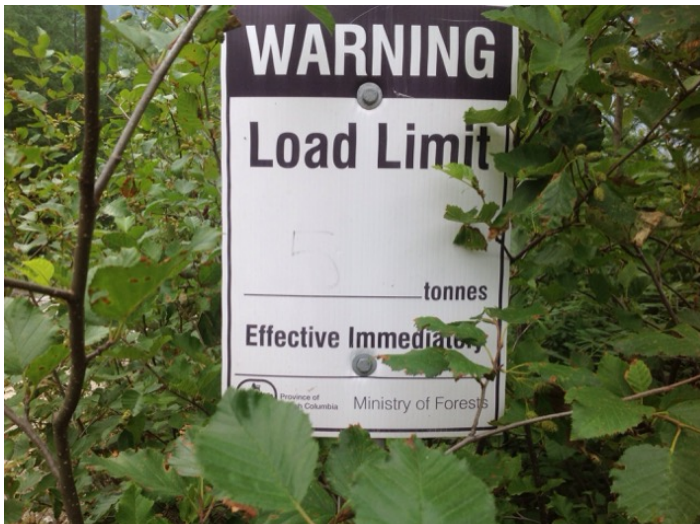
load rating sign

5 tonnes load rating. Monitor holes in deck.

Posted Load Rating 5

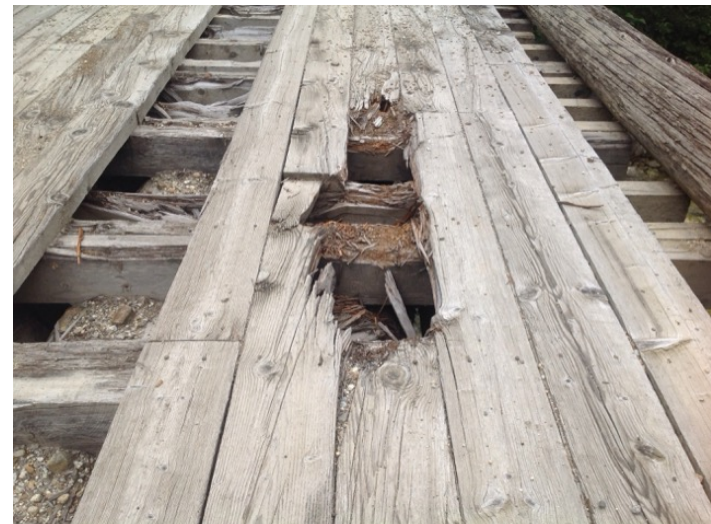
hole in deck

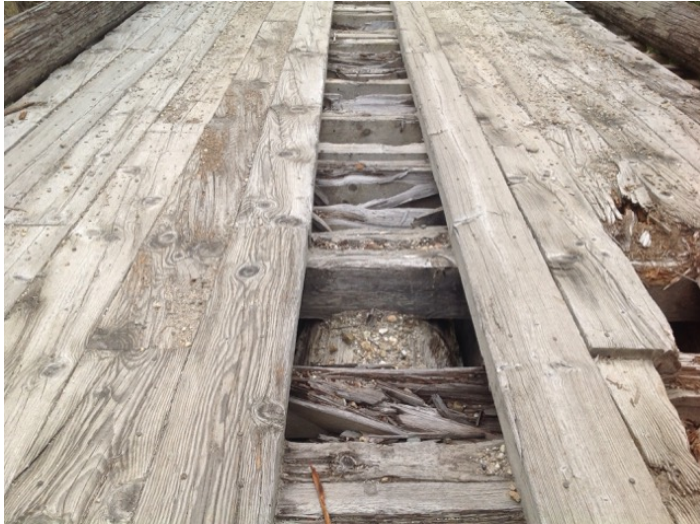
| Ties | Poor | rotting |

tie condition

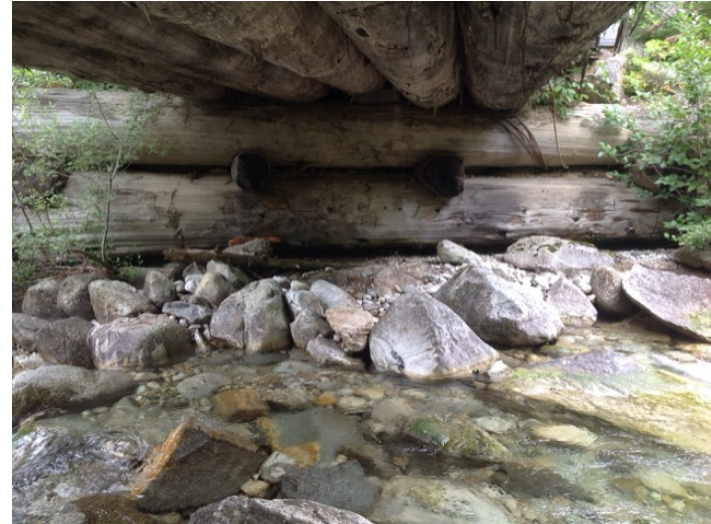
Right Bank Abutment when facing downstream

Log/Timber Cribs Fair

Hardware Poor loose

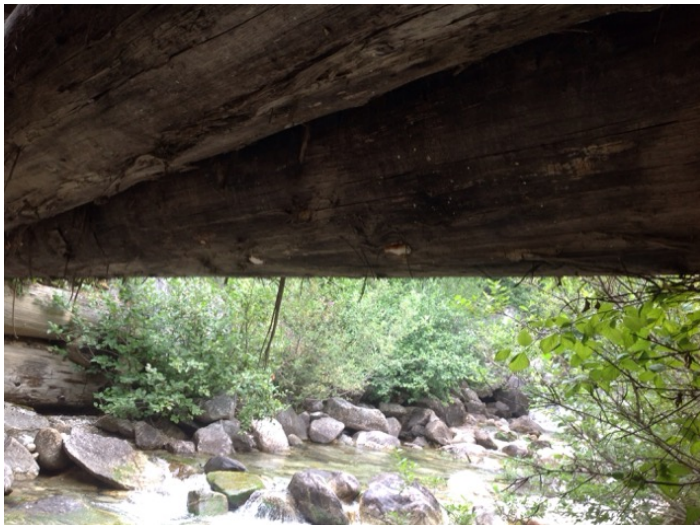
| Stringer<br>Number | Needle Beam to Crib (m) | | Diameter<br>(mm) | Needle Diameter (mm) | | | Comment |
|---|---|---|---|---|---|--|---|
| 1 | Fd | Y | 800 | 210 | Poor | | sap and pocket rot |

stringer 1 - conks starting to form
