CK-2474

NAHATLATCH 46km

2015 Inspection

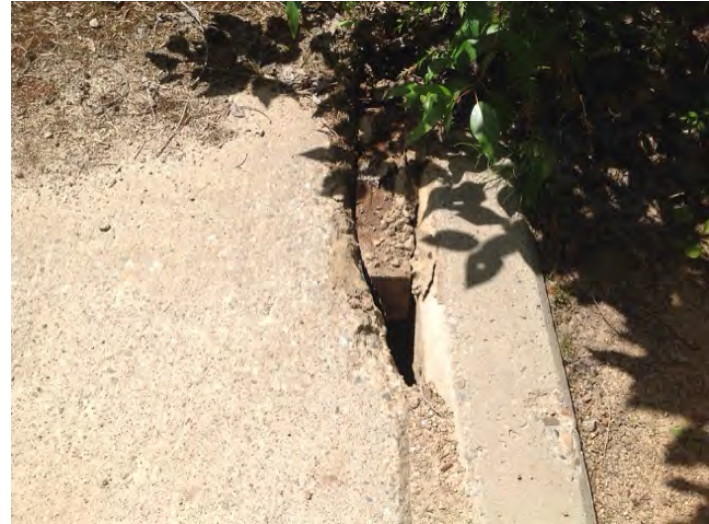
left approach 1st panel damage

Replace guardrail, risers and blocks when active. Brush approaches. Repair damaged panel(s). Replace missing deck clip. Present load rating of L75 or 68 tonnes to continue.

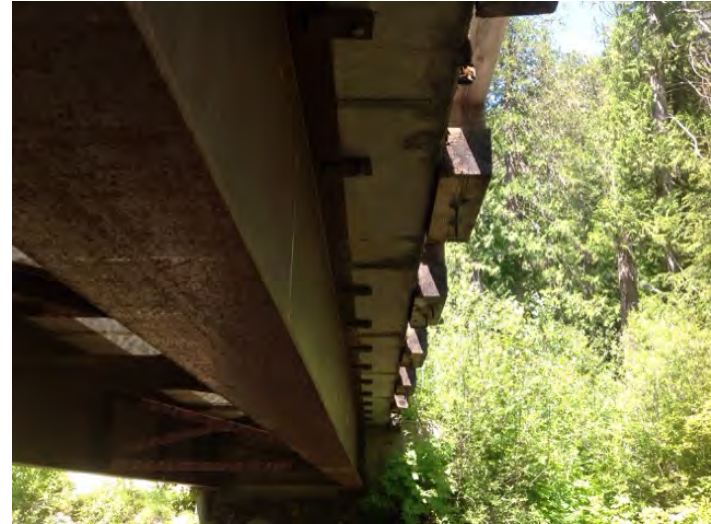
| Deck to Girder Bolts | Fair | missing 1 clip |

deck clips - 1 missing downstream

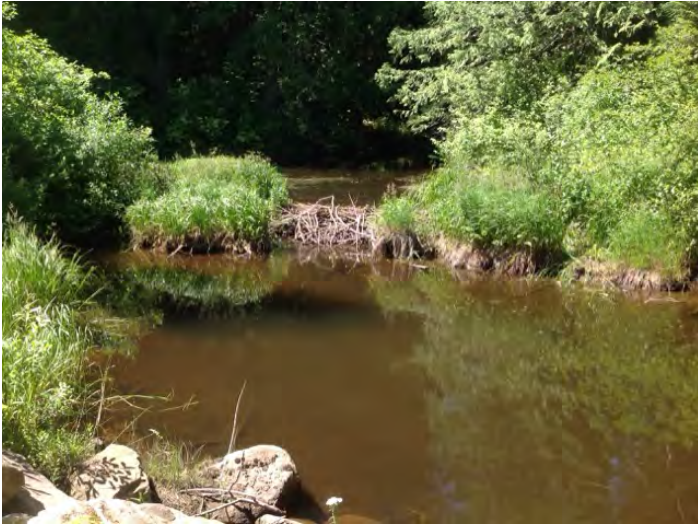
Comments beaver activity in area but very little risk to bridge

beaver dam 15 m upstream
