CK-2478

NAHATLATCH 42.6km

2015 Inspection

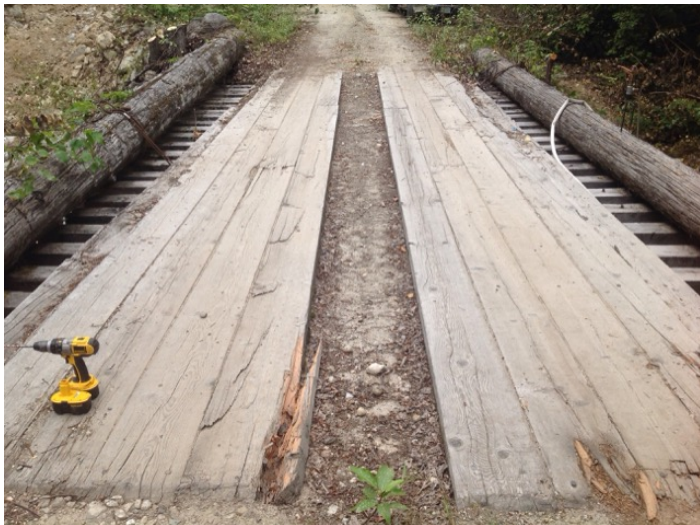
| Overall Deck Condition | Poor | rotting |

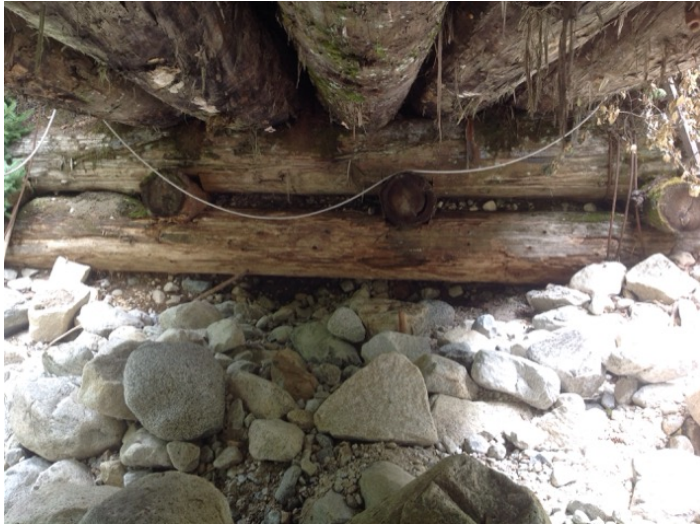
Right Bank Abutment when facing downstream

Log/Timber Cribs Poor scoured right

Bearings Poor scoured under right crib

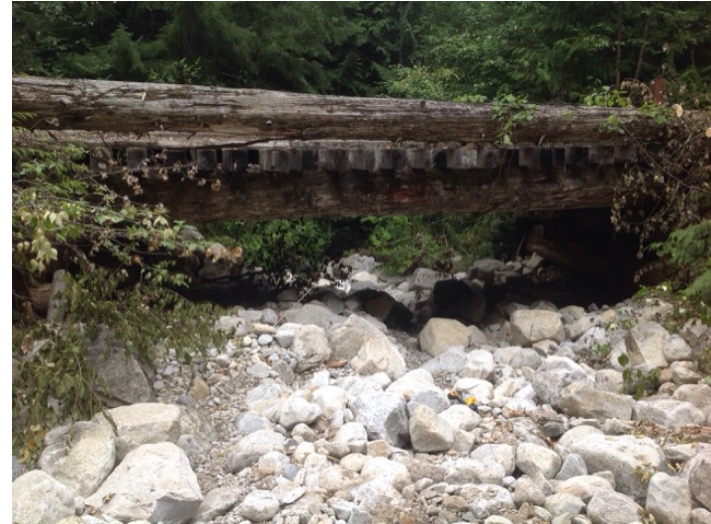
Upstream Profile

Comments stringers are rotten

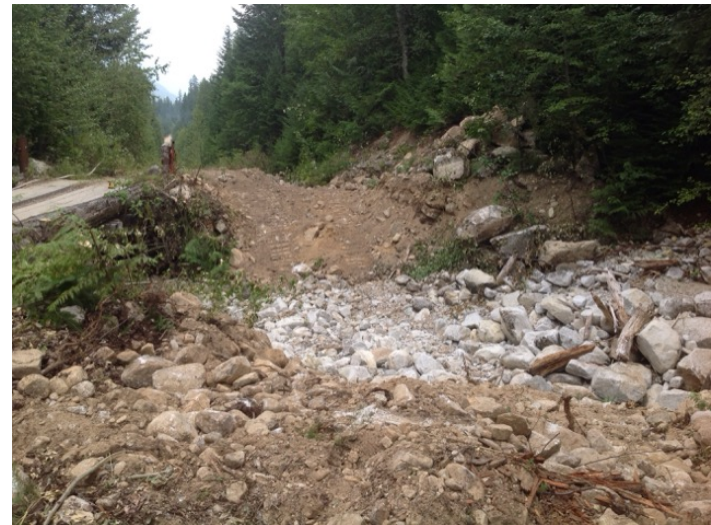
machine bypass just upstream

Structure condemned, 0 tonnes load rating. Post load rating sign and block access or remove structure. Due to the ongoing fire fighting efforts in the area a temporary bypass road was constructed immediately upstream of the crossing for machine access (stream is dry). Recommend upgrading this bypass route so vehicles can access while the stream is dry. If the stream starts to flow recommend placing a temporary crossing (bridge) if access is required.
