CK-2493

RUBY ELEVEN 0.15km

2015 Inspection

| Crossing Name | Mahood Creek |

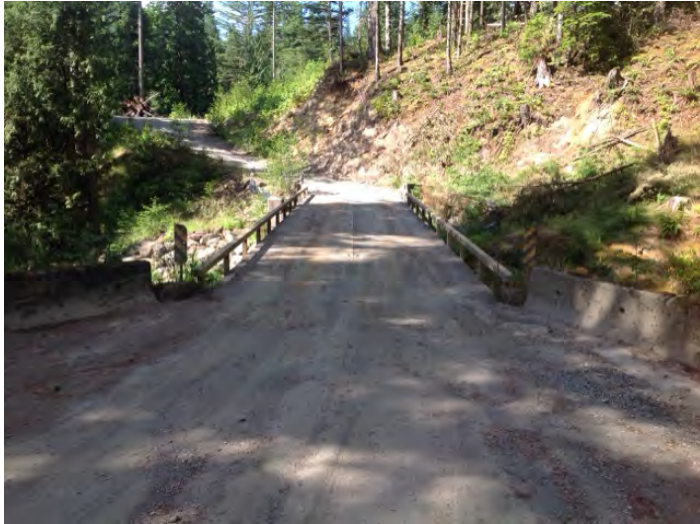
Approach from Left Bank when facing downstream

Delineator Missing  
Left ☐ 0 ☒ 1 ☐ 2

| 1 | Medium | replace delineator |

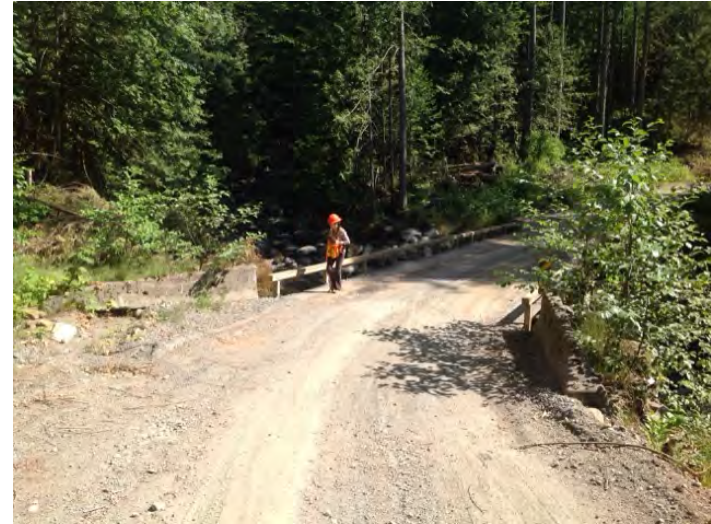
Approach from Right Bank when facing downstream

Bridge Ahead Signs  
Missing ☐ 0 ☐ 1 ☒ 2

| 2 | Medium | post bridge ahead signs |

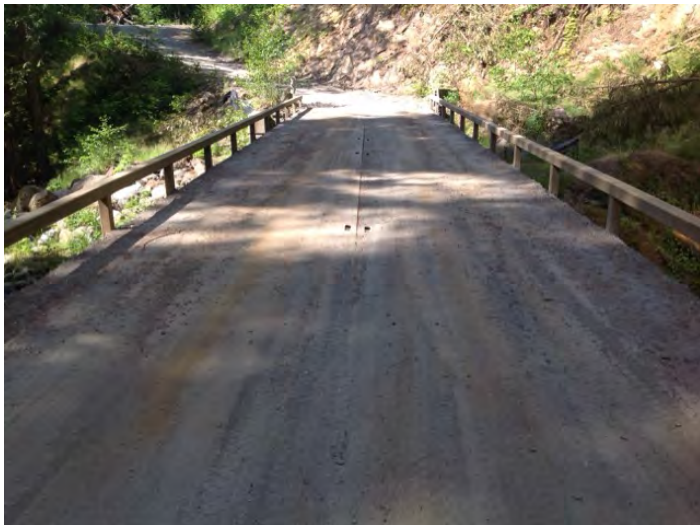
| Steel Deck Plate | Good | anti skid worn |
