2494

NORRISH WEST 0.1km

2015 Inspection

| Crossing Name | Dickson Creek |

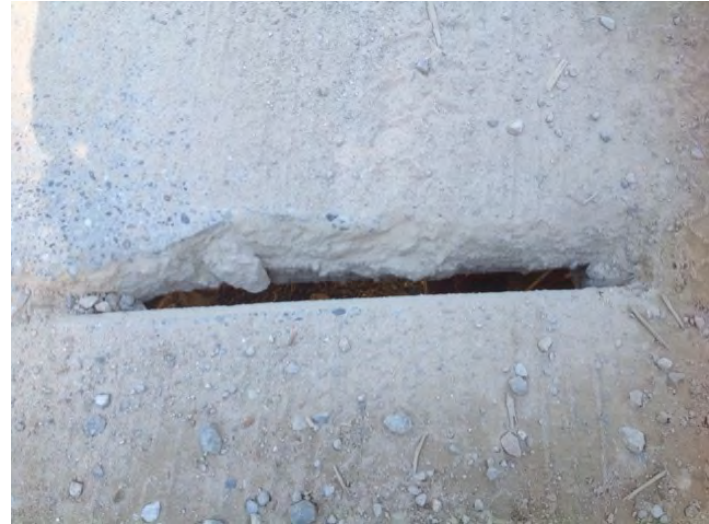
Concrete Deck Fair damage to many of the deck panels

panel damage on left approach

Many of the deck panels have sustained damage; I recommend repairing all of the damage ones before further damage is done. Replace all deck seals. Replace missing delineator. The present load rating of L75 or 68 tonnes can continue.

Comments recommend removing all panels and repairing - much damage sustained

| Repair Item | Priority | Repair Description |
|---|---|---|
| 1 | High | deck panels damage |

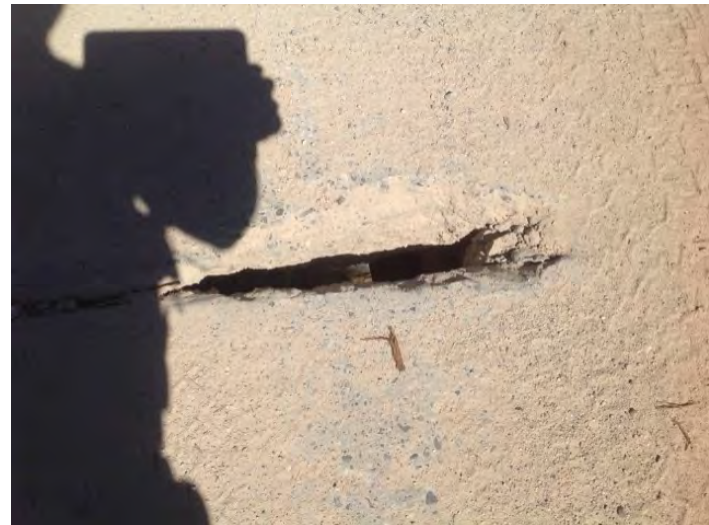
panel damage mid span

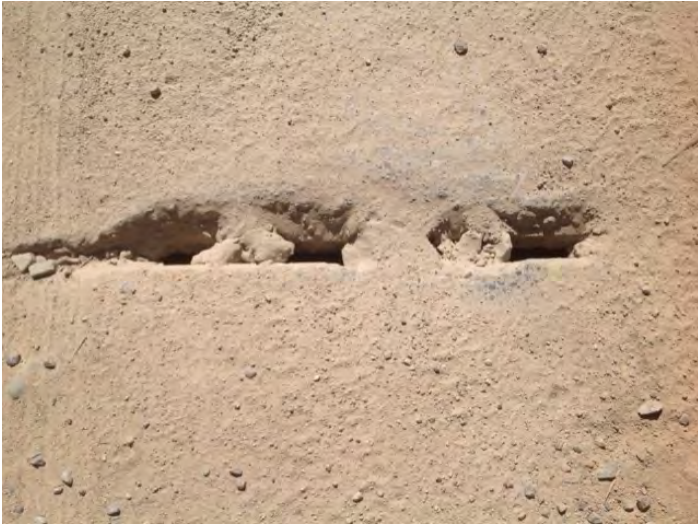
panel damage right approach

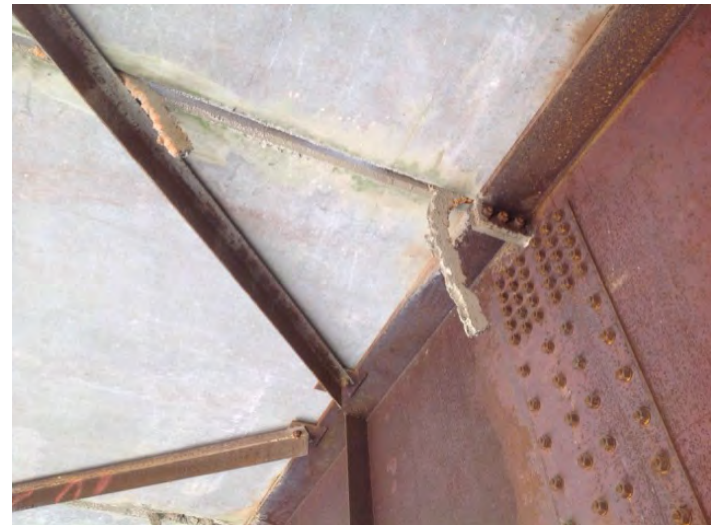
deck seals all falling out

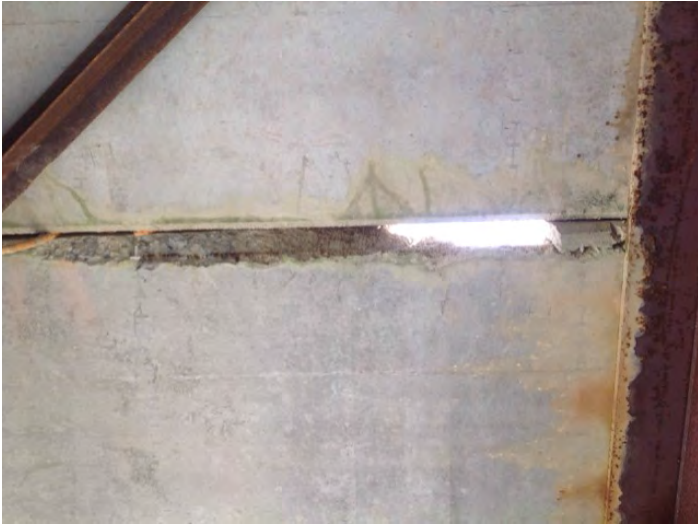
deck panel damage from underneath

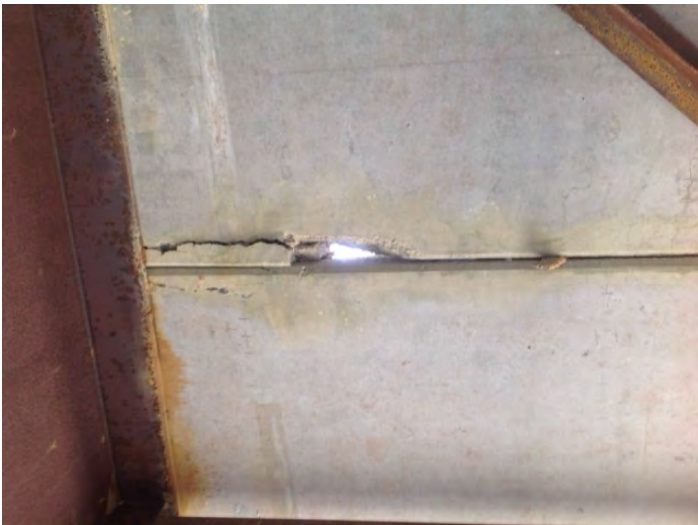
deck panel damage from underneath
