CK-2501

CHEHALIS-FLEETWOOD 4.3km

2015 Inspection

| Structure Class | Major Culvert |

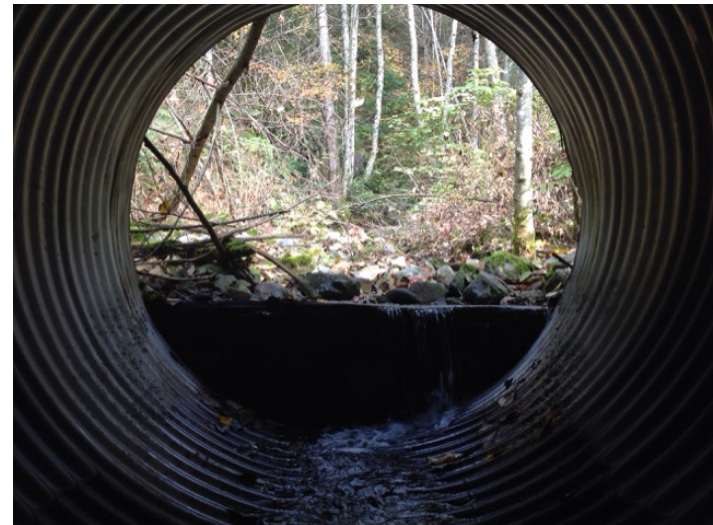
| Inlet | Fair | partially obstructed |

Inlet partially obstructed

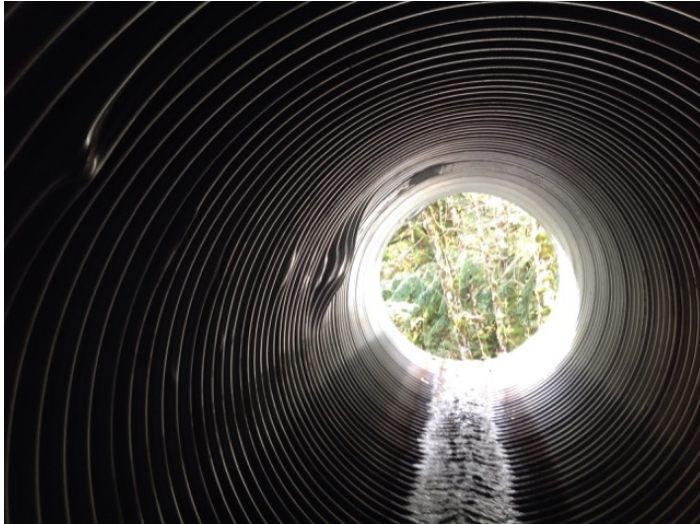
sidewall damage

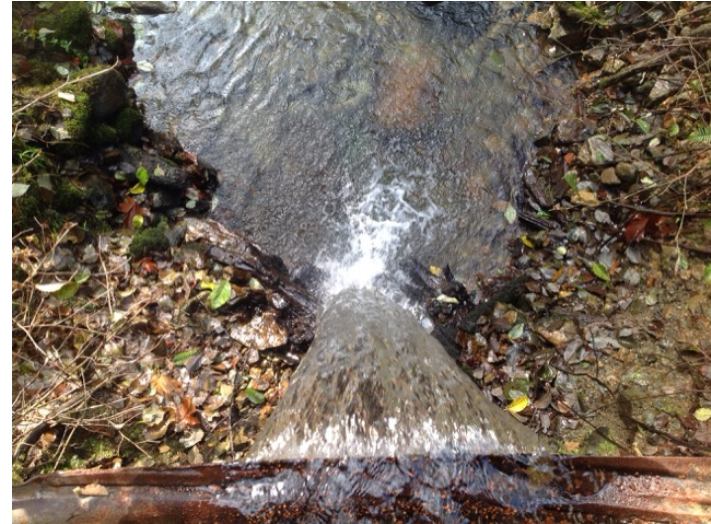
| Outlet | Fair | approx 3m drop |

Outlet drop

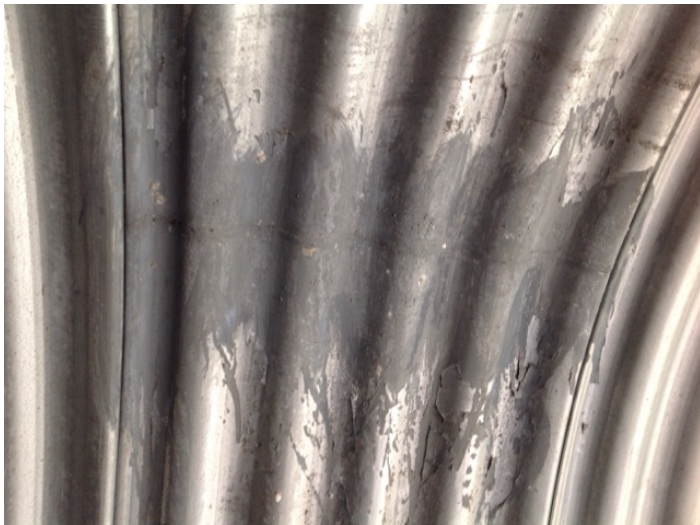
past culvert repair
