CK-2505

MURDO SIXTEEN 0.4km

2015 Inspection

Structure Class Woodbox/Log Culvert

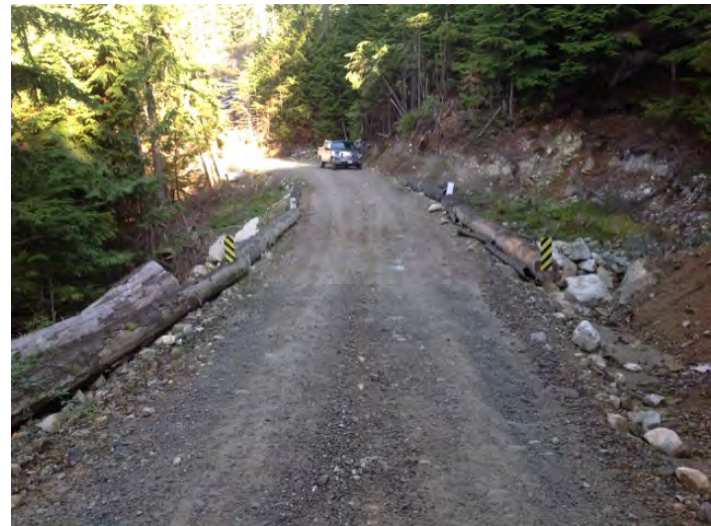
Approach from Left Bank when facing downstream

Fender Condition Fair missing left upstream fender

| Repair Item | Priority | Repair Description |
|---|---|---|
| 2 | Medium | replace missing fender log |

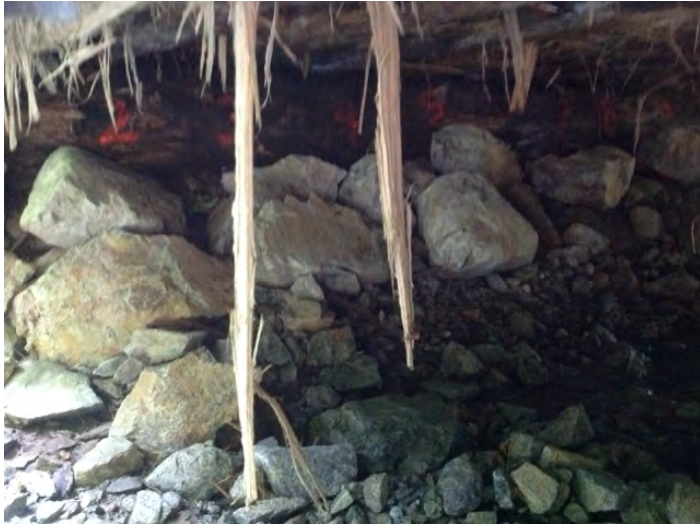
Left Bank Abutment when facing downstream

Caps or Sills Fair scoured downstream on both ends

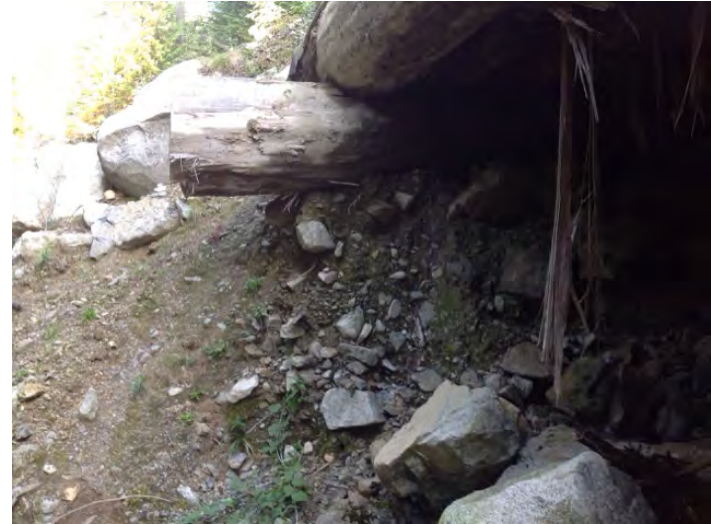
Replace the missing guide log on upstream left approach. Post bridge ahead signs. Monitor the fill at the outlet of the structure. The sill logs are already scoured and the remaining fill is over-steepened. If anymore scour has taken place then what is evident in this inspection then the usage should be halted and a repair plan determined. Present load rating of L120 or 109 tonnes to continue.

Comments    The scour does not appear to have changed from last inspection. Either deactivate and make passable by 4x4 or repair scour

scour under right downstream sill

| Repair Item | Priority | Repair Description |
|---|---|---|
| 3 | High | repair downstream scour on both abutments |

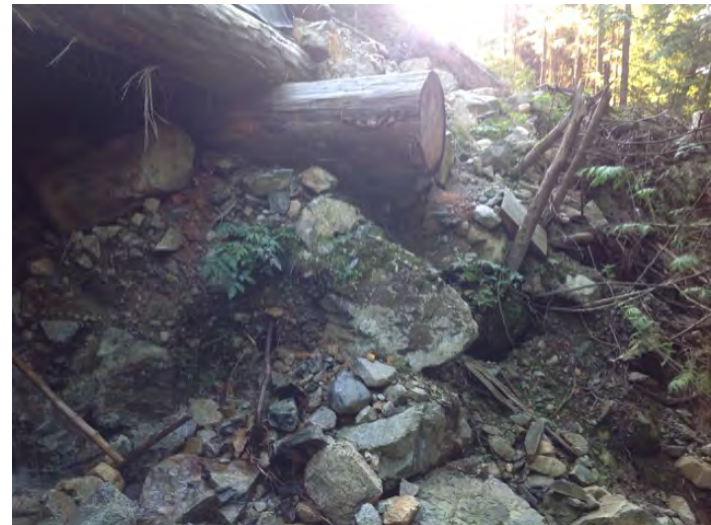
scour under left downstream sill
