CK-2506

ChehalisAlf 0.4km

2015 Inspection

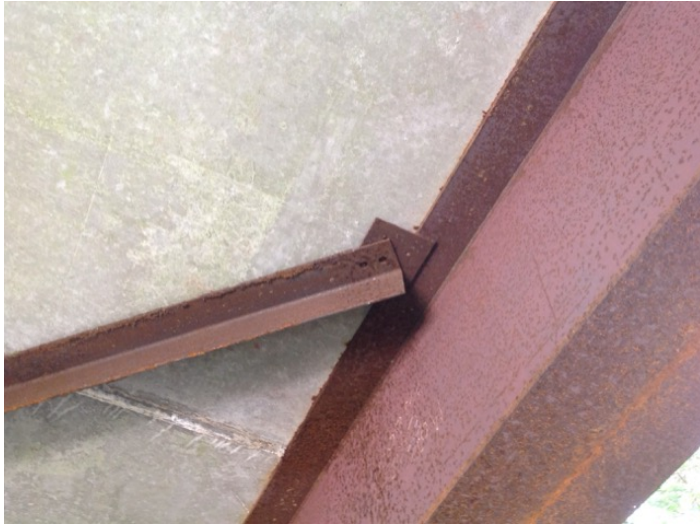
Bracing Poor missing bolts

Hardware Poor missing 2 bracing bolts

missing bracing bolts

| Item | Priority | Repair Description |
|---|---|---|
| 2 | Medium | replace missing bracing bolts |

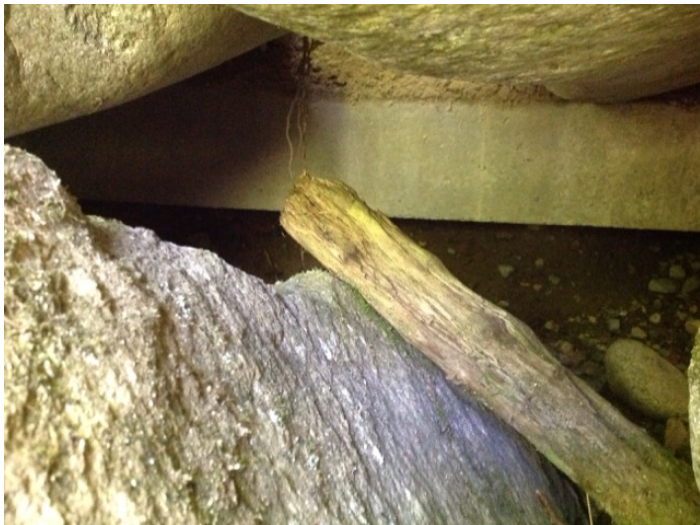
The right downstream precast footing is undermined and subject to further scour. The upstream footing is exposed to scour but at the time of the inspection was not. The riprap is all rounded and not well graded which will lead to further erosion of the footings. The guardrail system is rotten. There are missing bracing bolts. Recommend a complete replacement of the structure for long term use. Load rating is 40 tonnes until material under footing is replaced and proper bearing is attained. Please post.

Fill Poor material under downstream right footing is scoured

Bearings Poor material under downstream right footing is scoured, upstream is exposed but not scoured

scoured footings right approach - approx 500mm from front face

| Item | Priority | Repair Description |
|---|---|---|
| 1 | Medium | repair scoured footing prior to industrial traffic |

| Item | Monitor Description | Frequency |
|---|---|---|
| 1 | scour under footings | Anually |
