CK-2507

Winslow Creek 5.0km

2015 Inspection

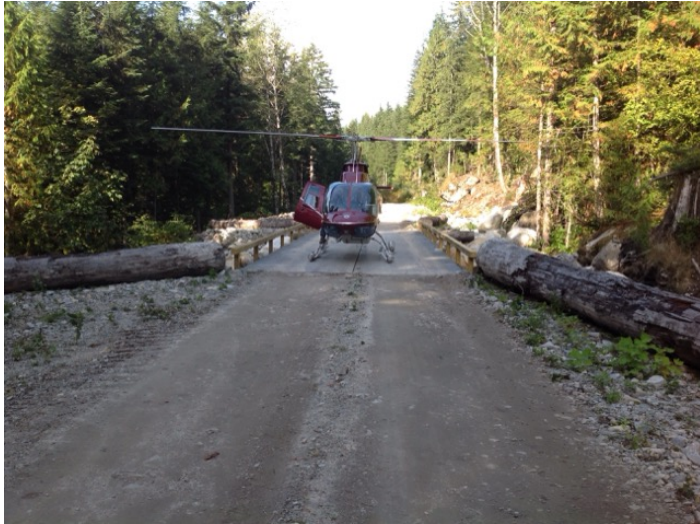
Approach from Left Bank when facing downstream

Bridge Ahead Signs  
Missing ☐ 0 ☐ 1 ☒ 2

Delineator Missing  
Left ☐ 0 ☐ 1 ☒ 2Delineator Missing  
Right ☐ 0 ☐ 1 ☒ 2

Replace delineators and post bridge ahead signs. Present load rating of L75 or 68 tonnes to continue.

| Repair Item | Priority | Repair Description |
|---|---|---|
| 1 | High | post delineators and bridge ahead signs |

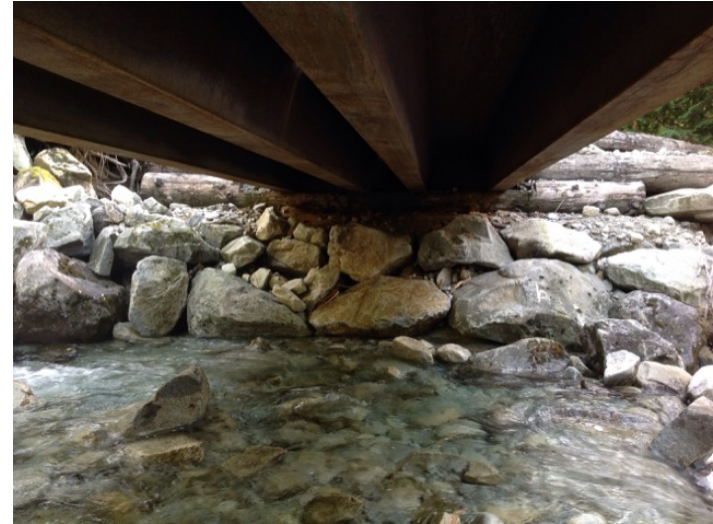
Left Bank Abutment when facing downstream

Caps or Sills Good log sills

Ballast Wall Good logs

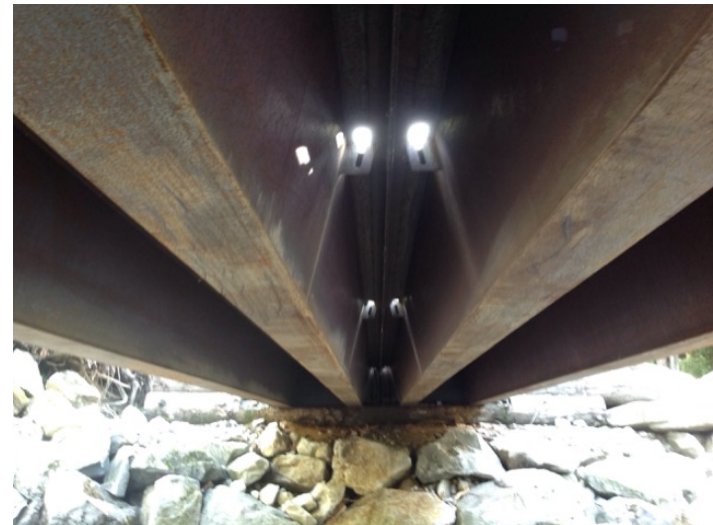
superstructure

Girders Good

Diaphragms Unrated can't see

Bracing Unrated can't see

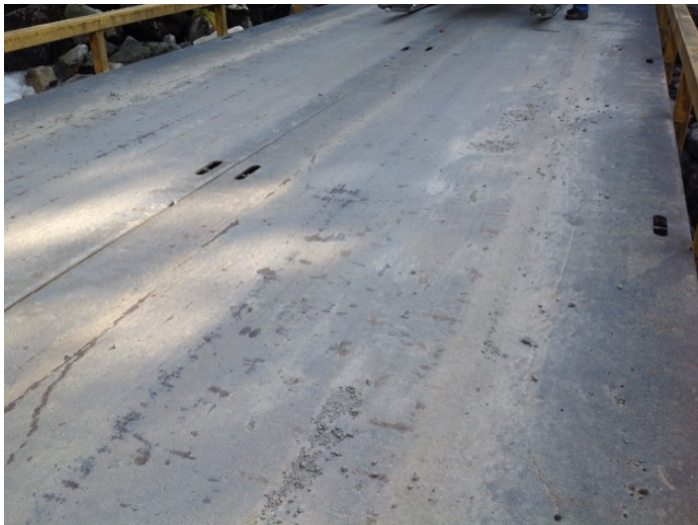
Steel Deck Plate      Good

Overall Deck Condition      Good
