CK-2512

CLEAR CREEK 14.7km

2015 Inspection

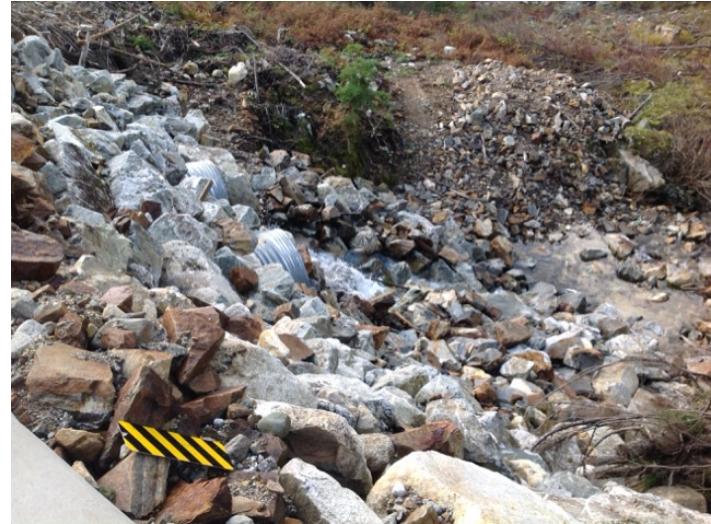
Outlet Fair

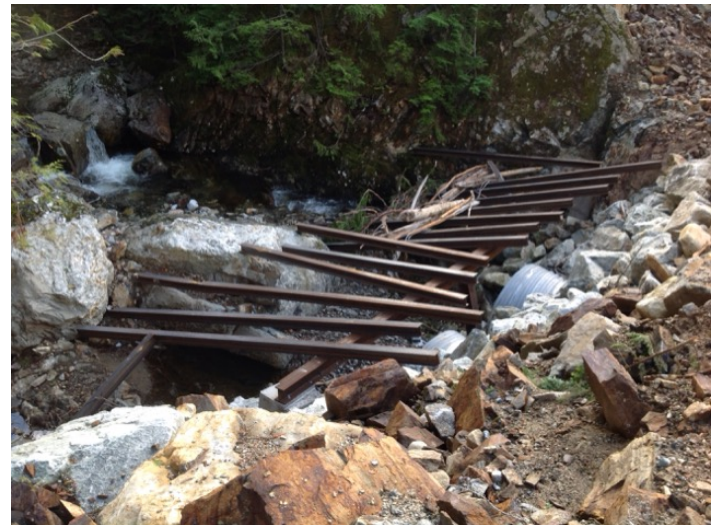
Inlet Good
