CK-2518

AMERICAN CREEK 12km

2015 Inspection

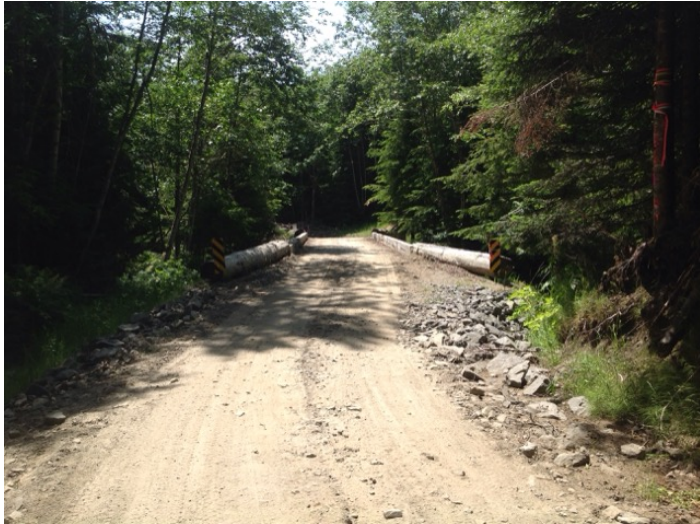
Approach from Left Bank when facing downstream

Delineator Missing  
Left ☐ 0 ☒ 1 ☐ 2Delineator Missing  
Right ☒ 0 ☐ 1 ☐ 2

| Repair Item | Priority | Repair Description |
|---|---|---|
| 1 | medium | replace missing delineator |

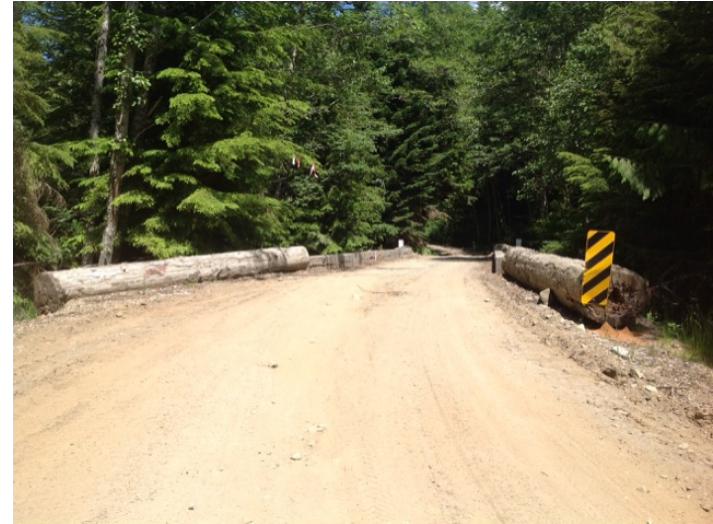
Approach from Right Bank when facing downstream

Bridge Ahead Signs  
Missing ☐ 0 ☐ 1 ☒ 2

| 2 | medium | post bridge ahead signs |

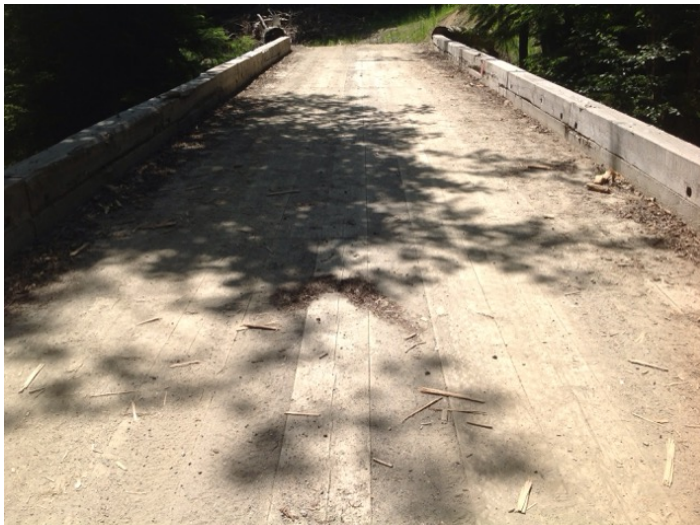
Deck

Running Planks Fair 6.5 standard modular panels

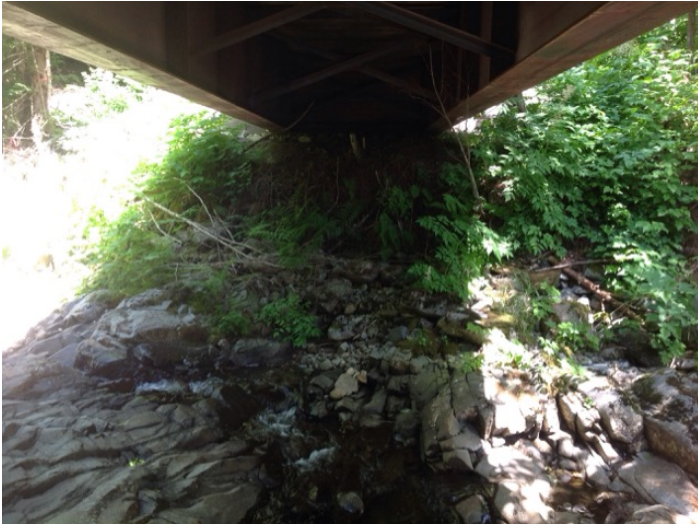
Left Bank Abutment when facing downstream

Caps or Sills Good timbers

Ballast Wall Good timbers

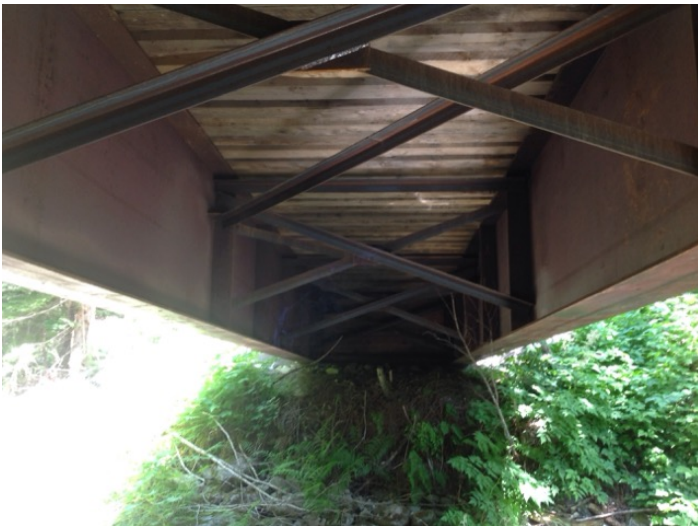
superstructure

Girders Good

Diaphragms Good 6 bays, welded
