CK-2519

AMERICAN CREEK 16km

2015 Inspection

| Crossing Name | East Fork Garnet Creek |

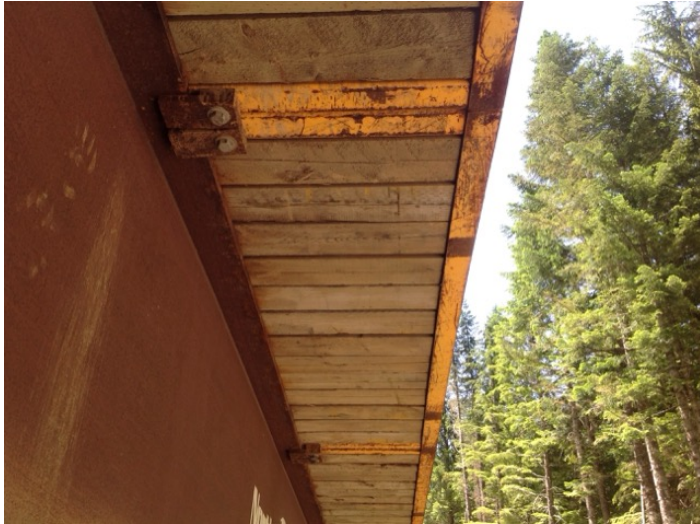
timber deck panels with HSS rails
