CK-2528

MOLLY HOGAN POINT 0.1km

2015 Inspection

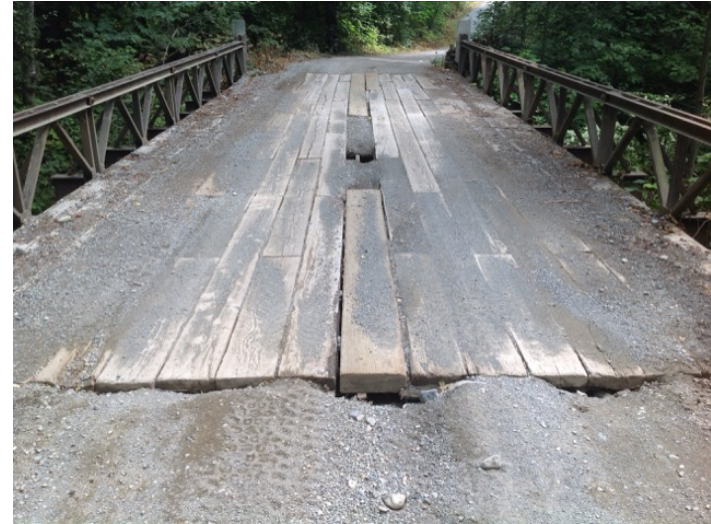
| Running Planks | Poor | holes and planks not nailed down |
| Sub Deck | Poor | rotten plywood |
| Overall Deck Condition | Poor | replace with proper deck or replace entire structure |

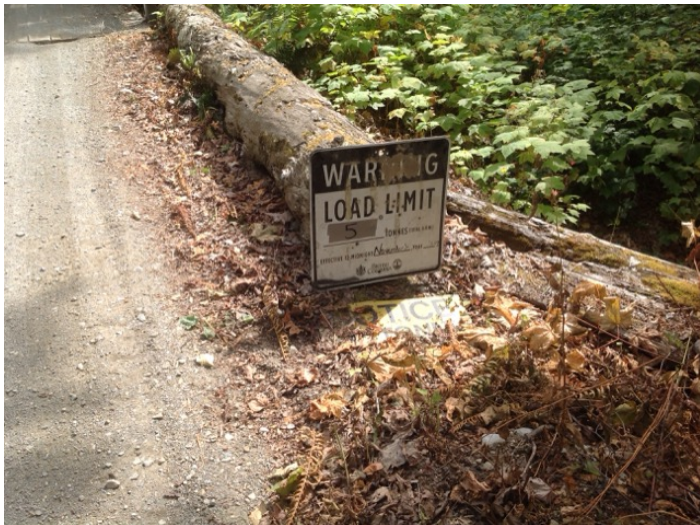
load rating sign

Posted Load Rating 5

Limit loading to 5 tonnes. The structure is tentatively planed for replacement in the summer of 2016.

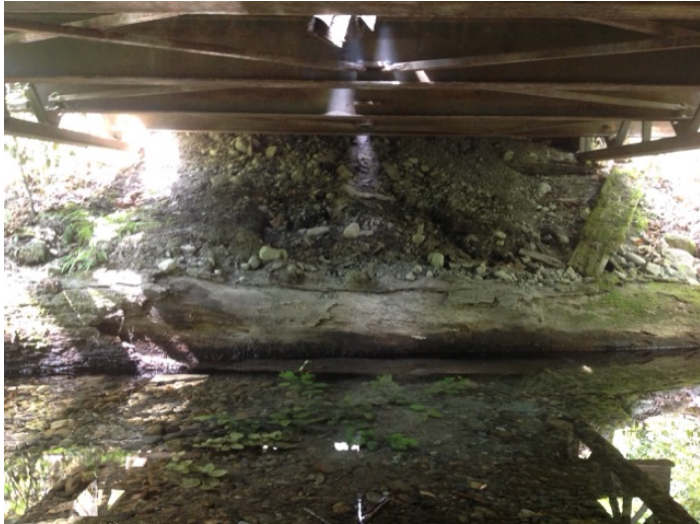
Right Bank Abutment when facing downstream

Caps or Sills Poor logs

replacement structure can be moved downstream 3 meters or skewed (move woods abutment 3 meters downstream)

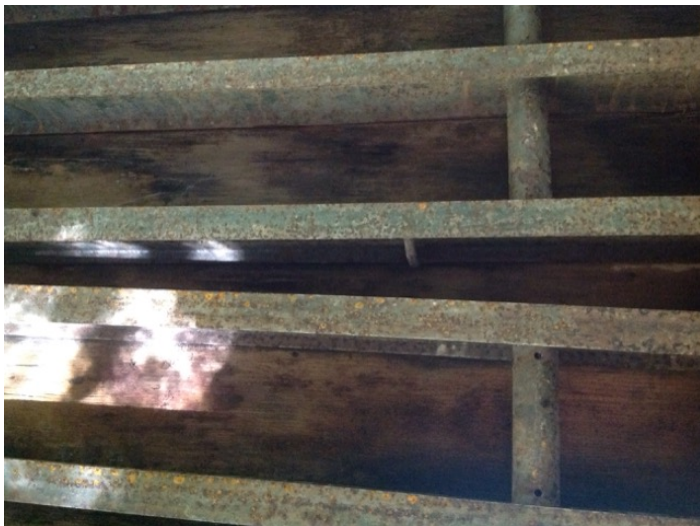
steel stringers are moving

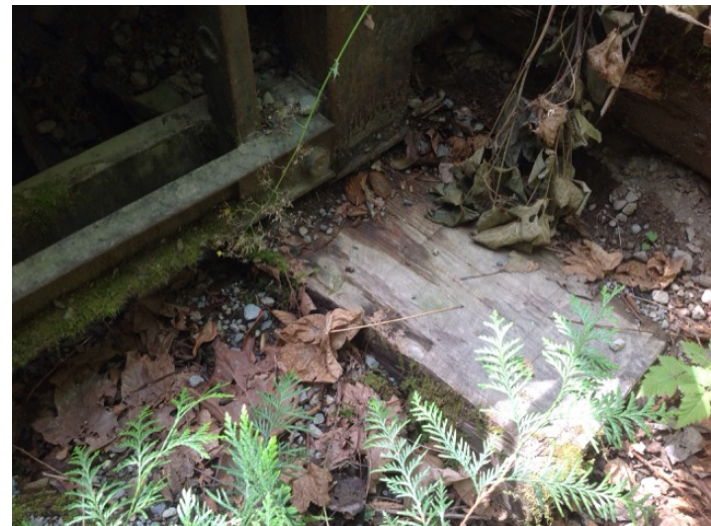
log sill
