CK-2007

ANDERSON SEVEN 0.1km

2016 Inspection

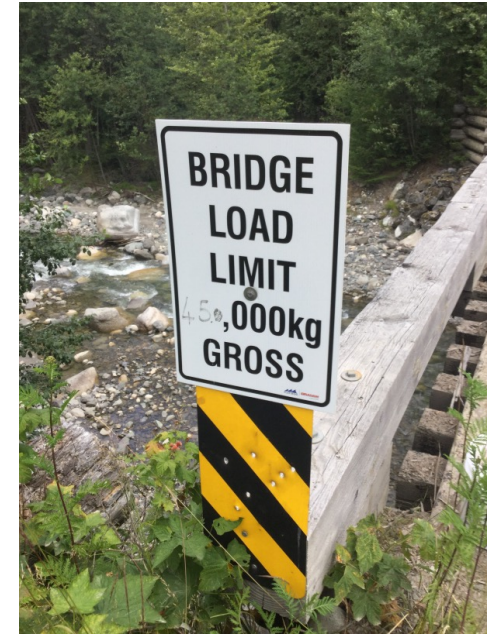
Load Posting

Previous inspection report noted posting was increased from L45 to L75 with addition of pier, stiffeners, and diaphragm. With the removal of the pier the current posting should be reviewed to ensure the posting can increase from the design load of 41 tonnes to the current posting of 45 tonnes.

Posted Load Rating 45

Replace missing wear planks; place fender logs; install bridge ahead signs; grade approaches and brush. Monitor crib condition and bearing. Because the temporary pier has been removed the load rating is now reverted back to the original design rating of L45 or 41 tonnes.

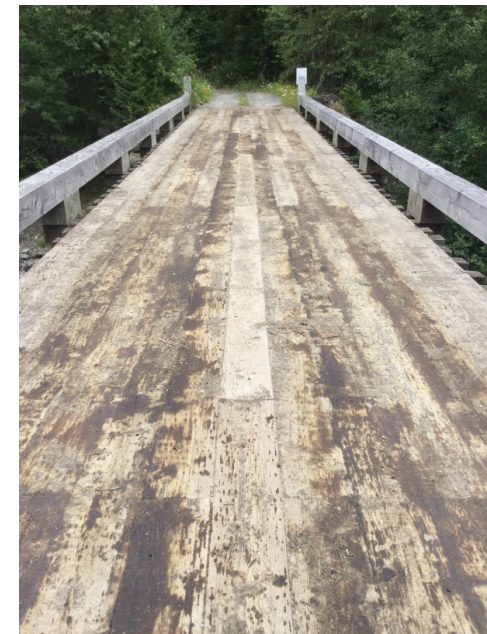
Deck

| Running Planks | Fair | Running planks removed since previous inspection, leaving structural deck to form running surface. Localized wear with exposed nail holes from previous running planks. |

| 4 | Medium | Replace wear planks |

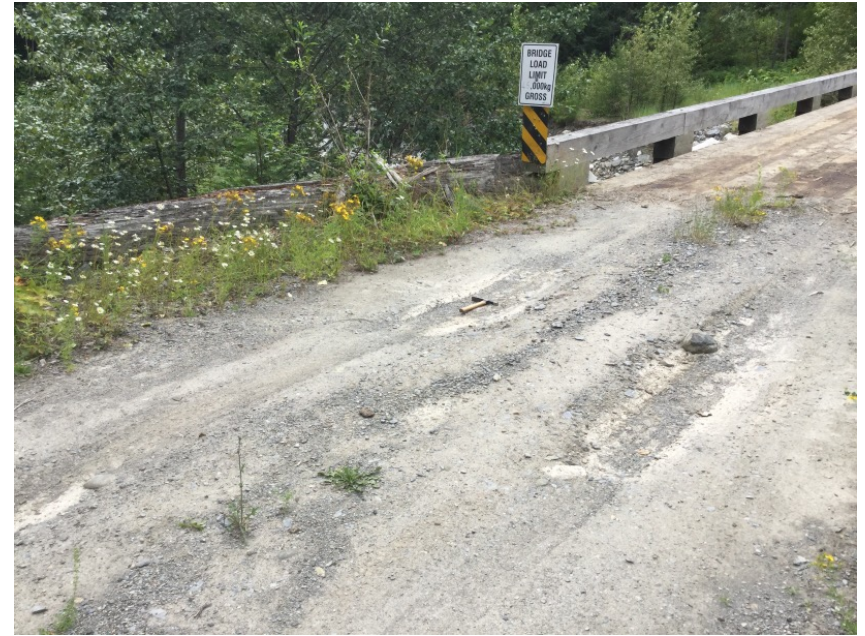
Right end upstream guide log is rotten, no fenders at other corners of bridge.

Large potholes in both approaches.

Typical Potholes in Approach & Rotten Guide Log

| Item | Priority | Repair Description |
|---|---|---|
| 1 | Medium | Replace fender logs. Regrade approaches for industrial use. |

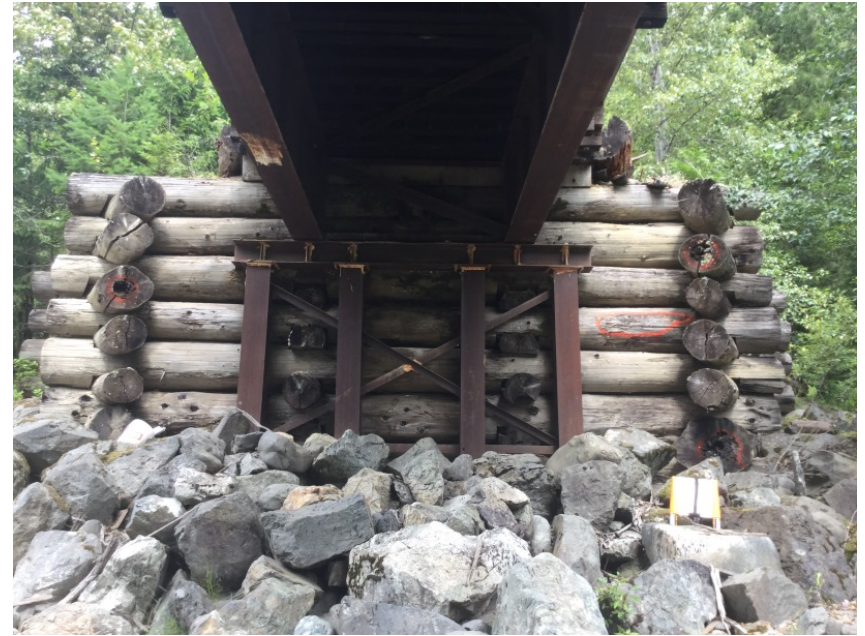
Right Bank Abutment

Log crib abutments only retain fill. 600-850 mm dia. logs. Up to 400 mm centre rot noted in larger logs. No signs of crushing or distress.

| 1 | Monitor condition of log crib abutments. | Routine Inspection |

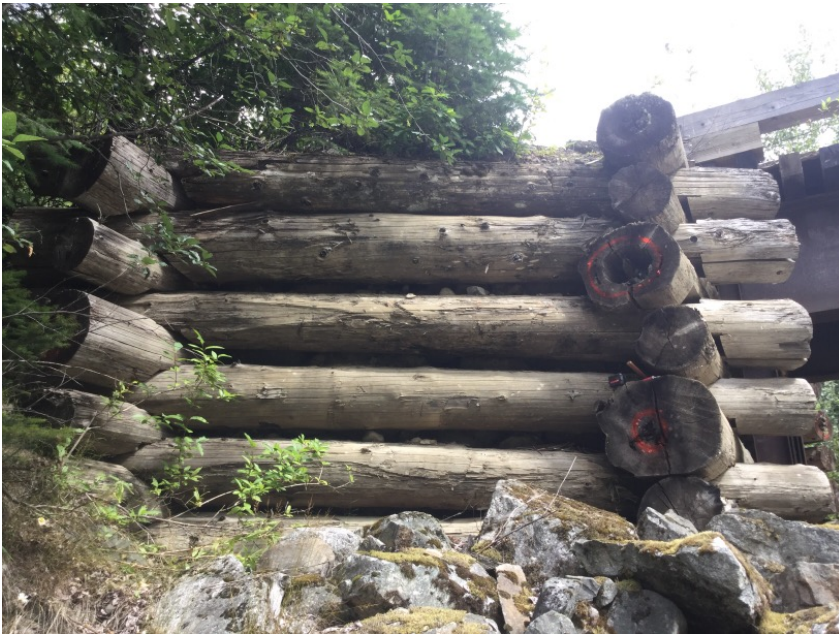
Right Abutment Downstream Wing Wall

Typical 10 mm sap wood rot. 400-800 mm dia. logs. Centre rot typically noted up to 400 mm. No signs of crushing or distress noted.

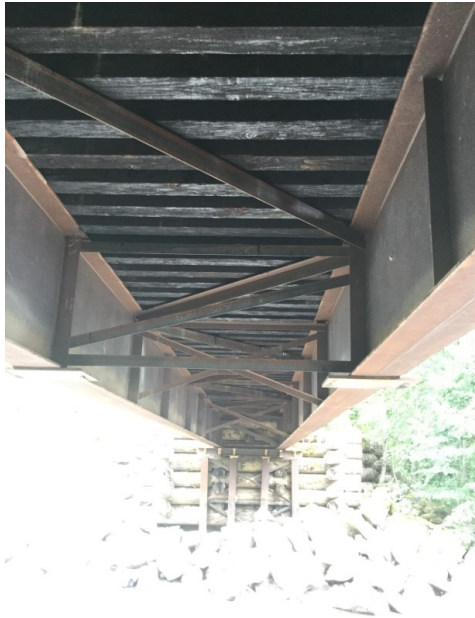
Pier support removed since previous inspection.

Girder Condition & Removed Pier Bearing Plates

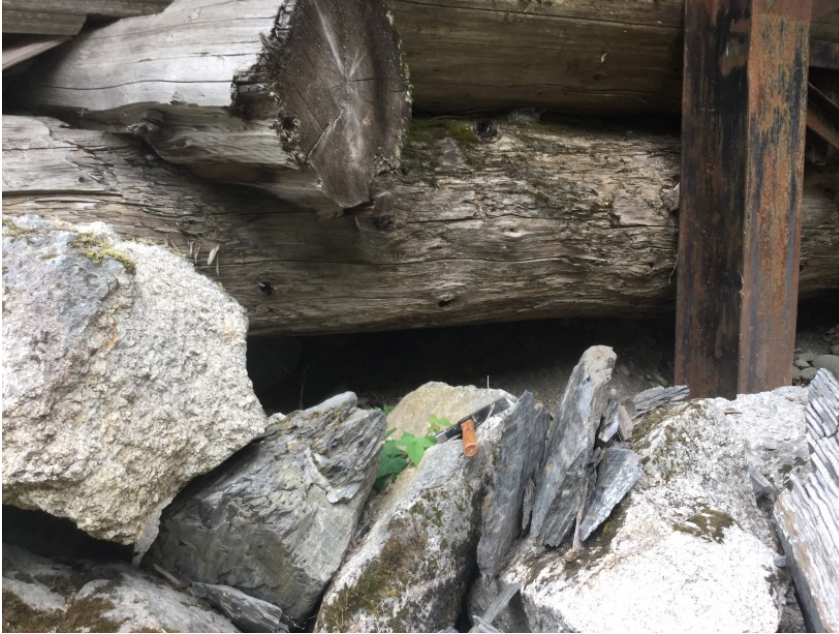
Left Abutment Upstream Corner: scour hole extending 300 mm behind base log extends 2.5 m along log. No sign of abutment movement.

Left Abutment Upstream Corner Scour

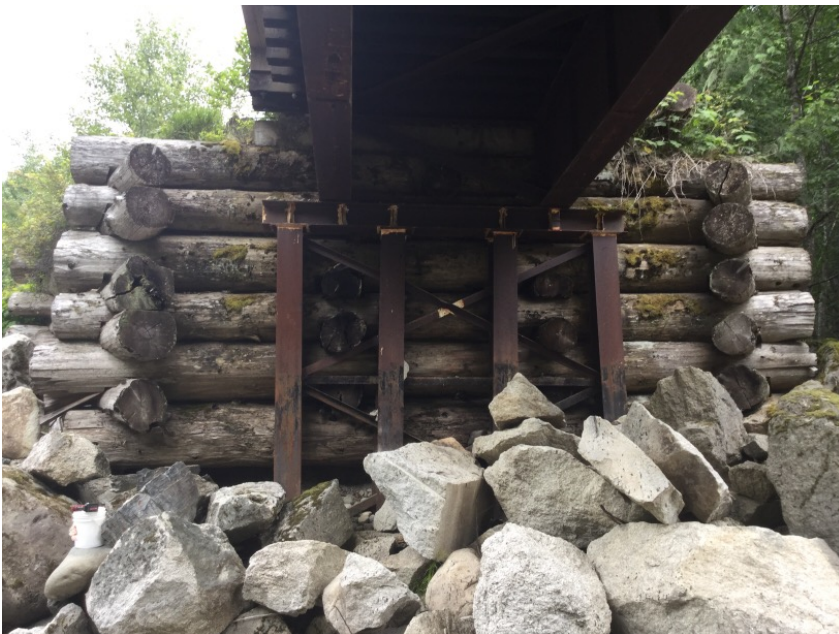
Left Bank Abutment

3 logs tied into log crib at each abutment. Up to 250 mm of centre rot noted in left abutment logs. No signs of crushing or distress.

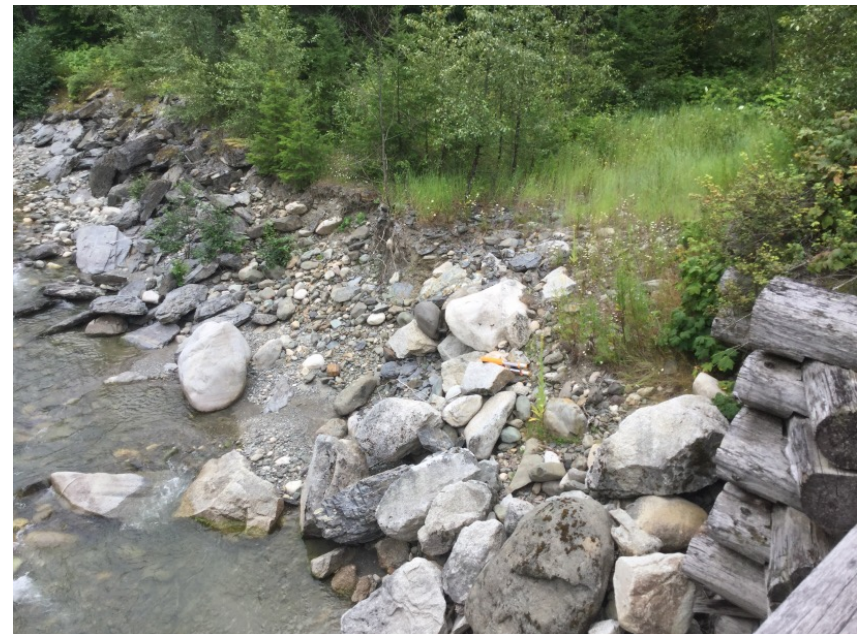
Left bank erosion upstream of riprap. Does not affect bridge.

Left Bank Erosion at Upstream Corner
