CK-2008

ANDERSON SEVEN 0.3km

2016 Inspection

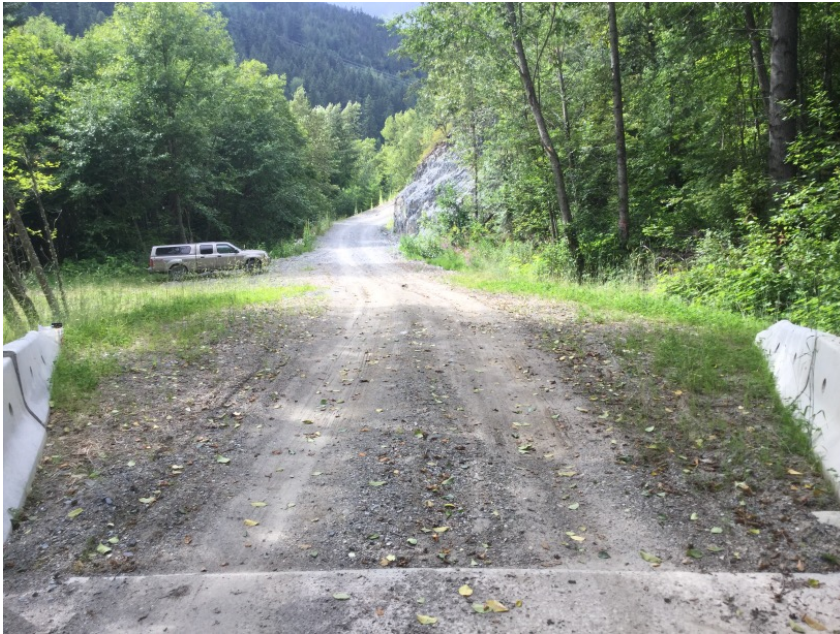
Right Approach Facing Away From Bridge

Road surface 65 mm below level of deck, with rutting, potholes and signs of ponding.

| 2 | Medium | Regrade approaches. |

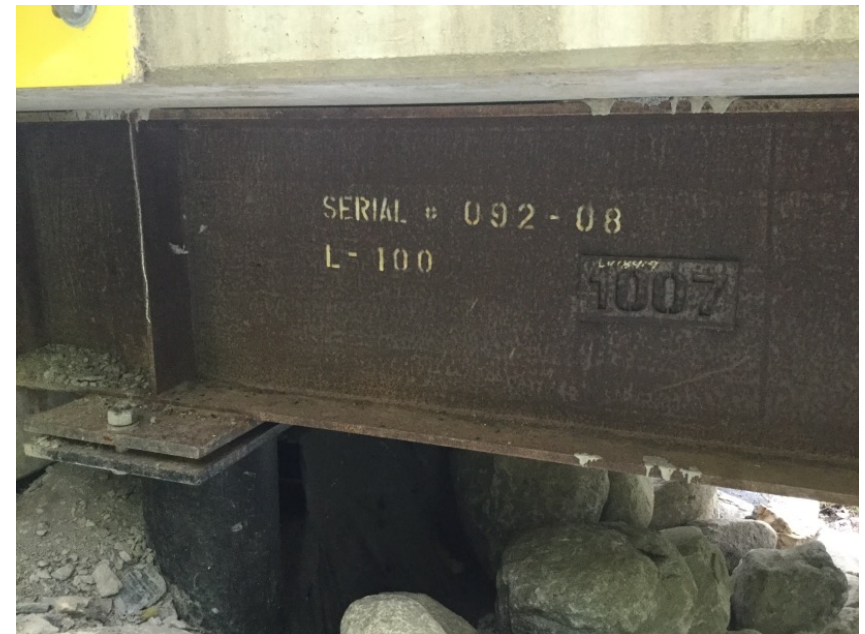
Structure ID

Serial/ID Plate L100. No bridge number tag provided.

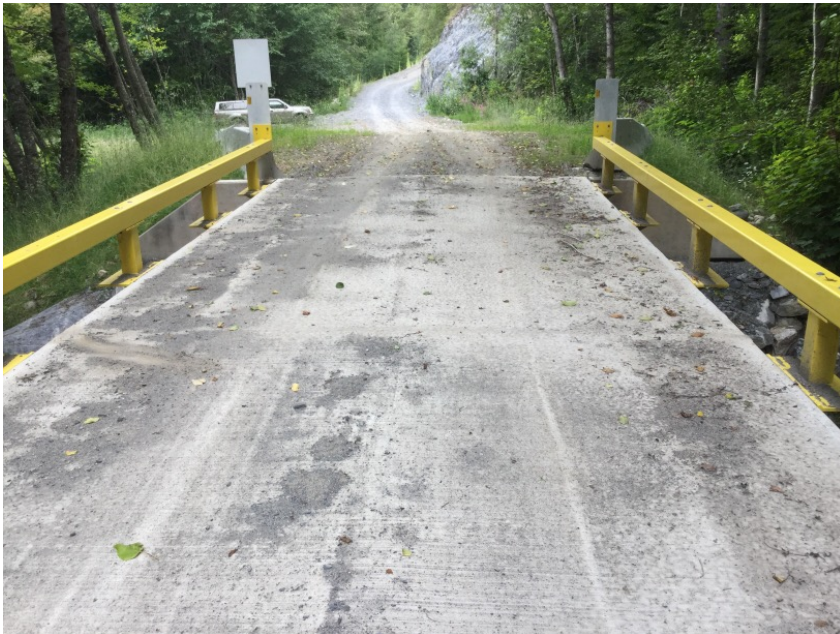
| Concrete Deck | Good | Precast concrete deck panels. Deck is 65 mm above both approaches. Spall in right abutment wheel track at deck edge. |
| Grout Pockets | Unrated | Cannot identify location of pockets due to debris on deck. |

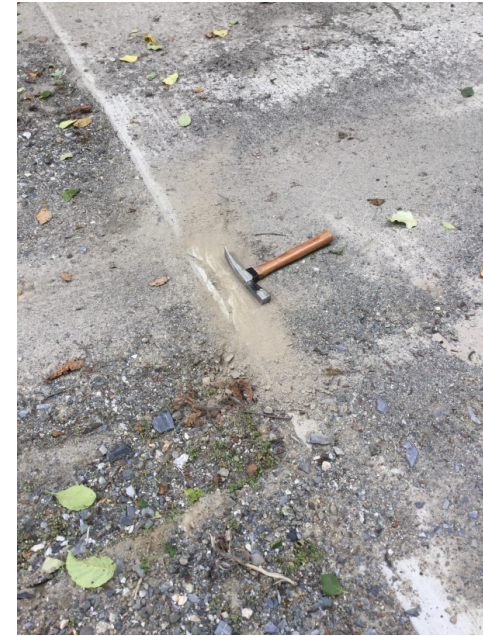
Spall in Wheel Track at Right Abutment Deck Edge

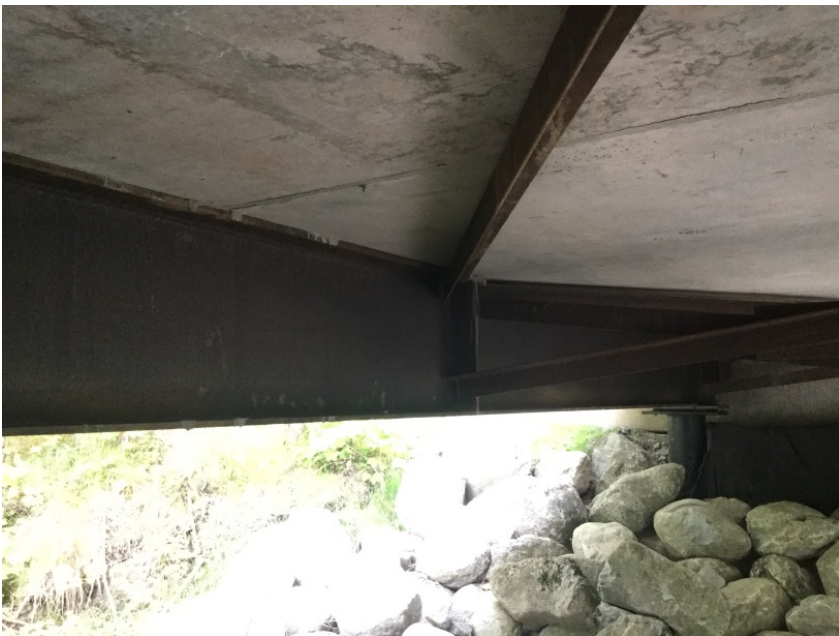
Girder and Bracing Condition

Girders Excellent

Bracing Excellent

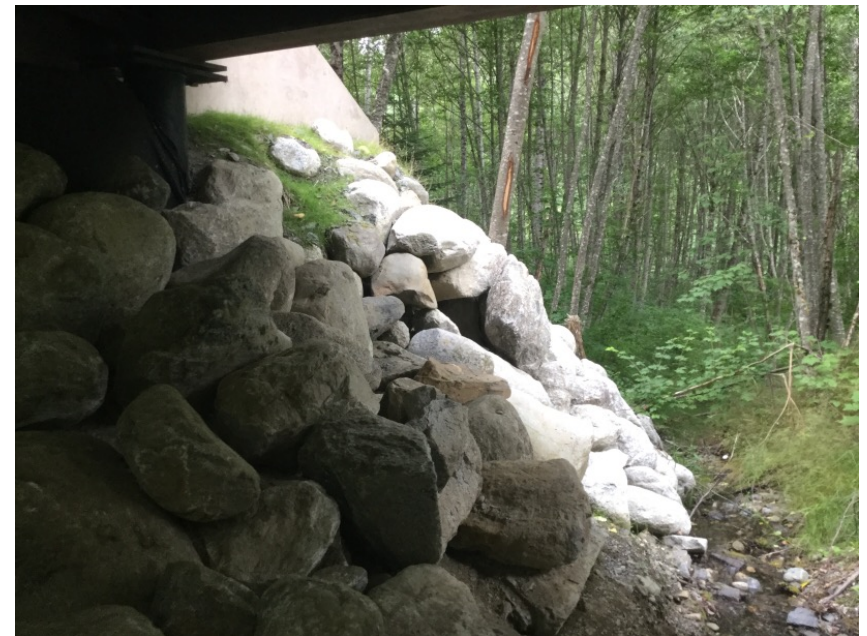
Oversteepened at left abutment downstream corner.

Round material, over steepened at left abutment downstream corner.

Oversteeped Left Embankment
