CK-2019

CAYOOSE CREEK 0.1km

2016 Inspection

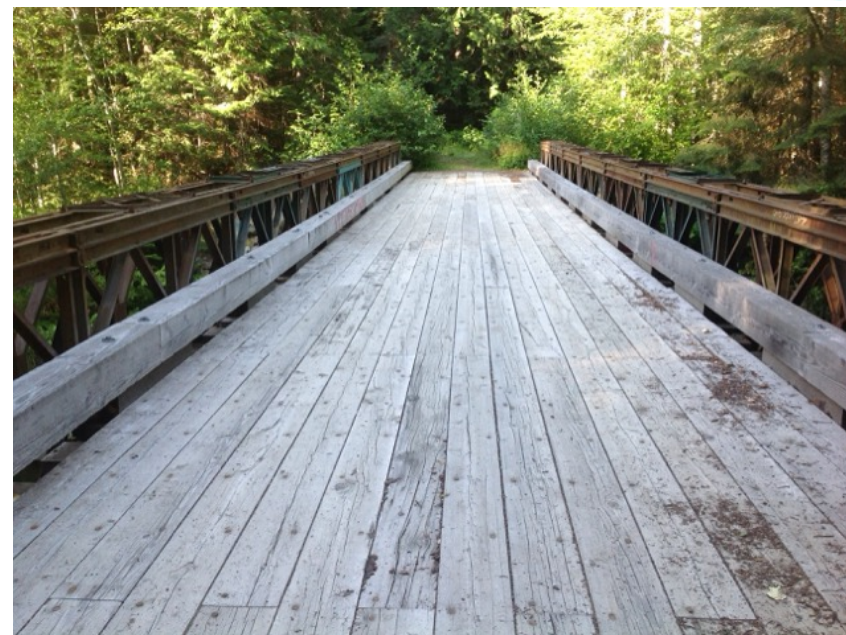
Deck

| Running Planks | Fair - poor | |
| Ties | Fair - poor | 100mm x 250mm on 500mm centers |

| Repair Item | Priority | Repair Description |
|---|---|---|
| 4 | Medium | replace deck (ties, planks and guardrail) prior to industrial activity - replace missing steel stringers at same time |

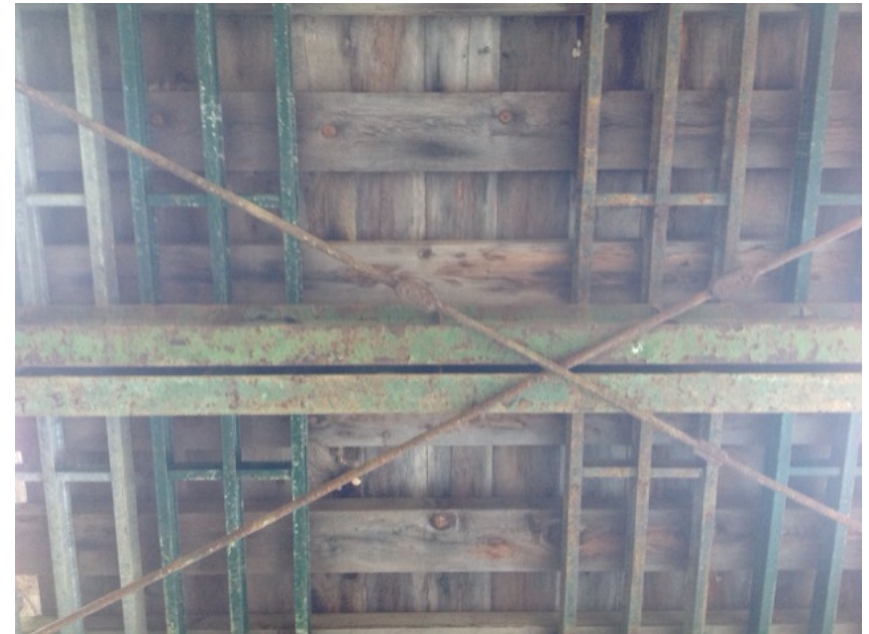
missing 10 foot section of steel stringer

The deck is at the end of its industrial life - 9 years old - replace ties, planks and guardrail prior to industrial activity. There are 2 missing steel stringers and I recommend replacing those at the same time as the deck. Replace the missing pin clips; replace the delineators and brush the approaches at the same time as well. Limit loading to 40 tonnes until the deck has been replaced.

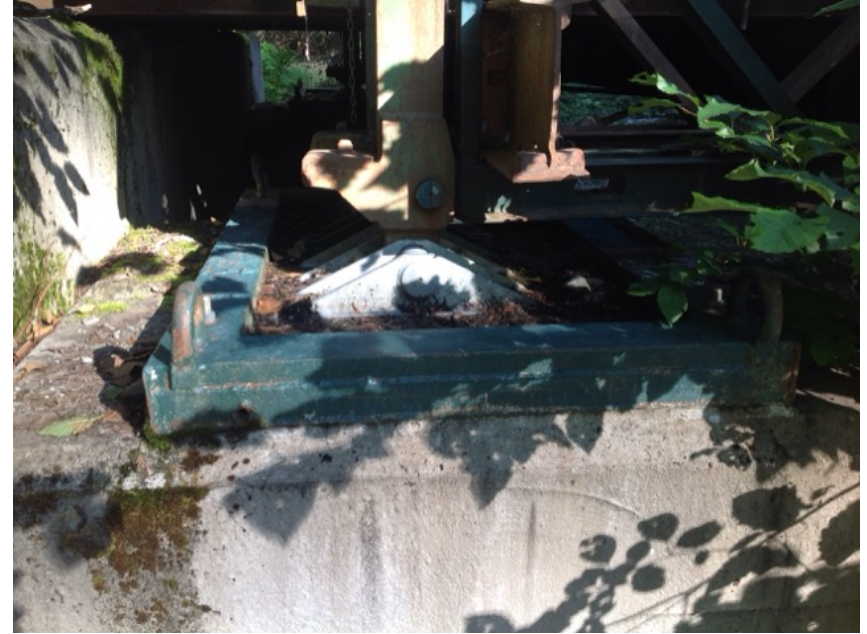
bearing plate - typical all 4 corners

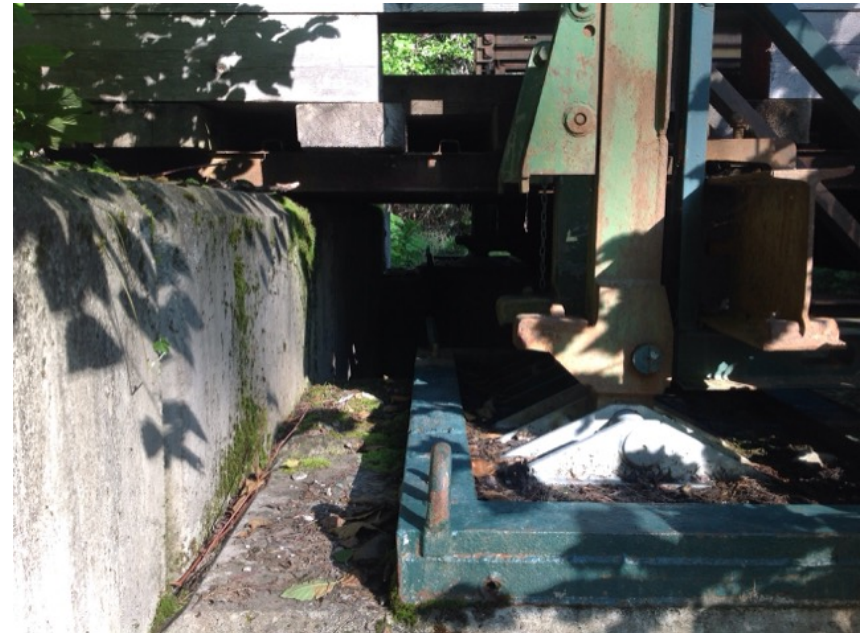
end post to ballast wall alignment

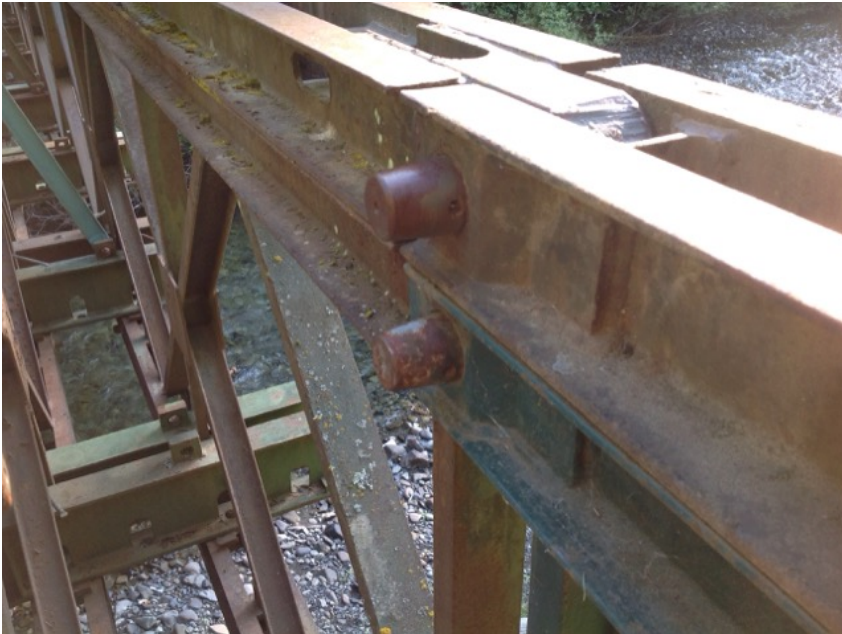
missing clips - approx 57 missing - all on top of the bay's

| Repair Item | Priority | Repair Description |
|---|---|---|
| 2 | High | replace missing clips prior to industrial use |

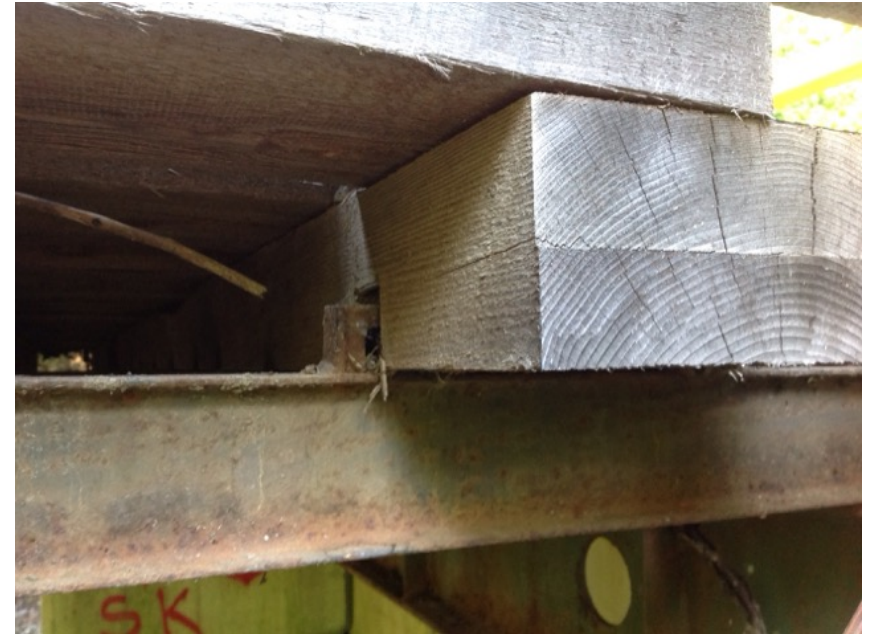
| Deck to Girder Bolts | Fair | not bolted but rather ties notched to fit |

ties are notched to fit on stringers

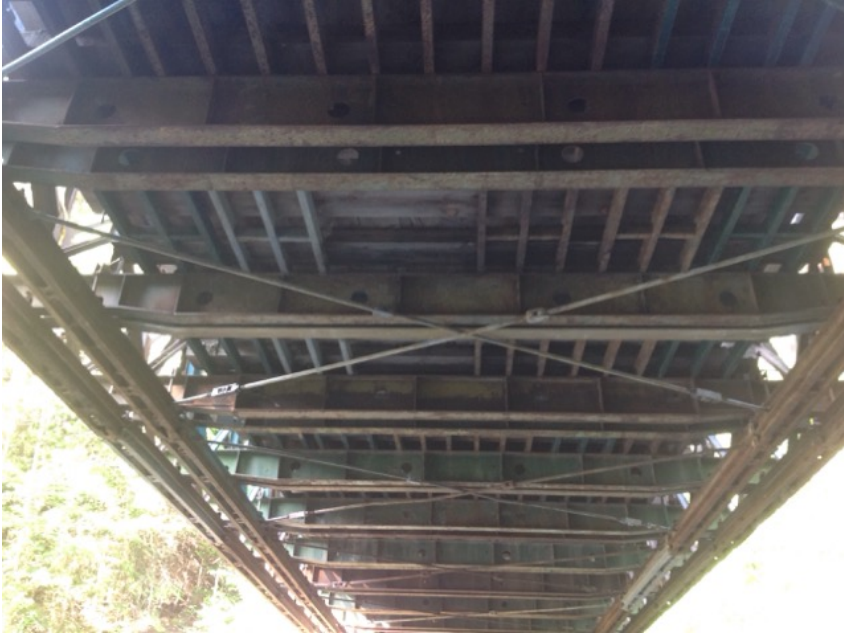
missing another 10 foot section of steel stringer

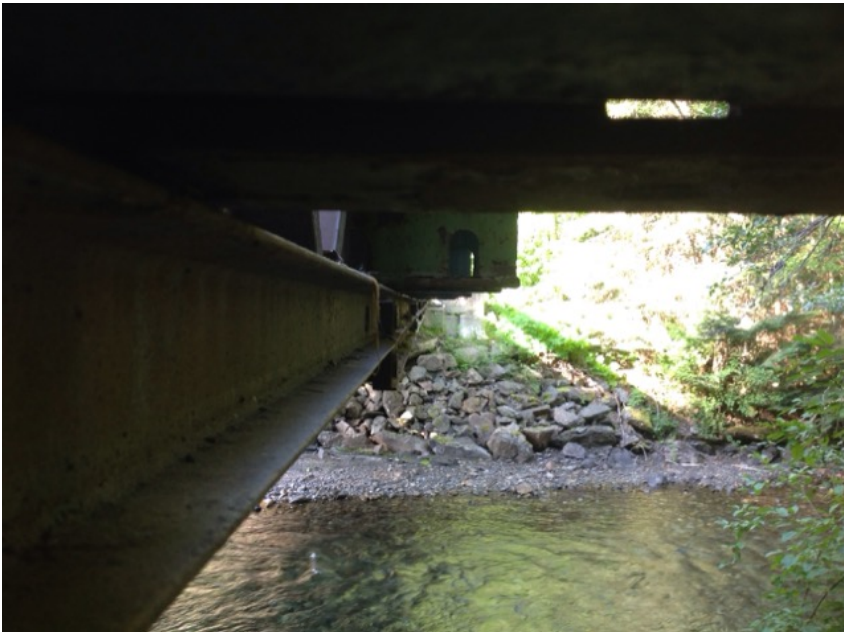
approx 20-30mm superstructure sag
