CK-2031

CHEHALIS-STATLU 1.7km

2016 Inspection

| Crossing Name | Statlu Creek |

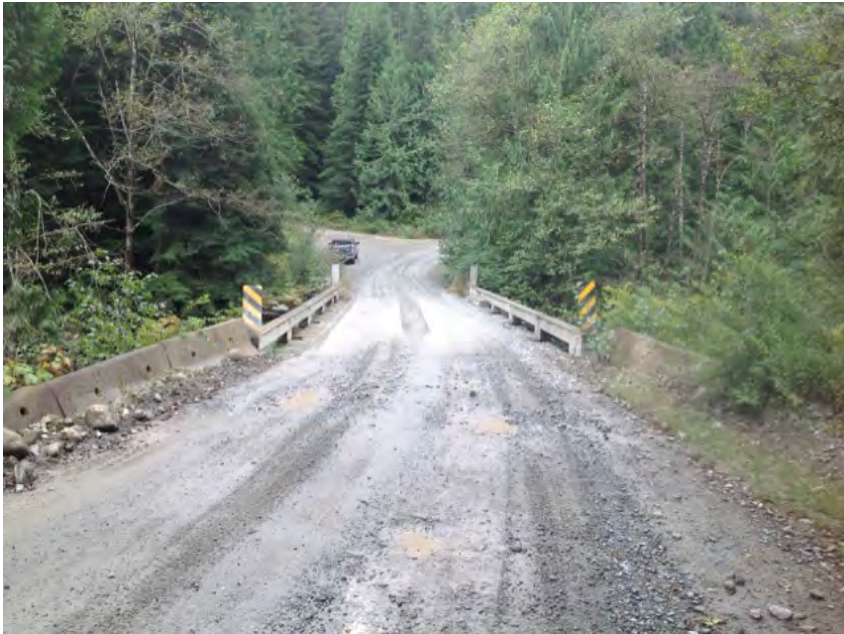
Approach from Left Bank when facing downstream

HC left approach

| 1 | Medium | Post bridge ahead signs |

| 2 | Medium | Brush approaches |

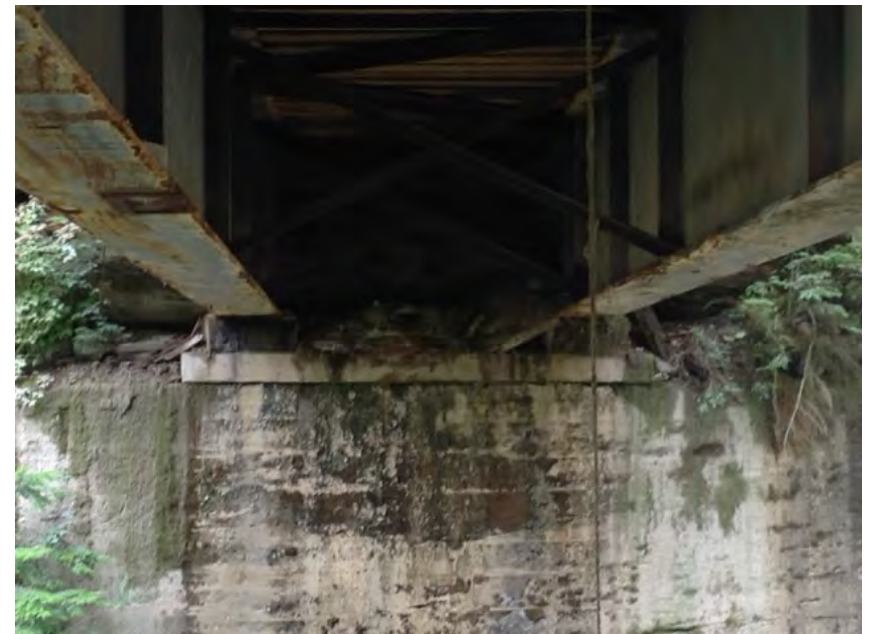
right bank bearing

Bearings Fair

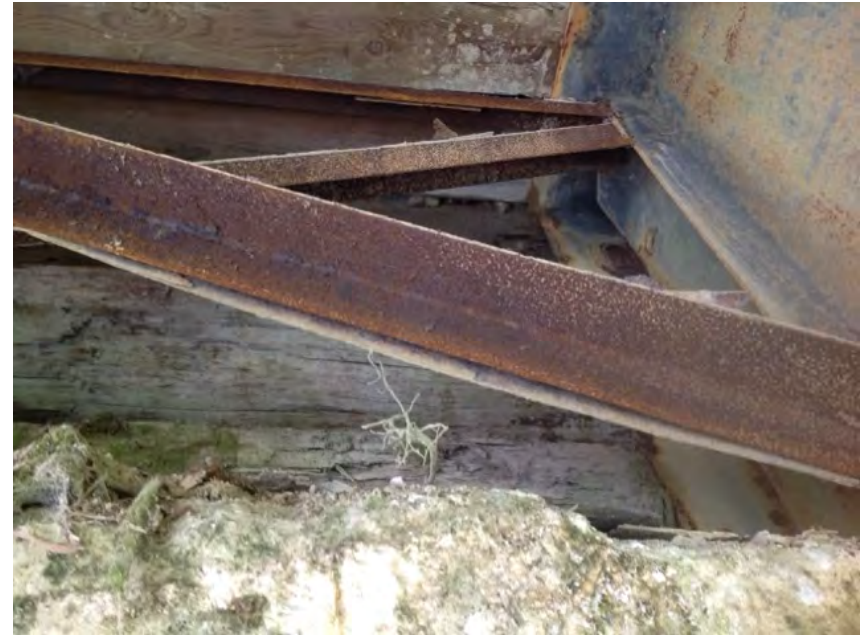
Diaphragms Fair delamination happening throughout

delamination of left bank diaphragm

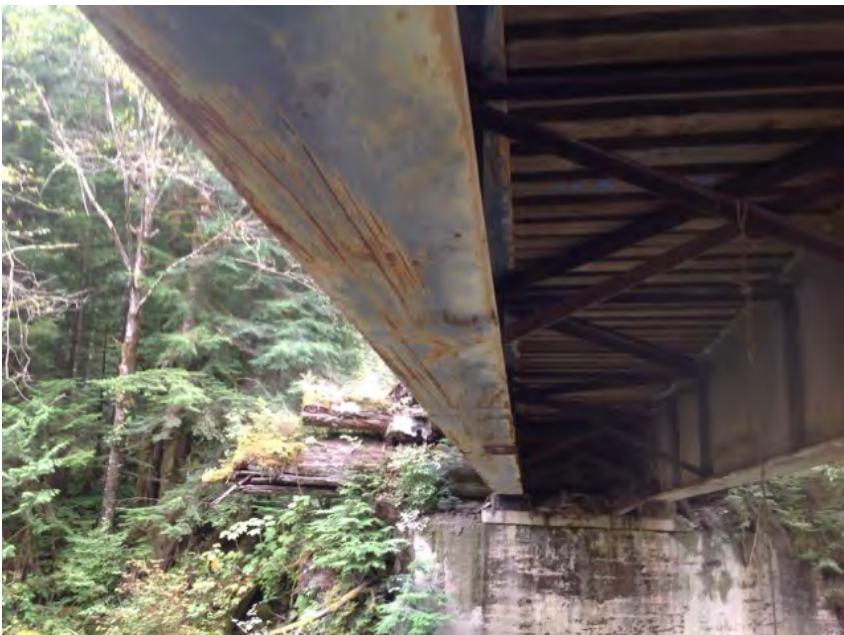
Girders Fair painted steel girders - not a matching set

painted girders

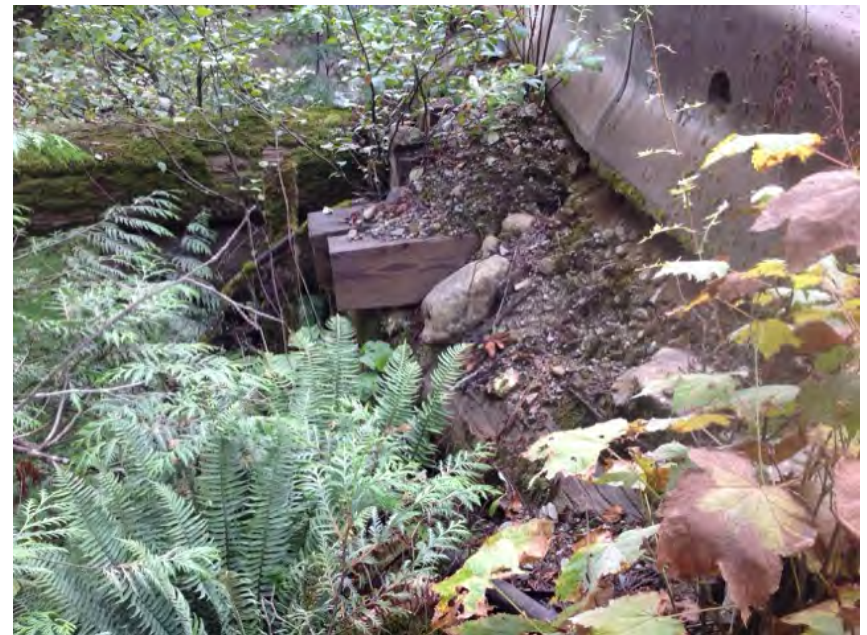
left downstream bank - ties and tiebacks retaining fill

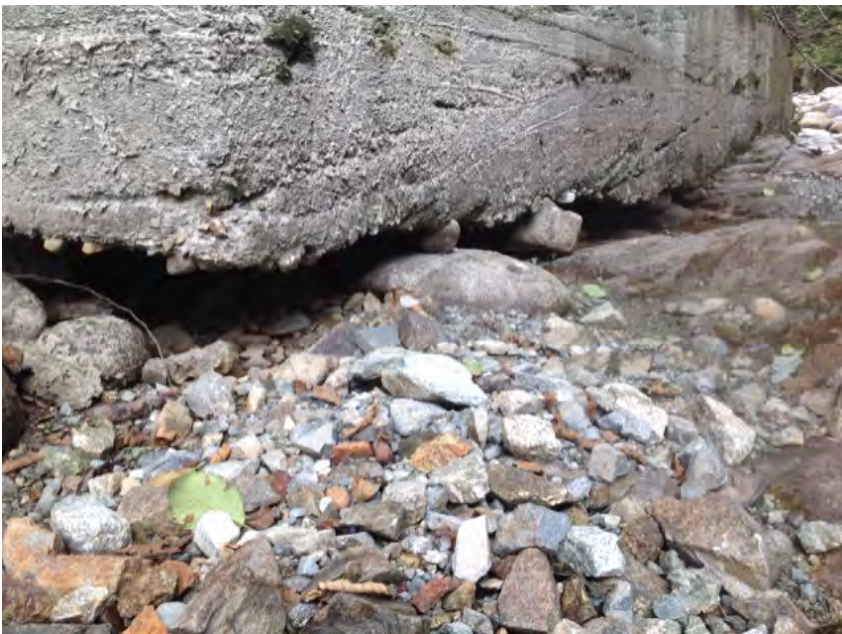
CIP both banks - monitor scour

scour under right bank CIP - extends up to 800mm

Post bridge ahead signs and brush approaches. Monitor the scour under the right bank abutment and the stability/condition of the wingwalls. Present load rating of L150 or 136 tonnes to continue.

| 1 | scour at base of right abutment | |

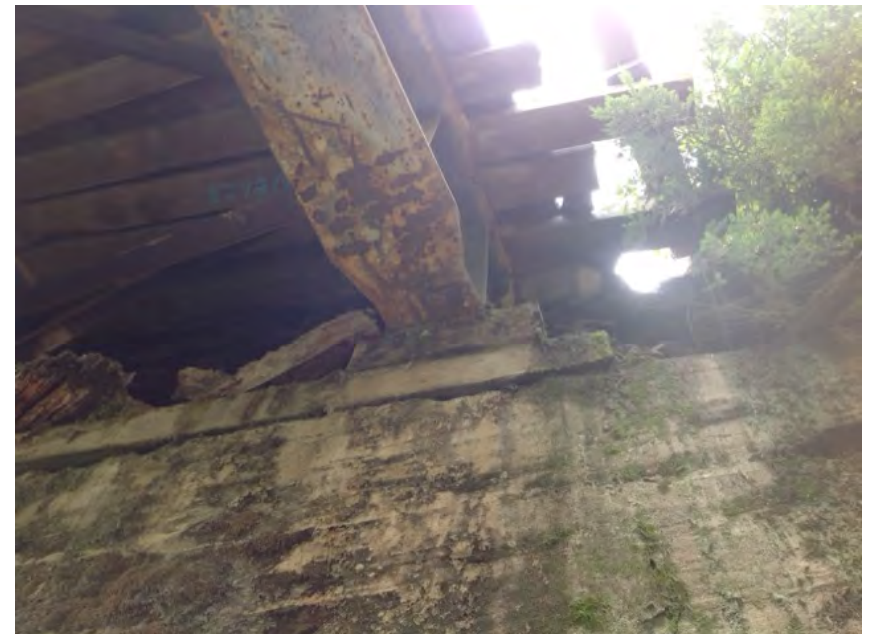
right bank upstream girder narrows at bearing
