CK-2052

CHILLIWACK RIVER 11.1km

2016 Inspection

| Crossing Name | Depot Creek | | |

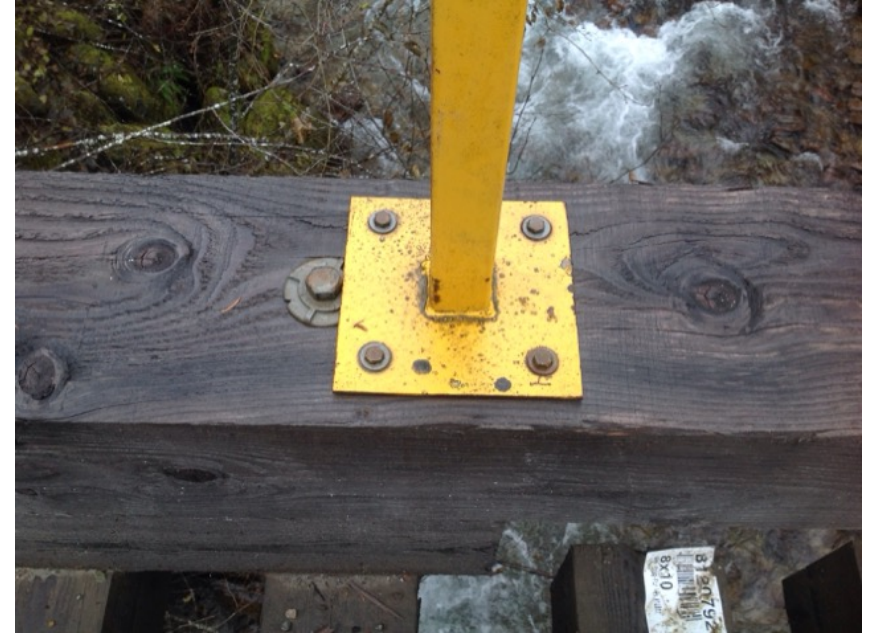
handrail connection to curb

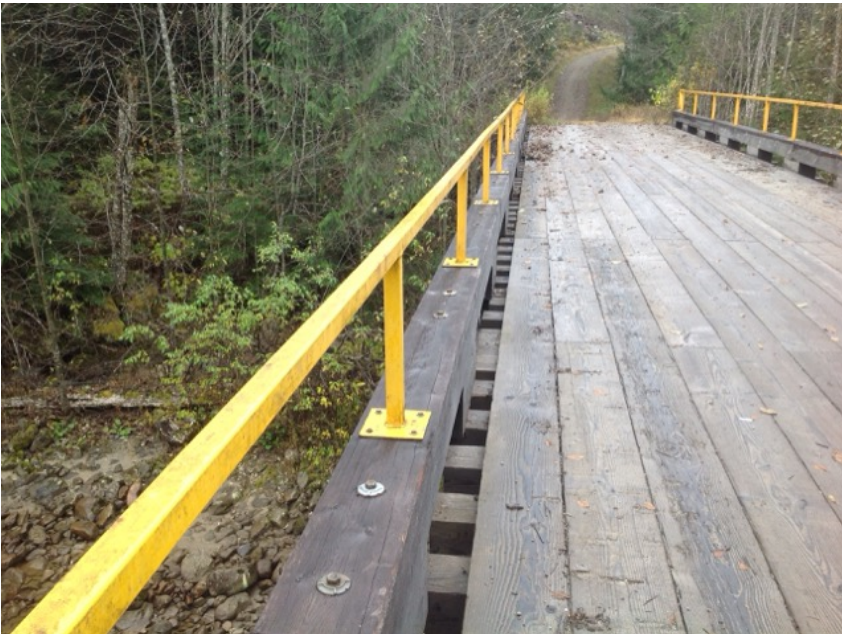
50mm x 50mm HSS handrail

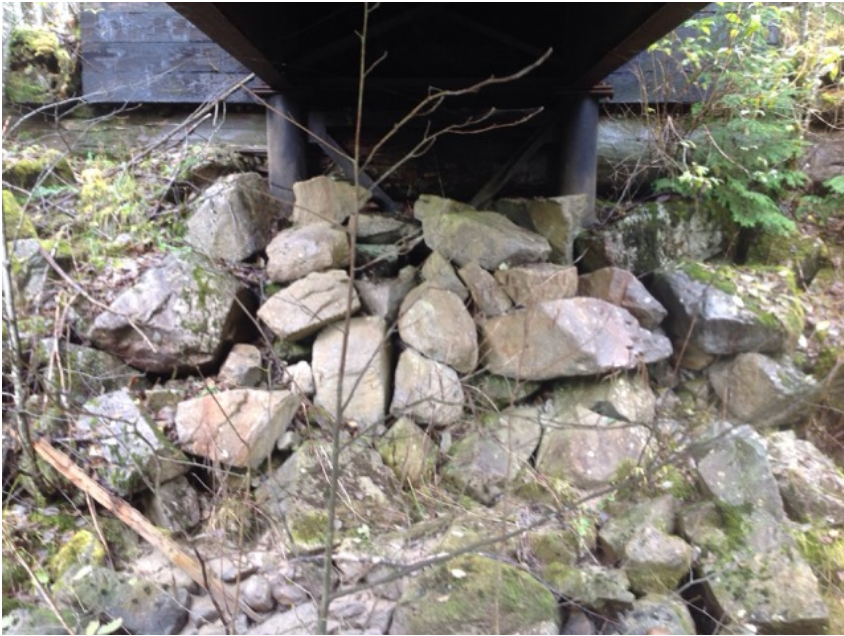
Left Bank Abutment when facing downstream

oversteepened on left bank but no flow

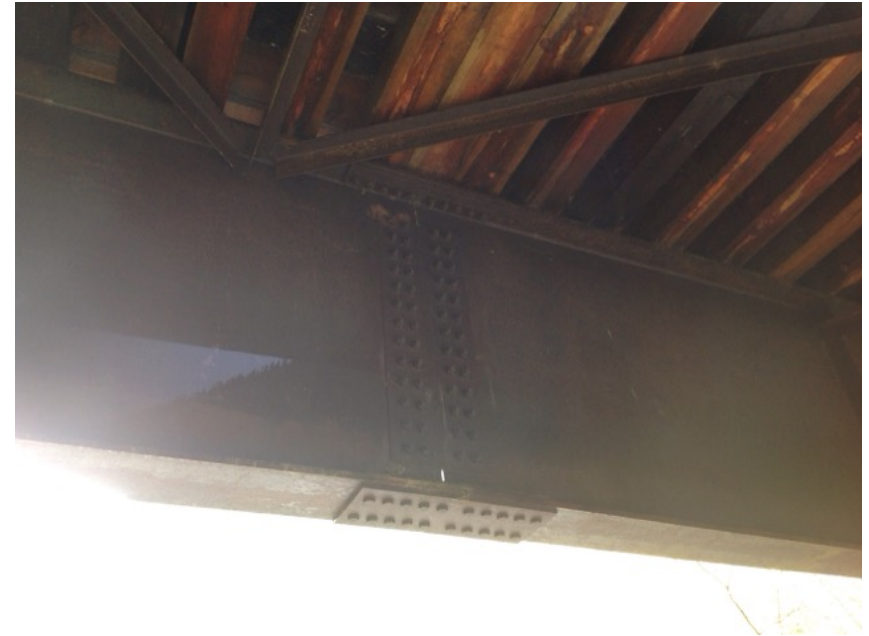
splice plates

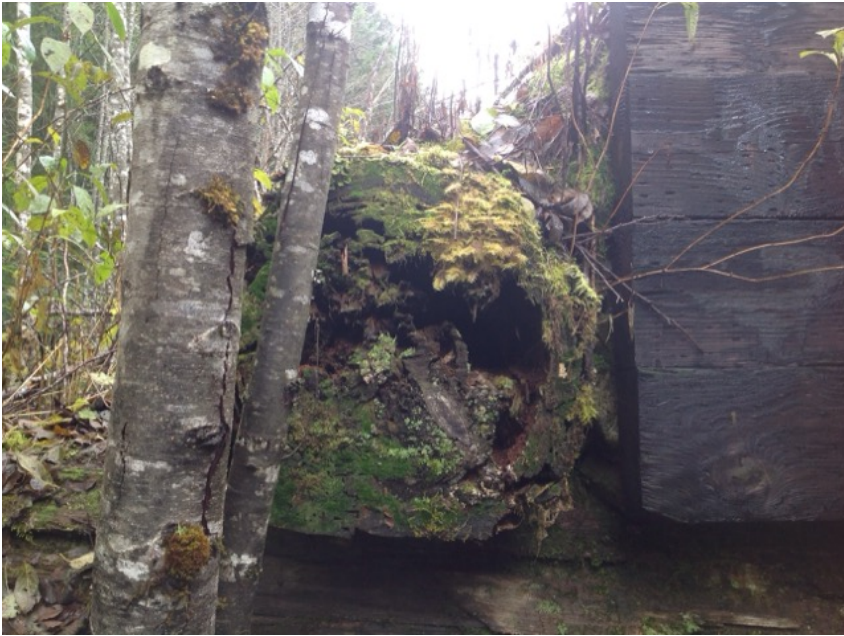
logs retaking fill in poor condition

wing logs retaining fill in poor condition

| 2 | Low | replace fill retaining logs prior to industrial use |

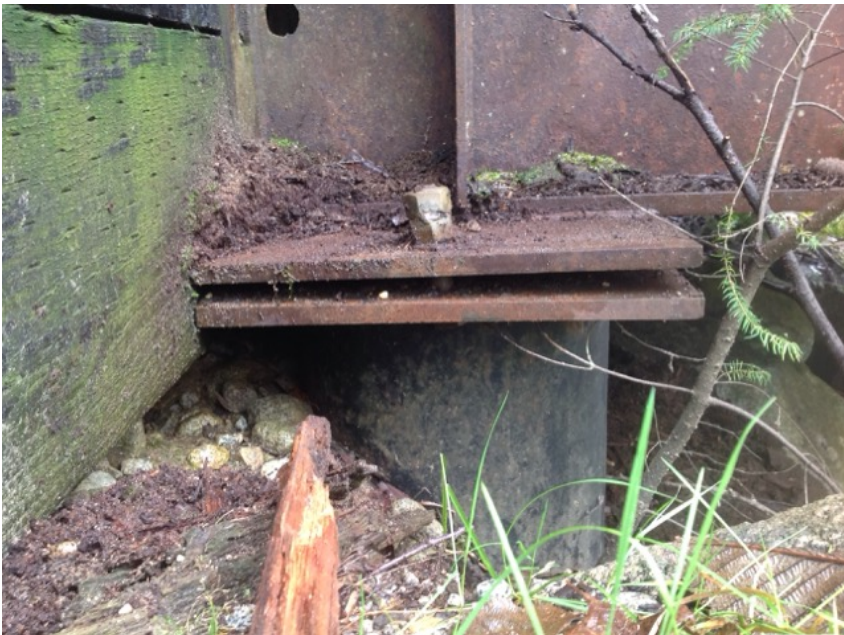
bearing plates on right bank not slotted and bolts stressed

monitor bolt condition

right bank bearing plates offset - holes not slotted and bolts stressed

| 1 | bearing bolts on right bank | Routine Inspection |
