CK-2053

LIUMCHEN CREEK 0.2km

2016 Inspection

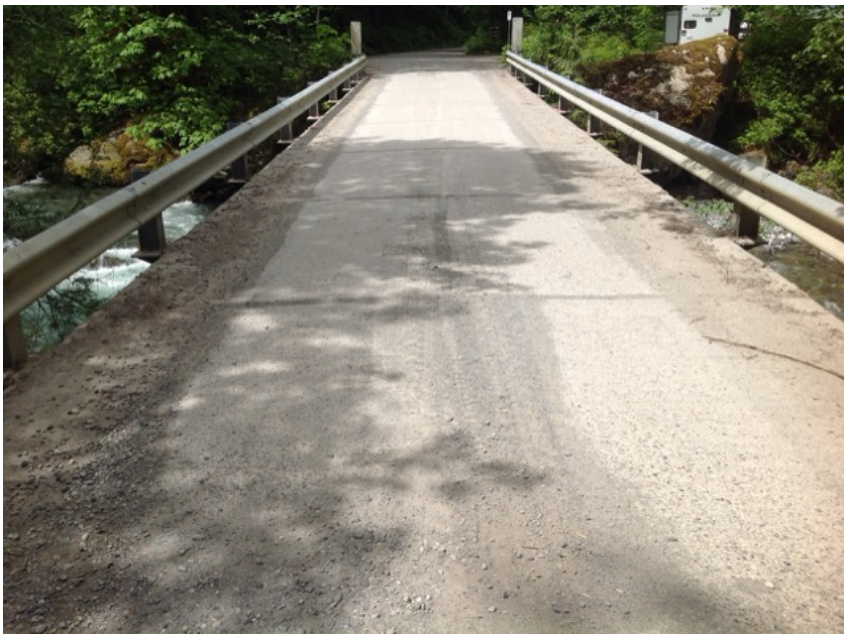
Overall Deck Condition      Good

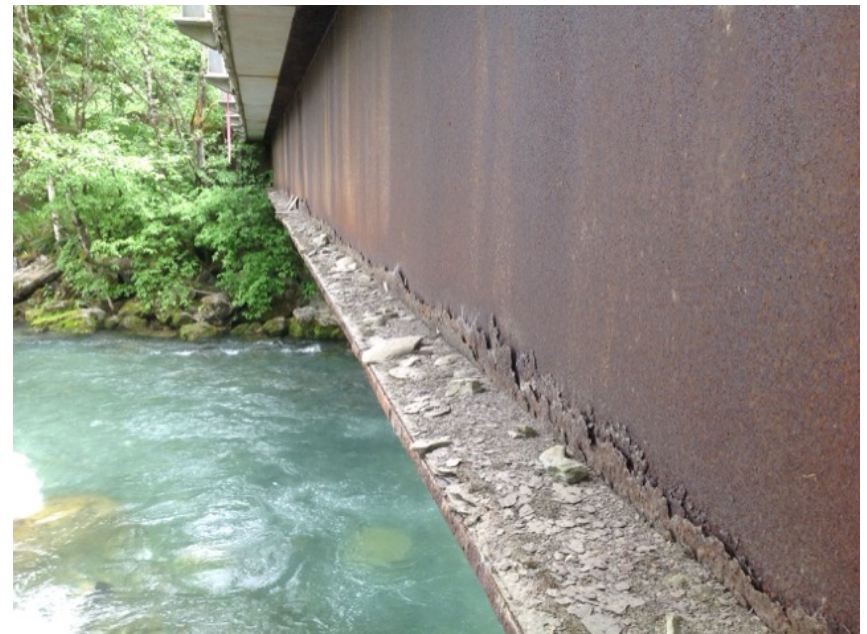
Girders Fair steel girders delaminating

delaminating steel

Monitor delaminating steel. Present load rating of CL-625 or 63 tonnes to continue.

1 monitor delaminating steel

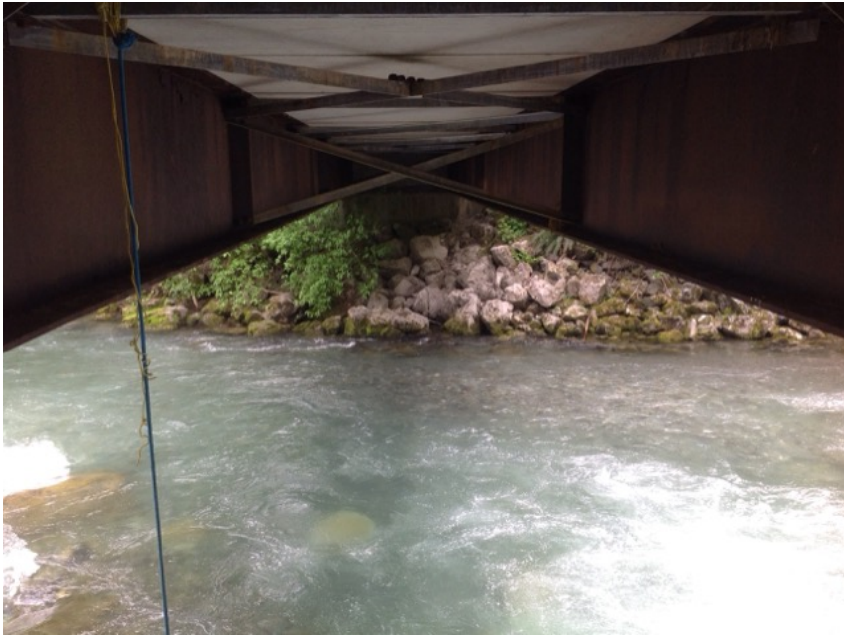
Right Bank Abutment when facing downstream

Concrete Fair CIP both ends

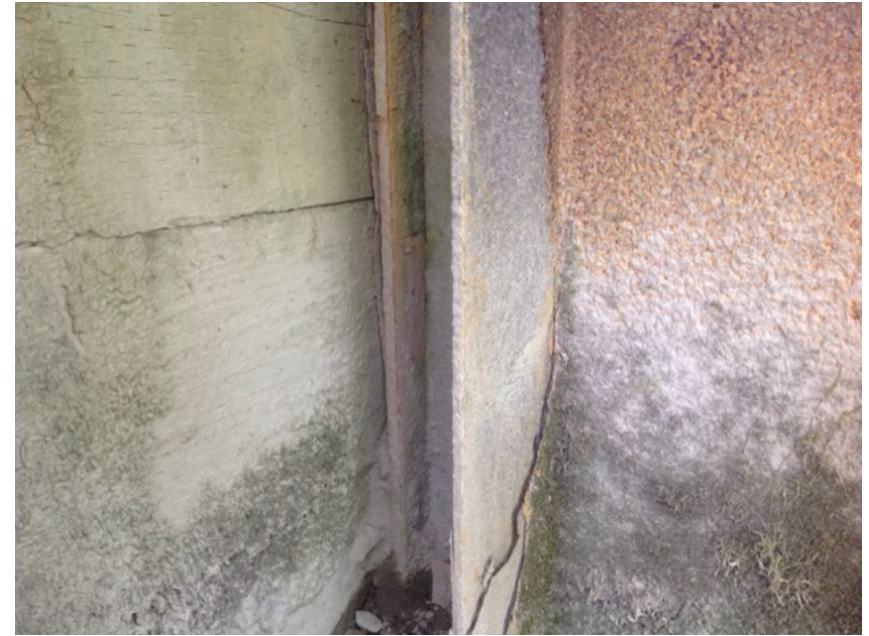
delaminating steel

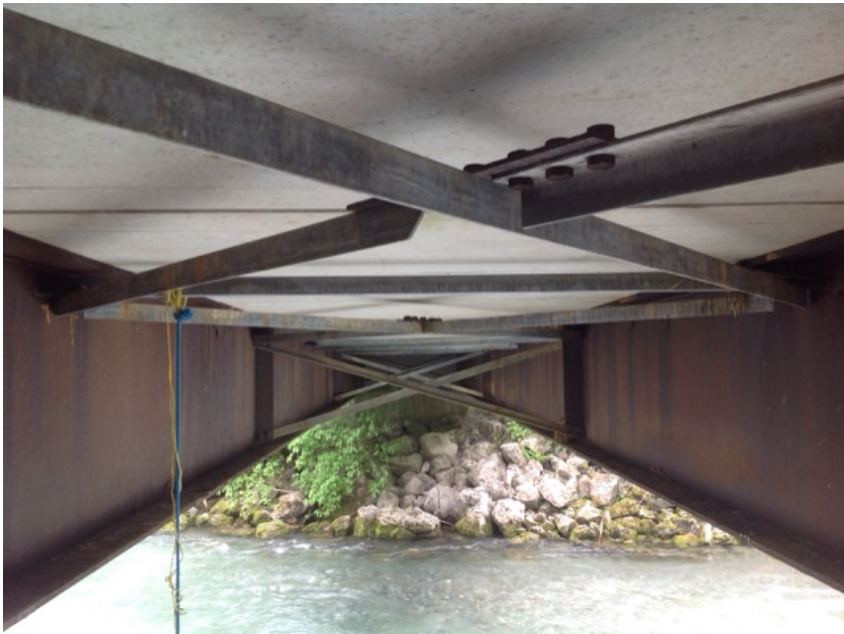
Diaphragms Fair 4x, galvanized and bolted

galvanized bracing and diaphragms

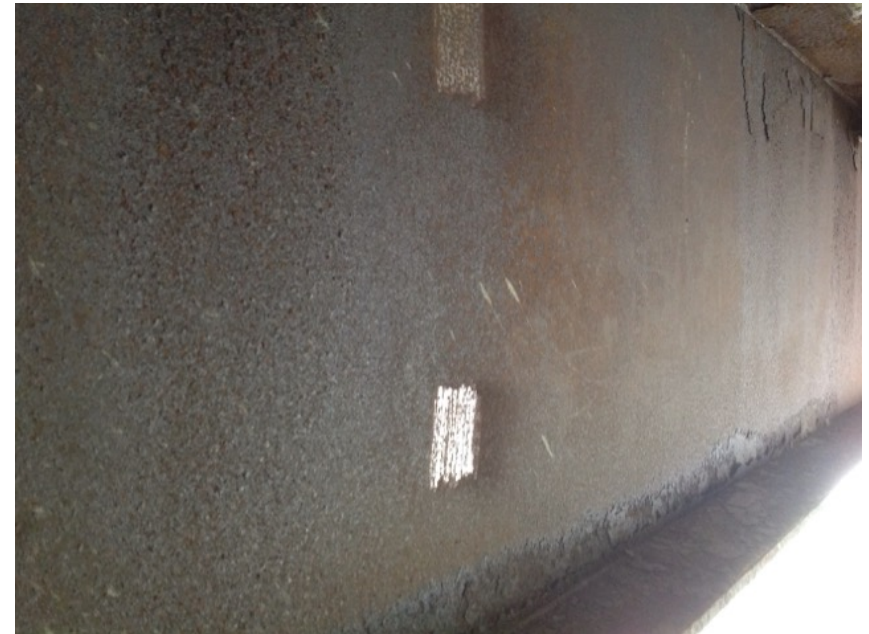
locations of previous web measurements - no further delaminating in these locations
