CK-2054

LIUMCHEN CREEK 0.9km

2016 Inspection

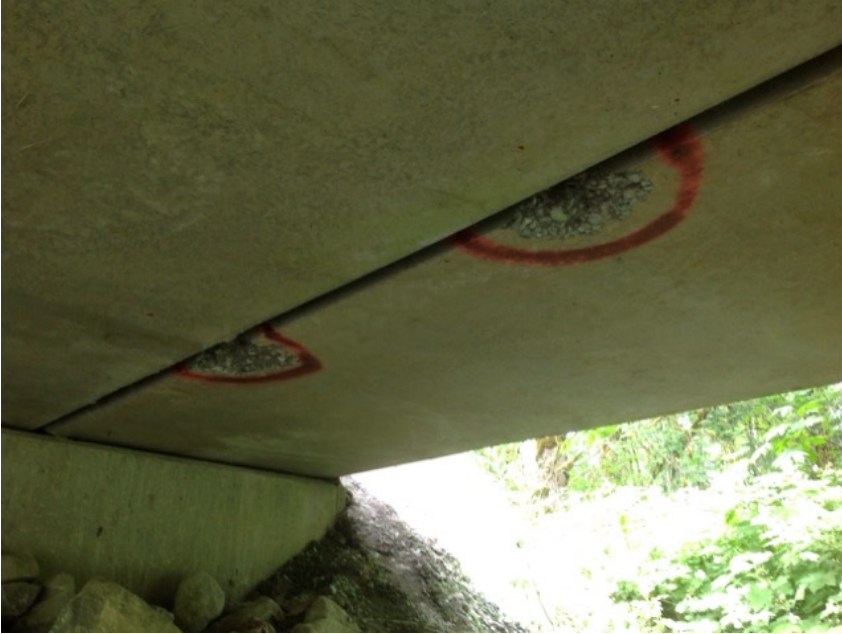
previously noted spalling concrete - has not expanded
