CK-2055

LIUMCHEN CREEK 2.5km

2016 Inspection

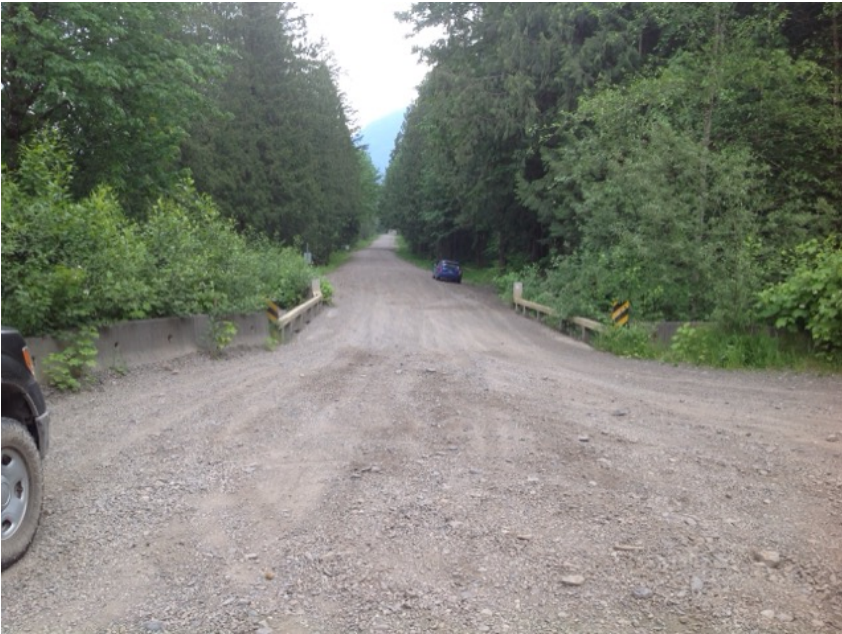
Approach from Left Bank when facing downstream

Brushing Required Y

| Repair Item | Priority | Repair Description |
|---|---|---|
| 1 | Medium | Brush approaches |

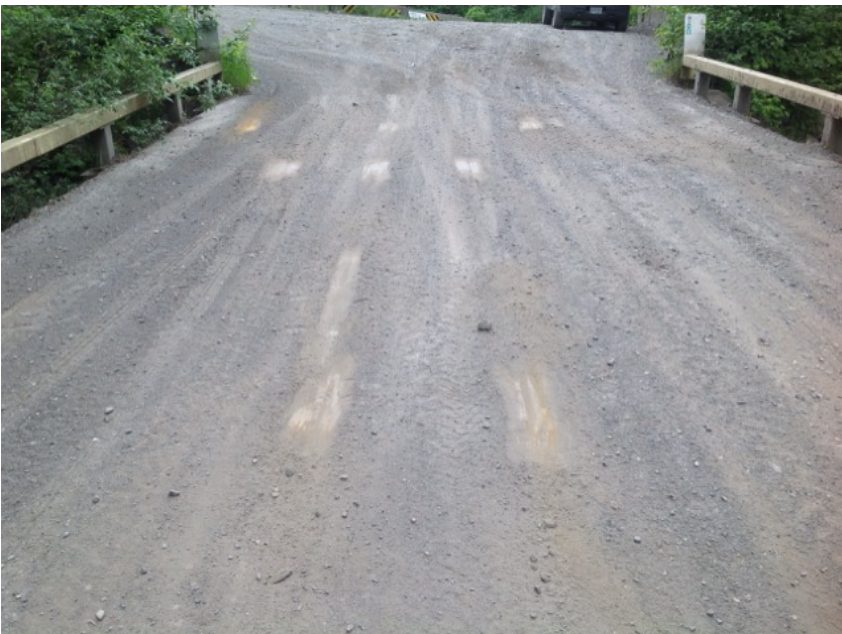
Overall Deck Condition      Good

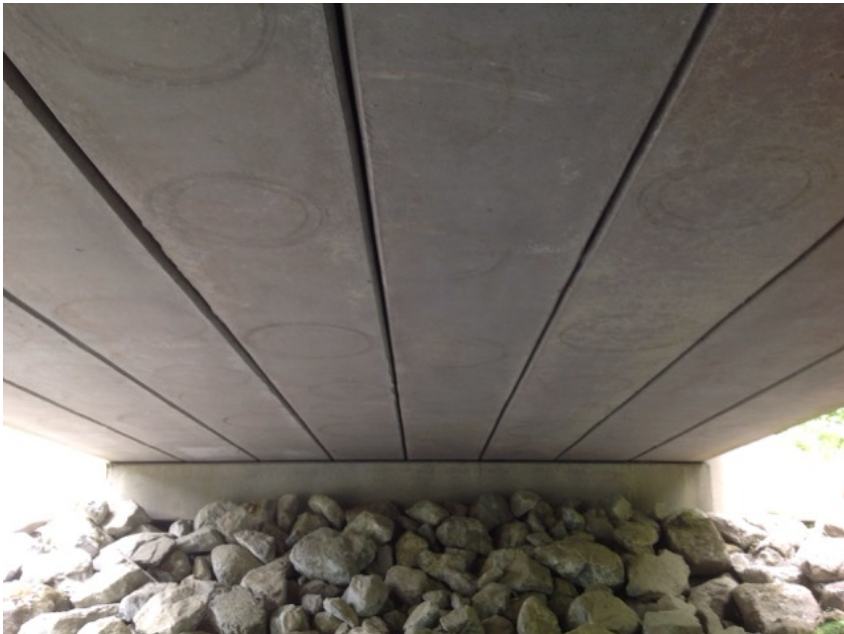
superstructure

Girders Good 8 concrete slabs
