CK-2064

CHILLIWACK-TAMIHI CR 6.3km

2016 Inspection

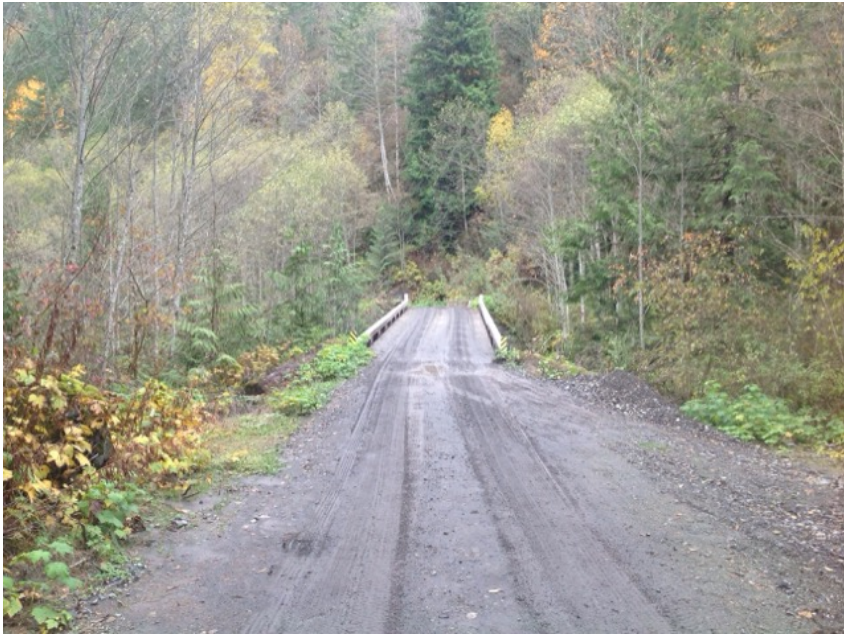
Approach from Left Bank when facing downstream

VC left approach and HC right approach

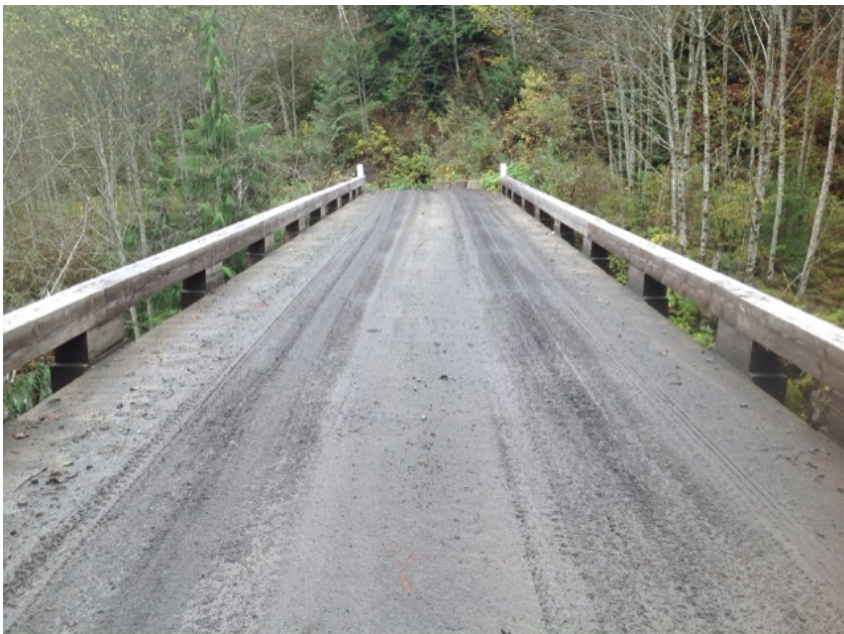
Overall Deck Condition      Good

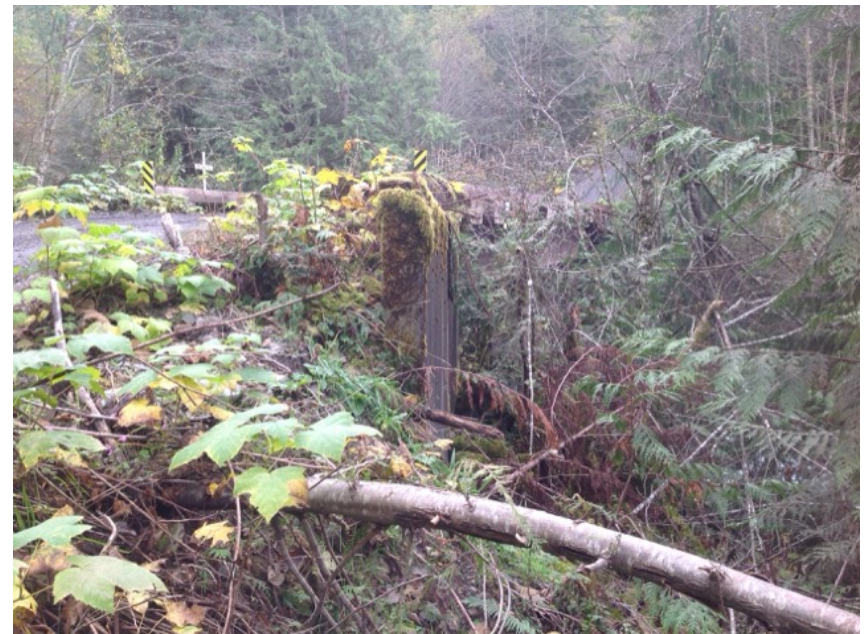
precast wingwall downstream right bank

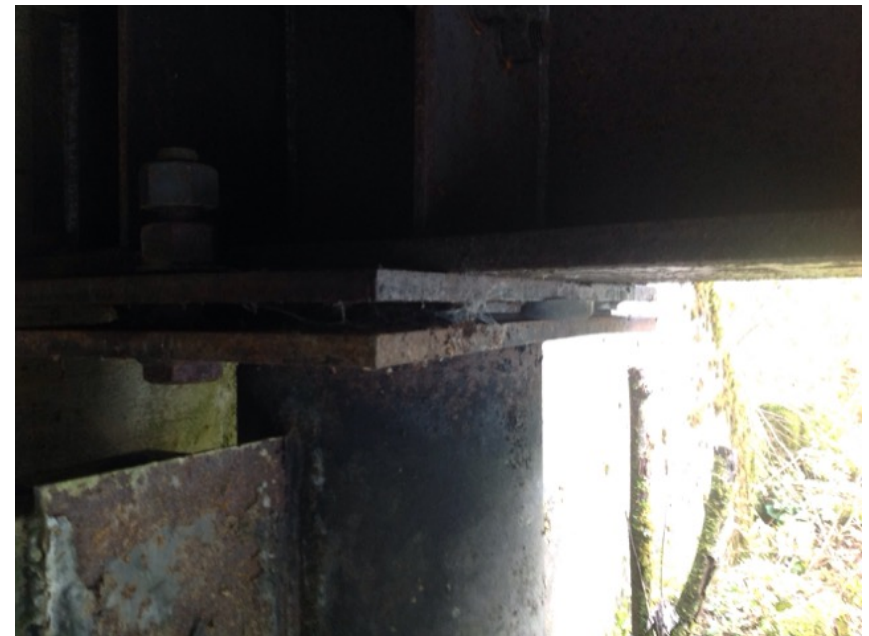
Caps or Sills Fair steel plates and rubber pads - buldging

right bank bearing pads - typical both sides

| Item | Monitor Description | Frequency |
|---|---|---|
| 1 bearing | | Routine Inspection |

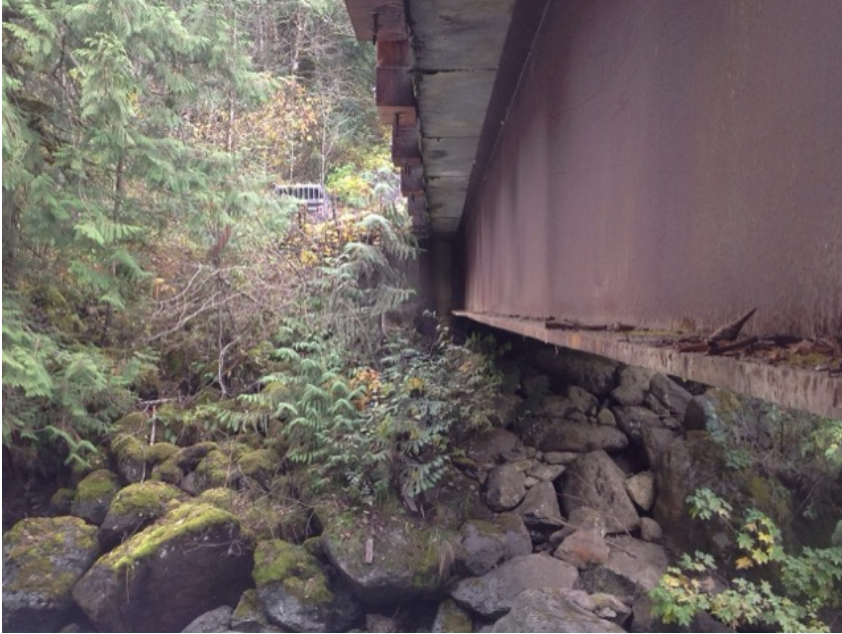
Assume girders were dropped during install as both have slight undulations along bottom flange.

bottom flange on both girders have slight undulations along length

slight undulation of bottom flange - upstream girder

Present load rating of L75 or 68 tonnes to continue.

| Item | Monitor Description | Frequency |
|---|---|---|
| 2 undulations in bottom flange of girders | | Routine Inspection |

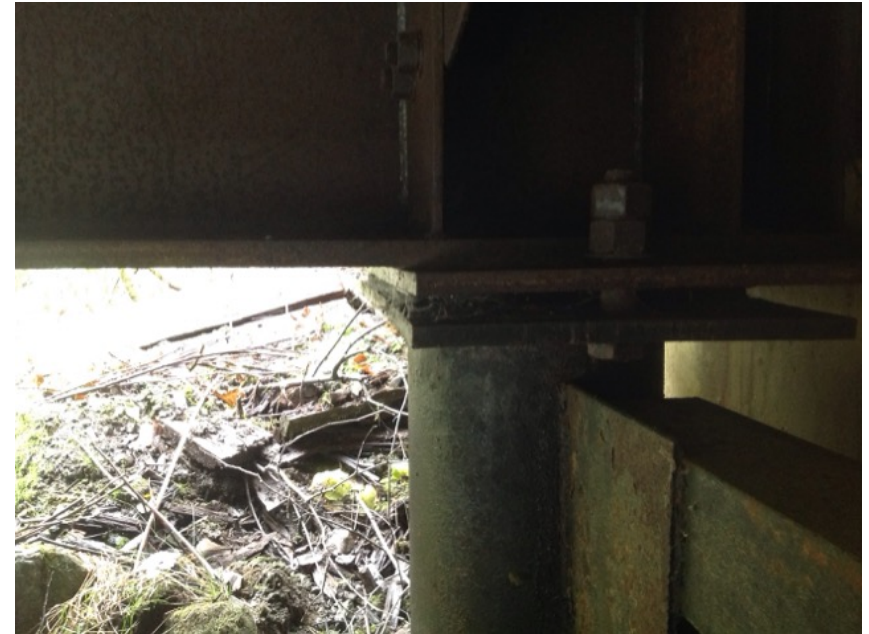
left bank bearing pads - typical both sides

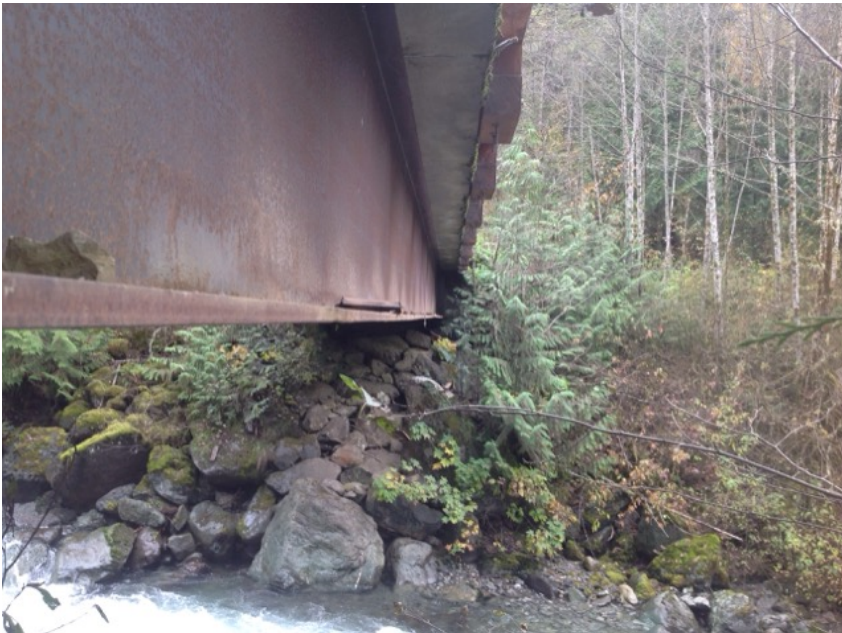
slight undulation of bottom flange - down stream girder
