CK-2067

CHILLIWACK-TAMIHI CR 10.6km

2016 Inspection

| Crossing Name | Tamihi Creek |

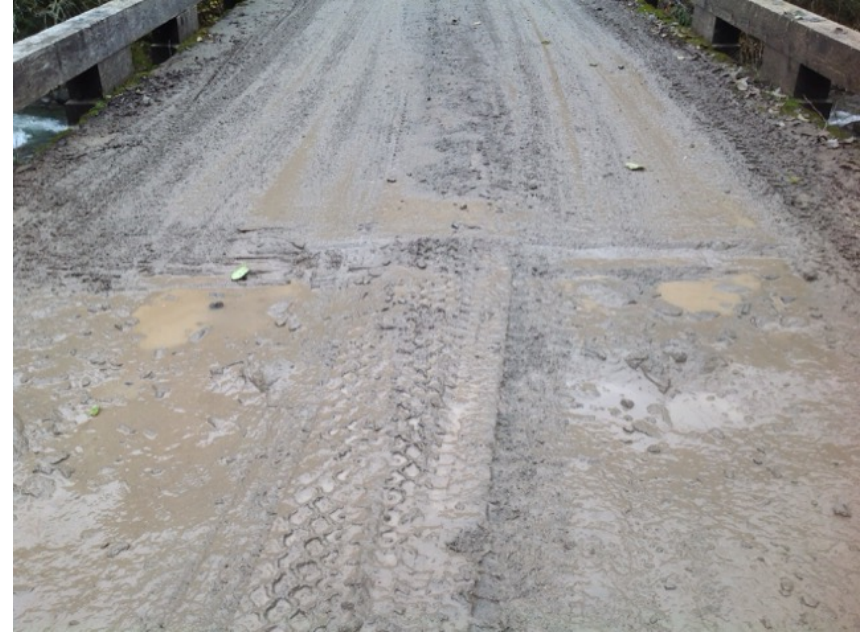
potholes at approaches

| 2 | Medium | grade in potholes |

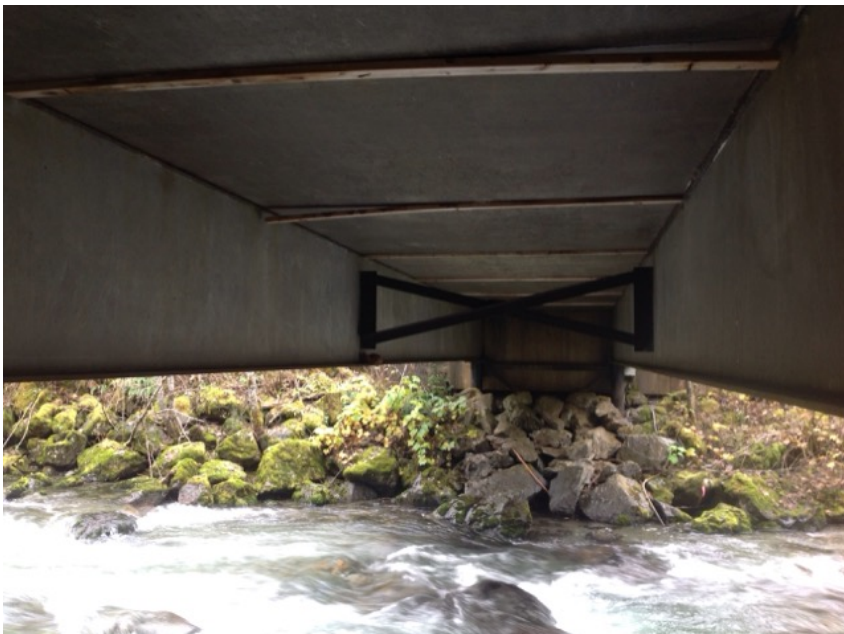
Girders Good composite

composite girders

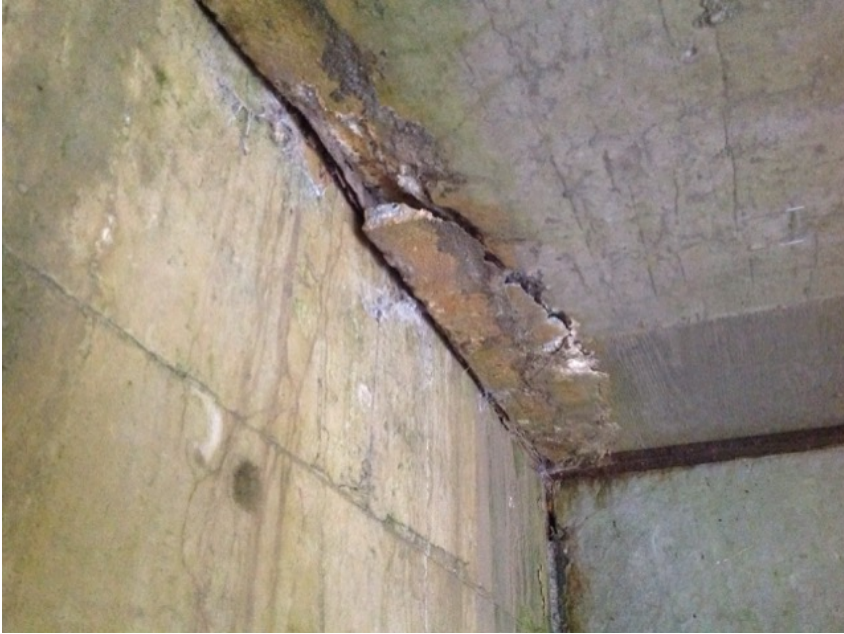
panel 1 left approach

Concrete Deck      Fair      damage to panel 1 on left bank - underneath

Repair damage to deck panel 1 on left approach (damage visible from underneath), and grade approaches. Present load rating of L75 or 68 tonnes to continue.

| 1 | Medium | repair damage to panel 1 |
