CK-2073

CHIPMUNK CREEK 1.5km

2016 Inspection

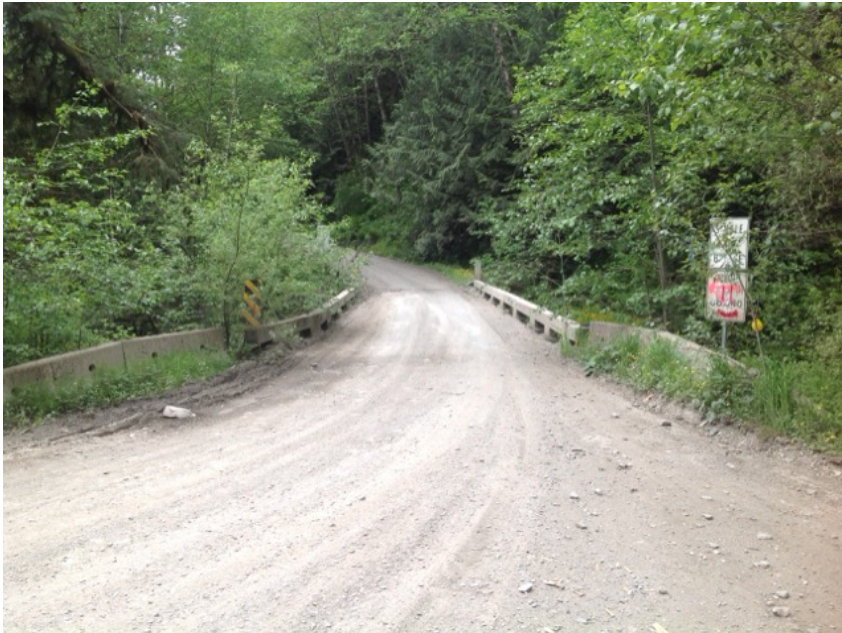
Approach from Left Bank when facing downstream

HC left approach, VC and HC right approach

| 2 | Medium | brush approaches |

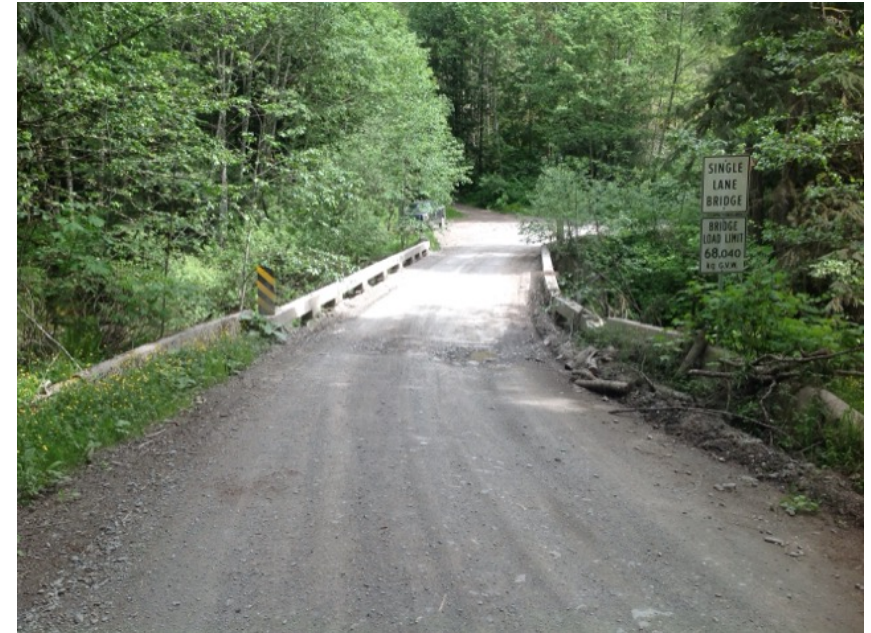
Approach from Right Bank when facing downstream

Delineator Missing  
Left ☒ 0 ☐ 1 ☐ 2Delineator Missing  
Right ☐ 0 ☐ 1 ☒ 2

| 1 | Medium | replace missing delineators |

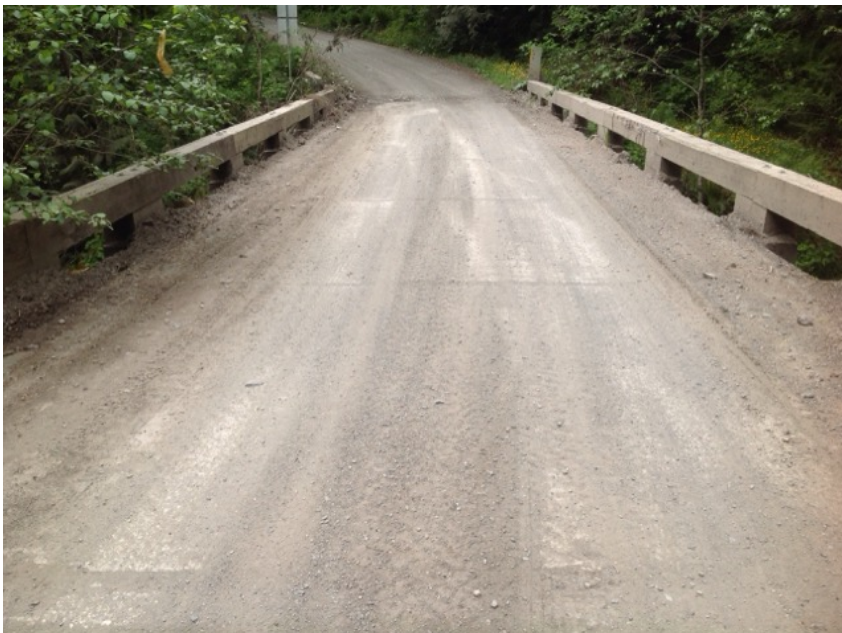
Overall Deck Condition Fair

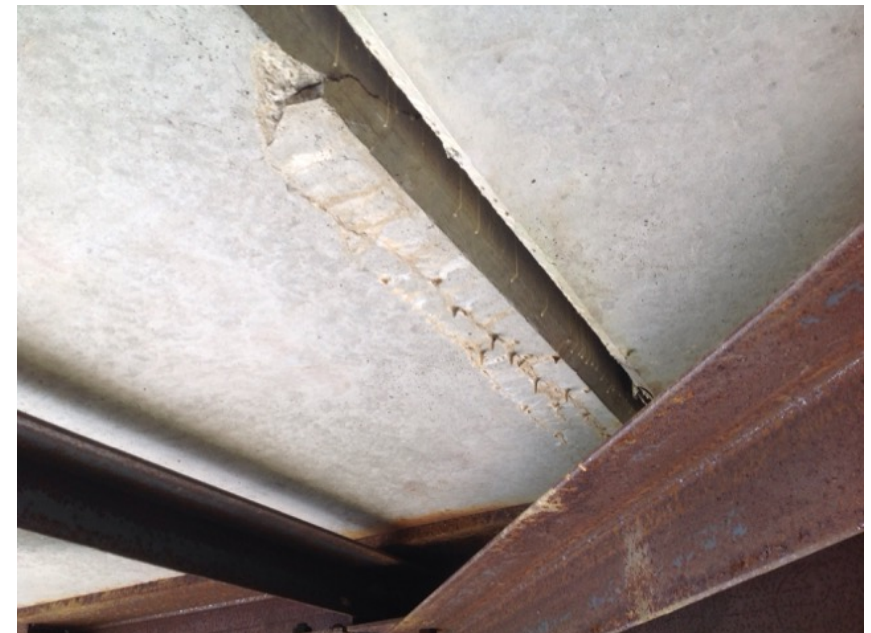
damage noted to first and second panel on right approach

| 1 | condition of damaged panels | |

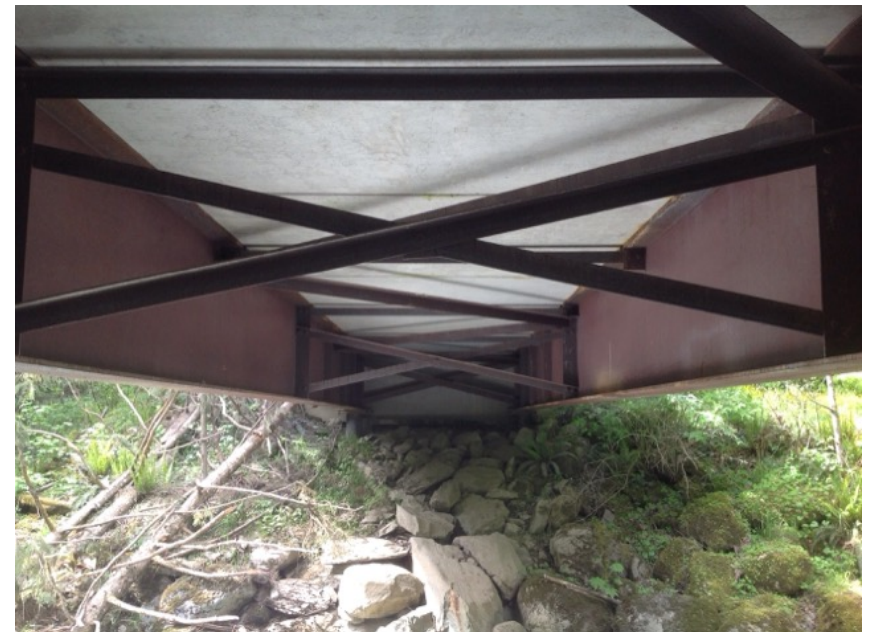
superstructure

Girders Good

Diaphragms Good 4x, bolted

Bracing Good bolted
