CK-2075

FOLEY CREEK 2.1km

2016 Inspection

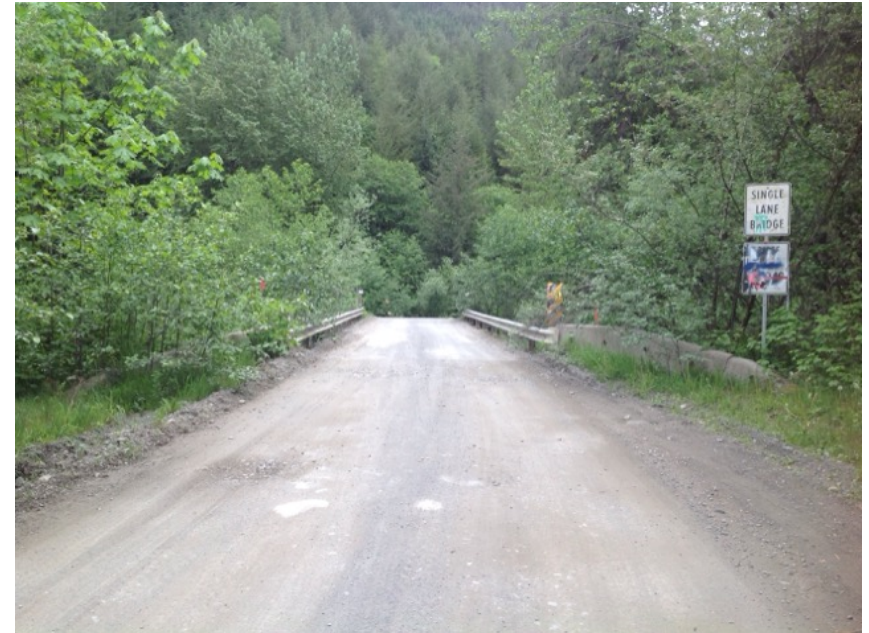
Approach from Left Bank when facing downstream

Delineator Missing  
Left ☐ 0 ☒ 1 ☐ 2Delineator Missing  
Right ☒ 0 ☐ 1 ☐ 2

| 1 | Medium | replace missing delineator |

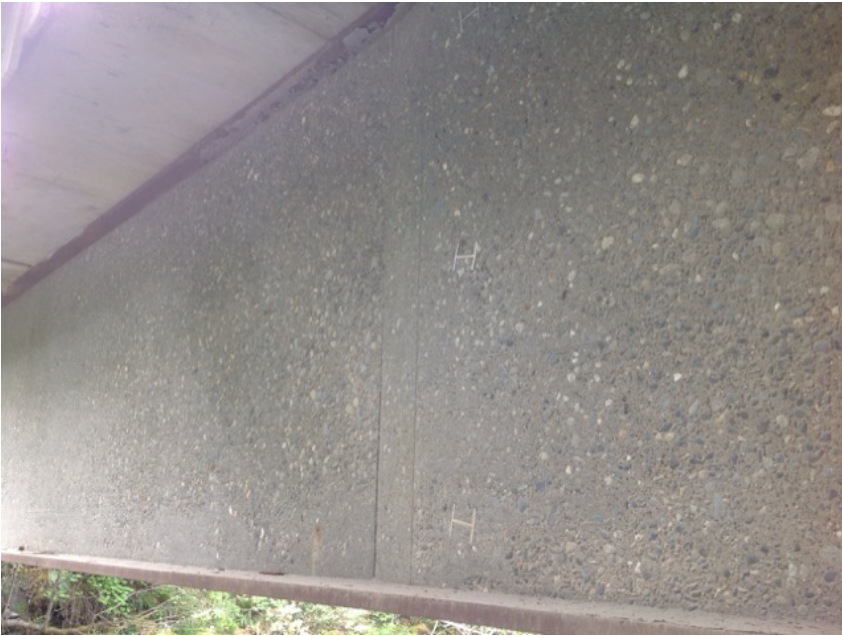
web flare

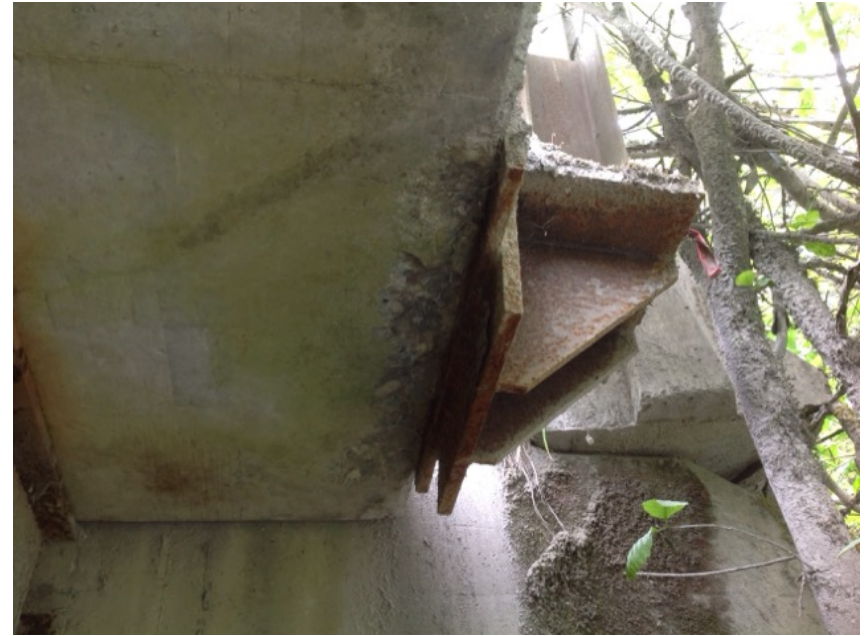
minor damage to upstream right approach deck panel under rail post

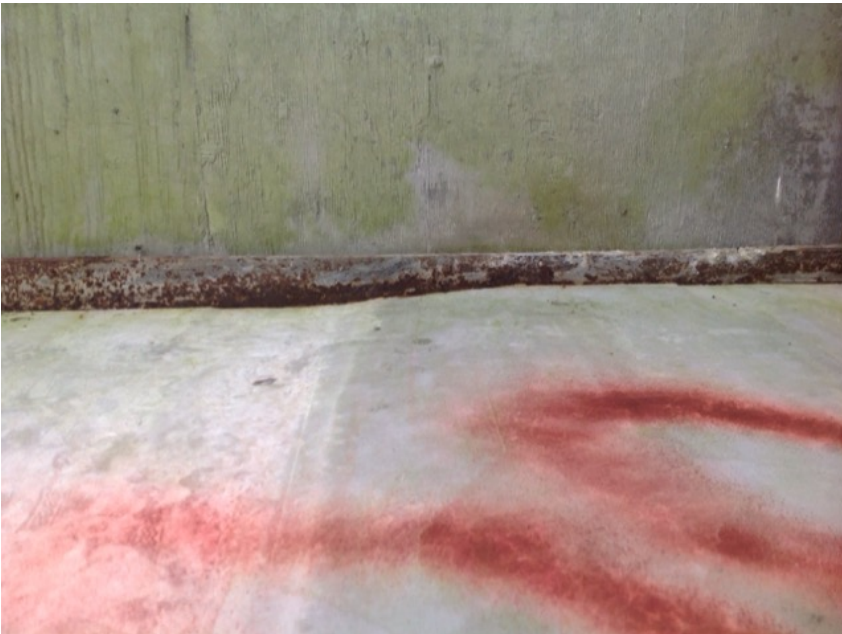
web flare
