CK-2076

FOLEY CREEK 4.4km

2016 Inspection

| Structure Class | Temporary Bridge |

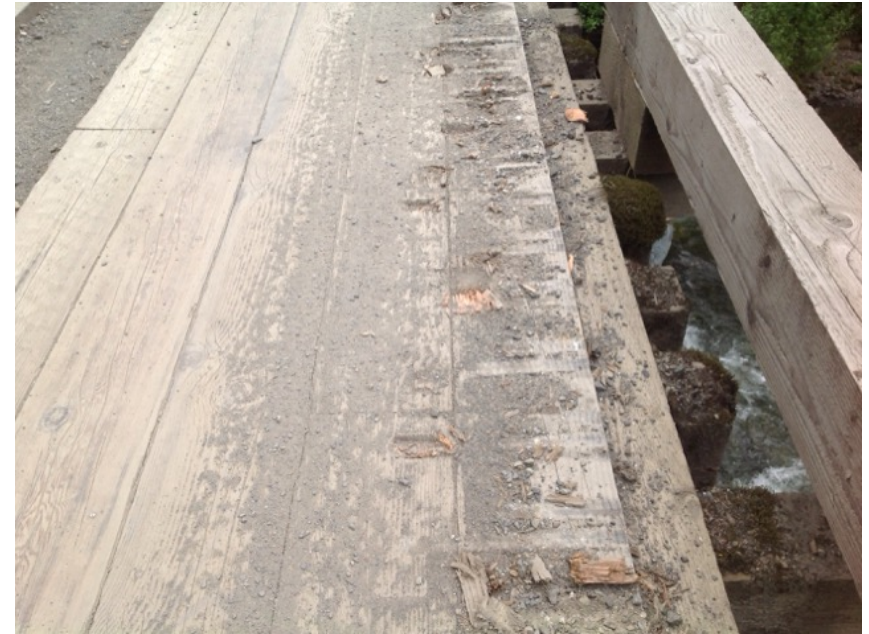
tracked machine recently walked over

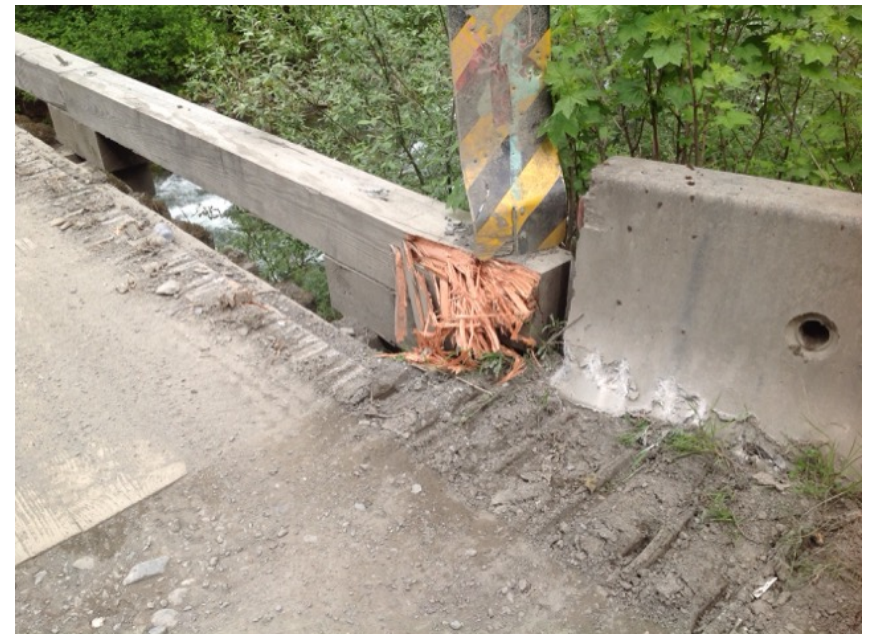
Curb Rail/Blocks/Posts Fair recent small damage

recent damage to upstream left approach rail

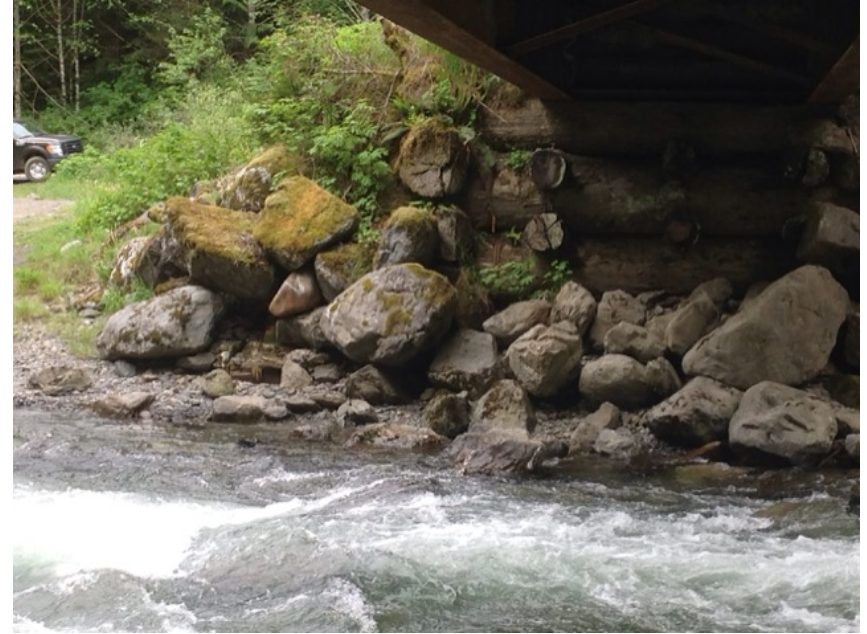
Riprap Fair scour noted downstream right bank

right bank downstream riprap scour

Present load rating of L60 or 54 tonnes to continue. Monitor tieback condition and scour as noted.

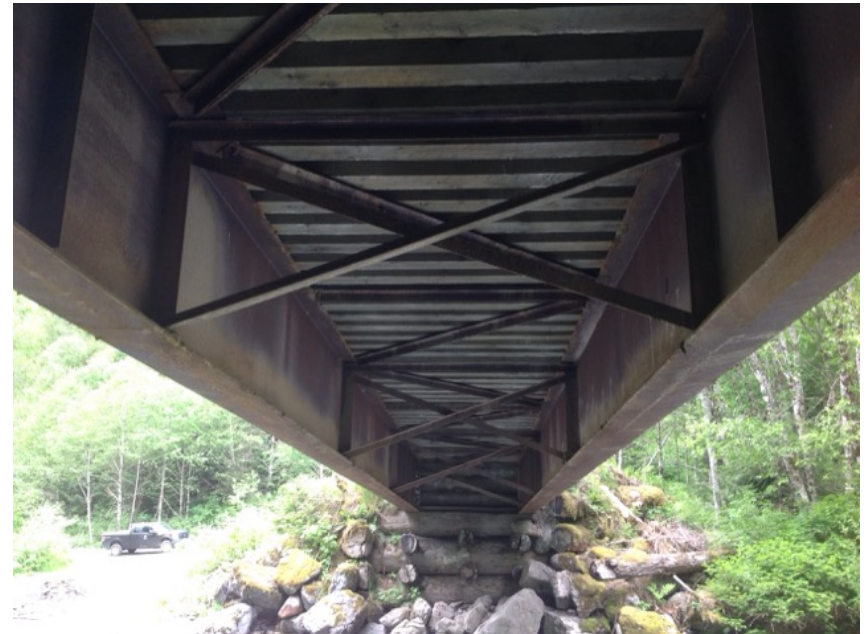
superstructure

Girders Fair surface rust
