CK-2077

AIRPLANE CREEK 0.1km

2016 Inspection

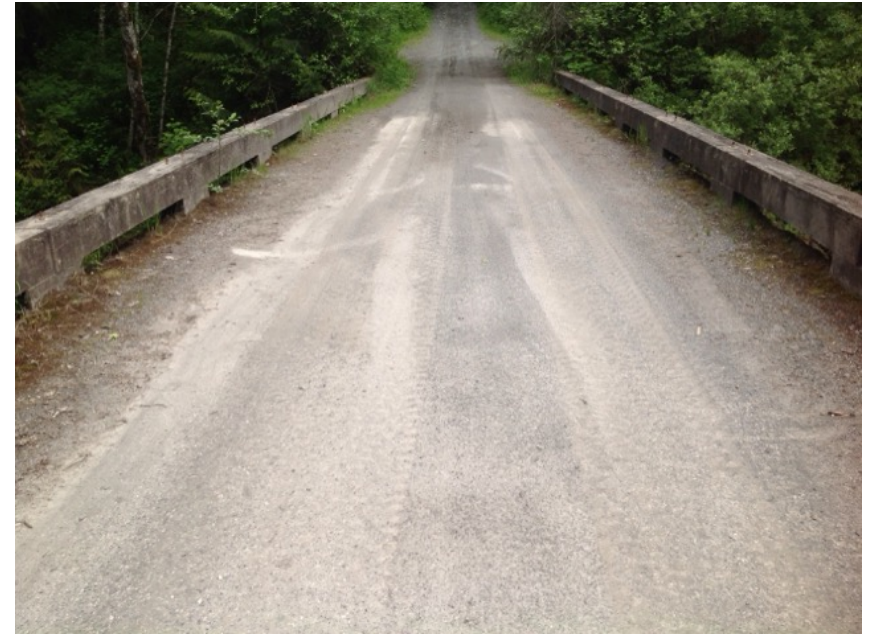
Deck

| Curb Rail/Blocks/Posts | Fair | fair to poor as risers have rot |

| 4 | Medium | replace guardrail prior to industrial use |

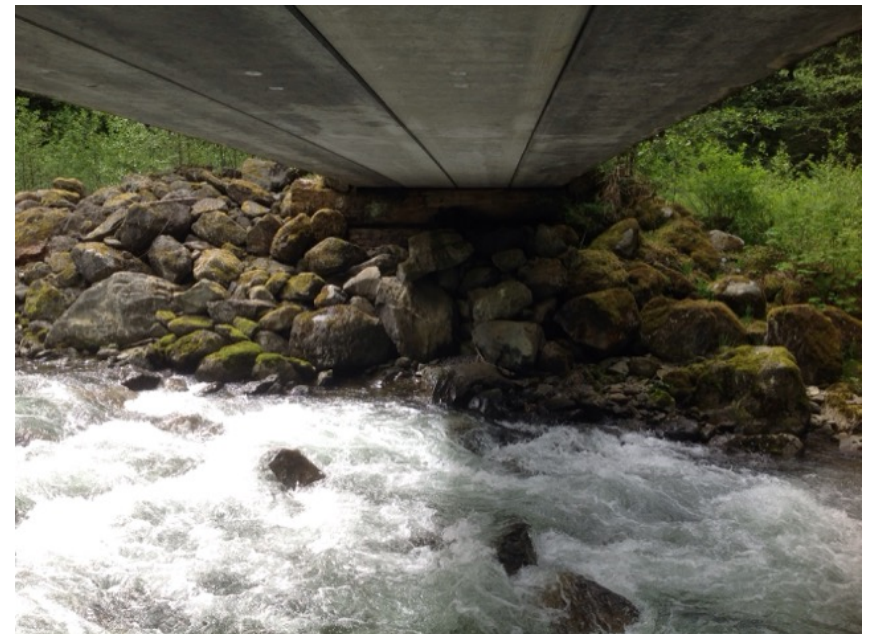
Left Bank Abutment when facing downstream

Log/Timber Cribs Fair 4x right bank, 2x left bank - visible

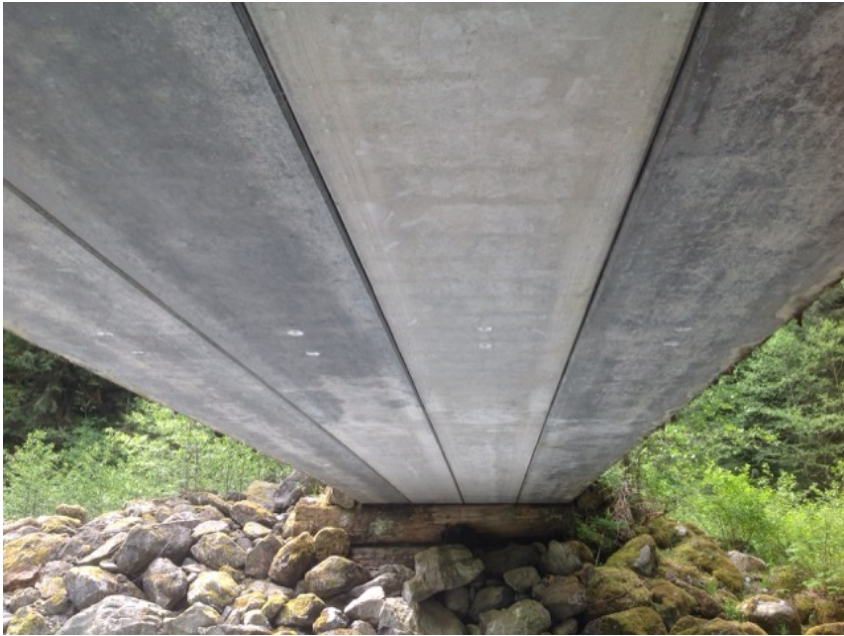
Girders Good appear good from underneath but asphalt overlay restricts inspection from above

superstructure - 4 concrete slabs
