CK-2084

CHILLIWACK SOUTH 0km

2016 Inspection

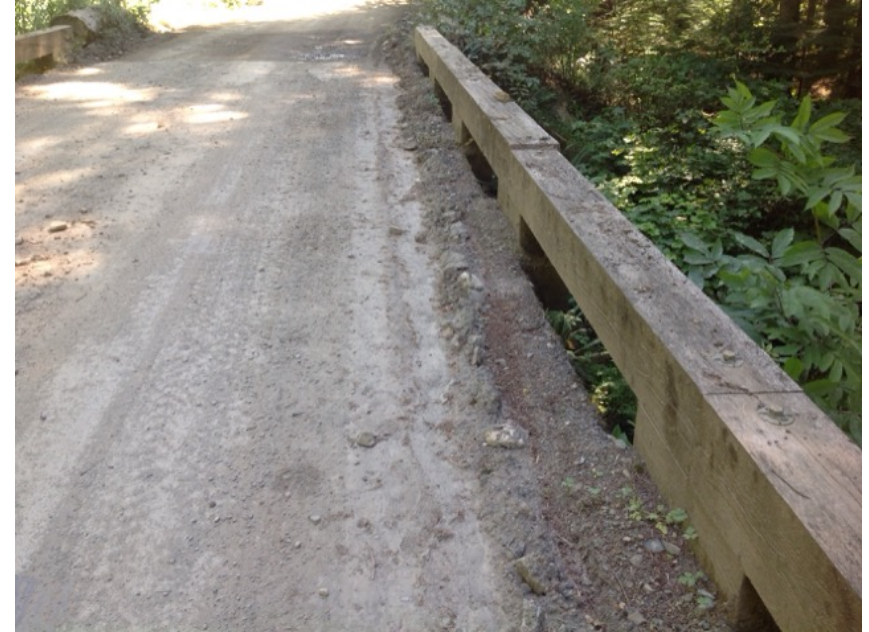
sediment on deck

| Repair Item | Priority | Repair Description |
|---|---|---|
| 1 | Medium | clean sediment off deck |

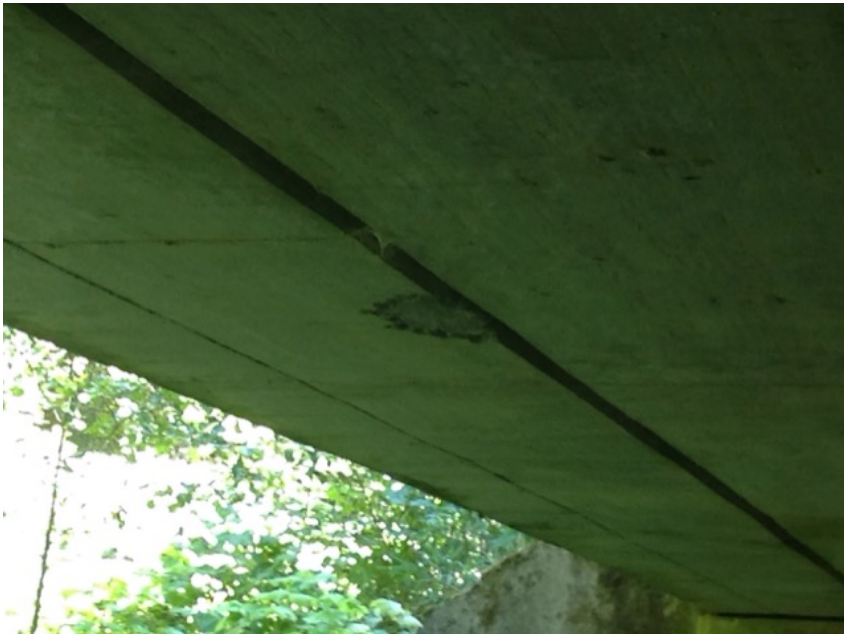
spall that was grouted

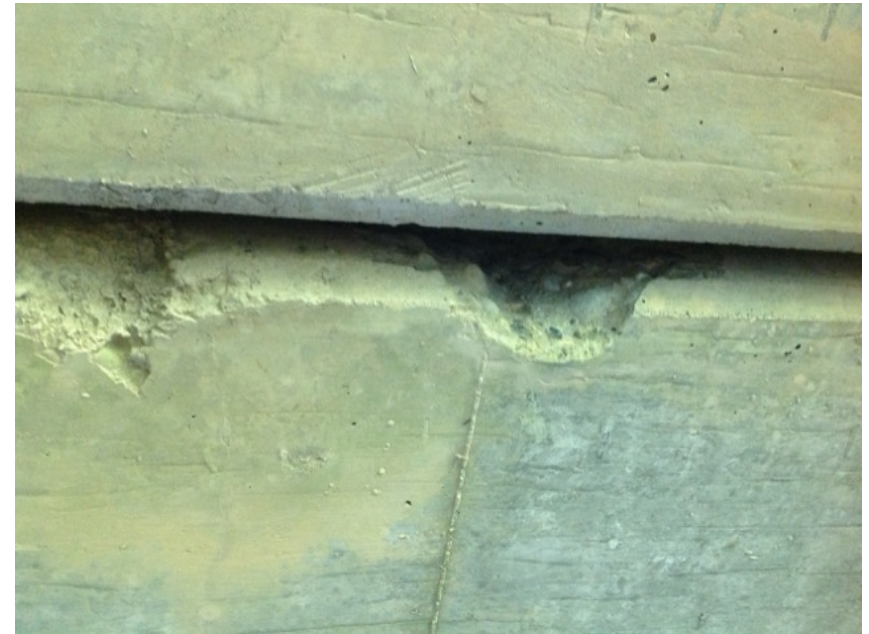
6 concrete slabs with welded shear keys - minor spalling noted

minor spelling on left bank 4th slab

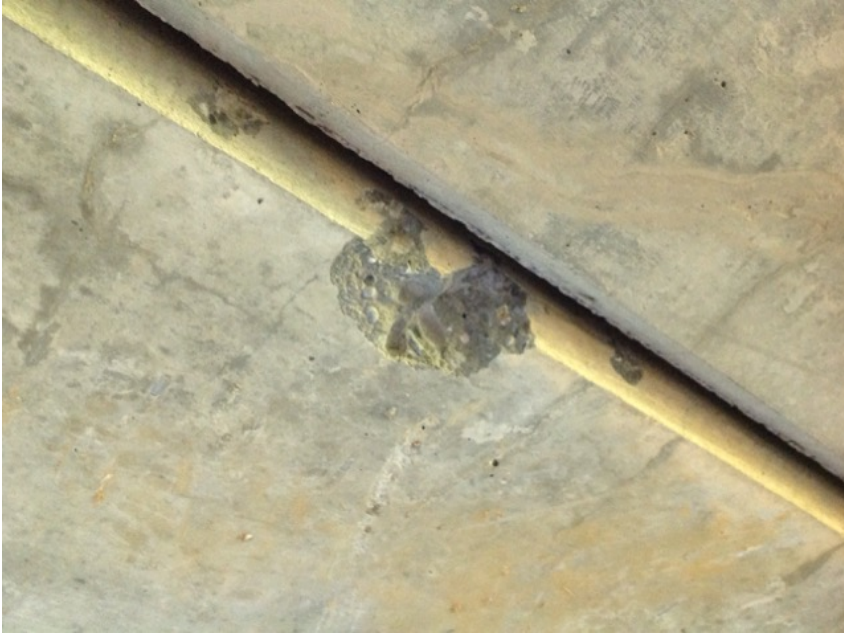
minor spalling on left bank 6th slab
