CK-2085

CHILLIWACK SOUTH 0.1km

2016 Inspection

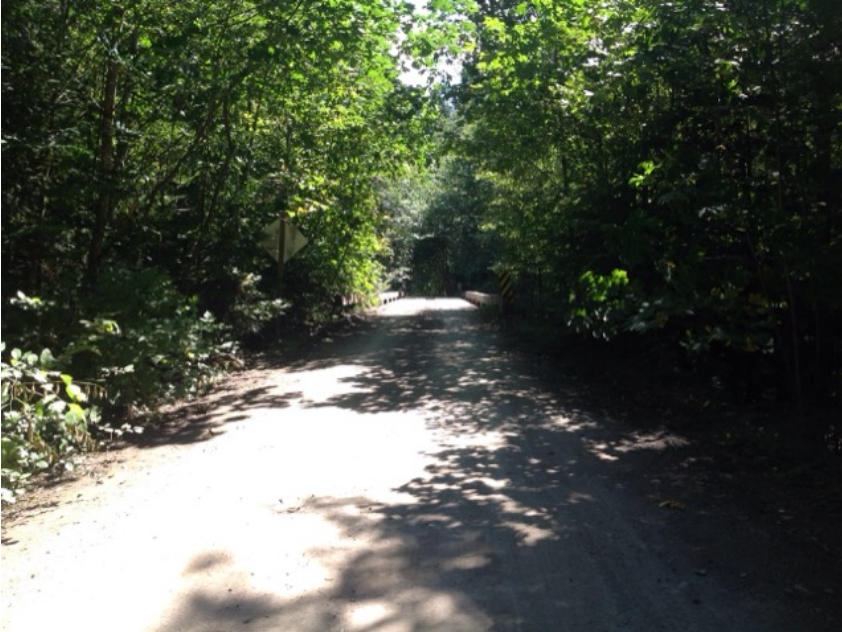
Approach from Right Bank when facing downstream

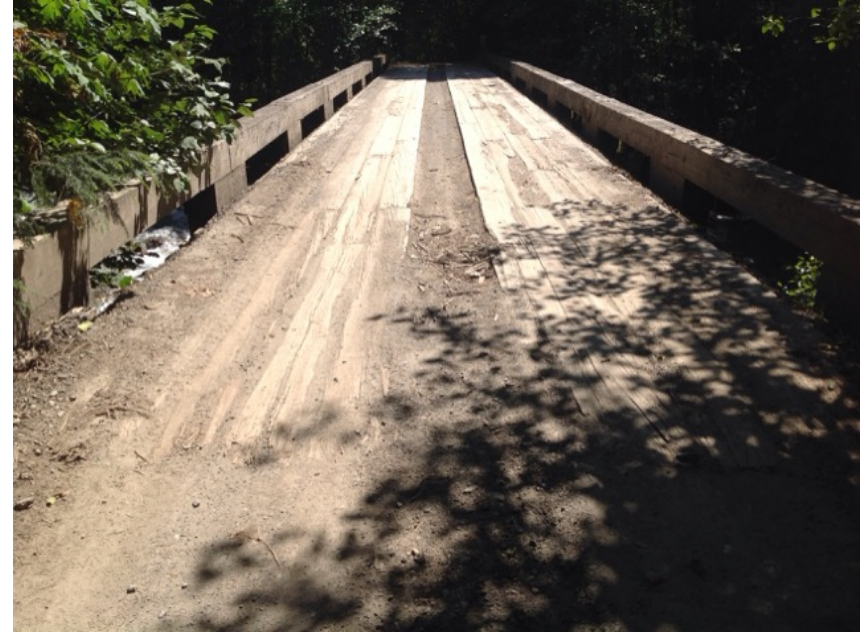
| Running Planks | Poor | some really rotten |
| Nails | Poor | protruding on planks |

Deck

| Repair Item | Priority | Repair Description |
|---|---|---|
| 1 | High | replace running planks |

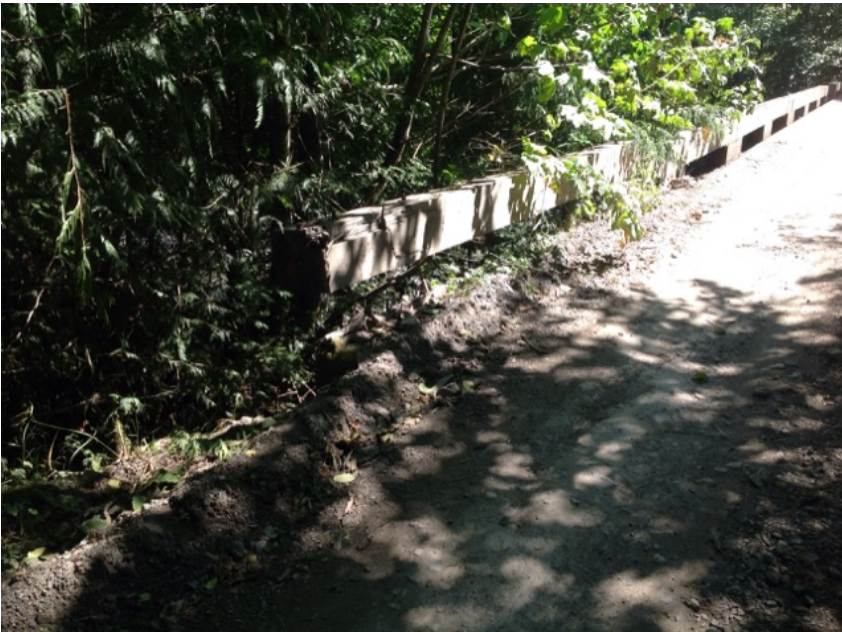
missing block on fender

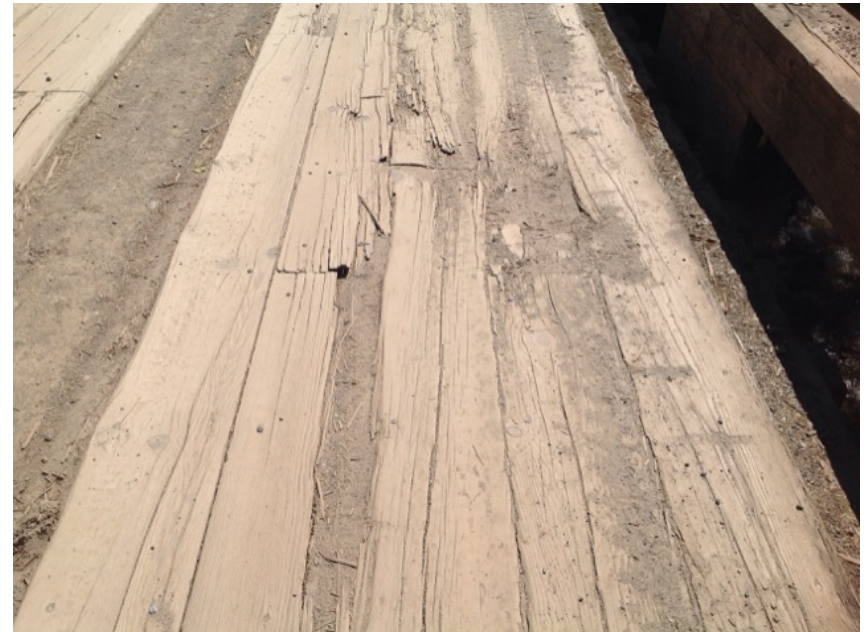
Deck

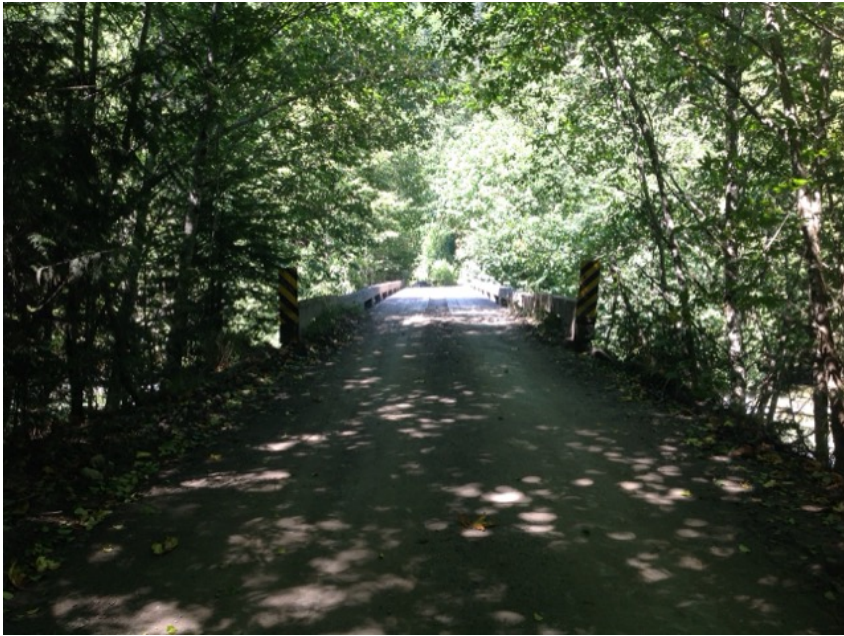
Approach from Left Bank when facing downstream

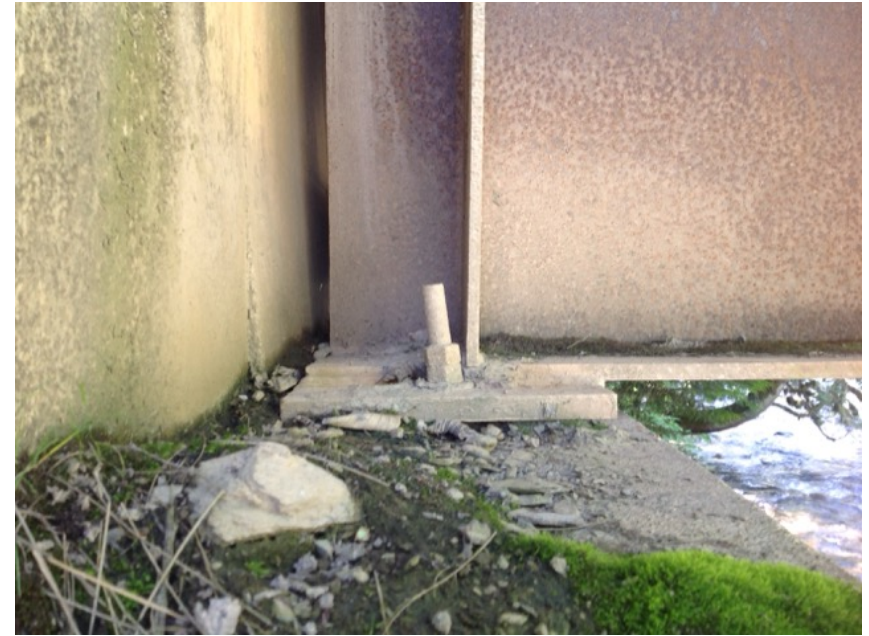
upstream left bank bearing

| Item | Monitor Description | Frequency |
|---|---|---|
| 1 | bearing bolt condition | |

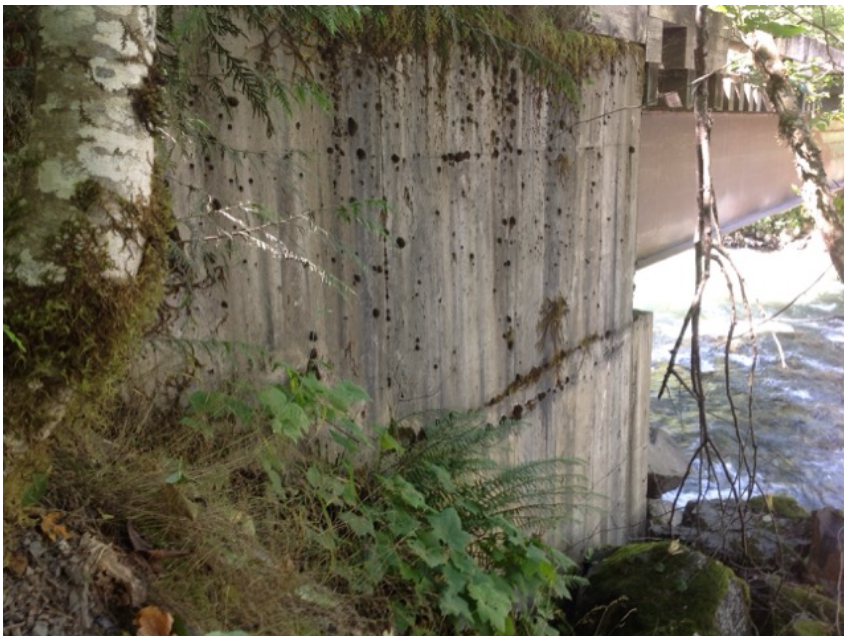
upstream left bank wing wall

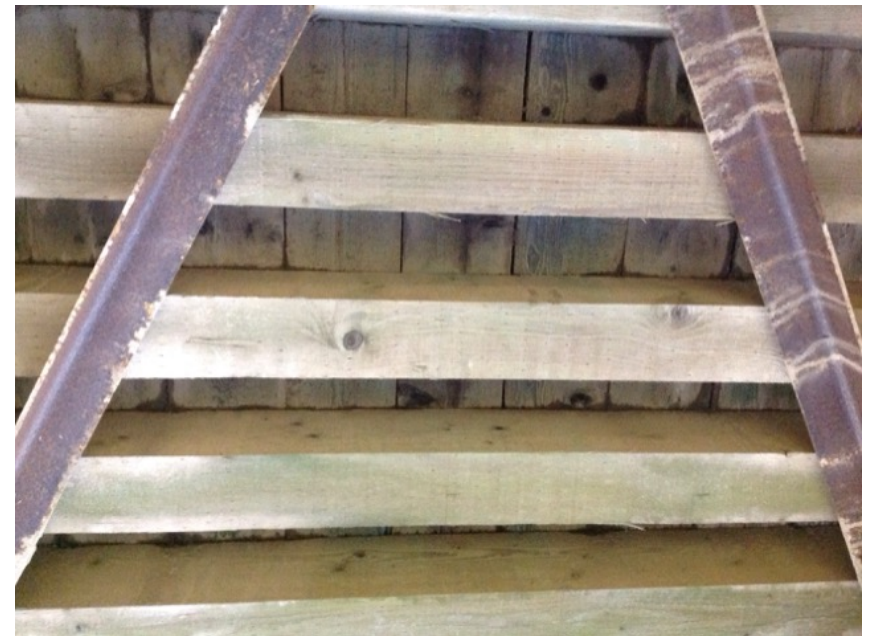
deck from underneath

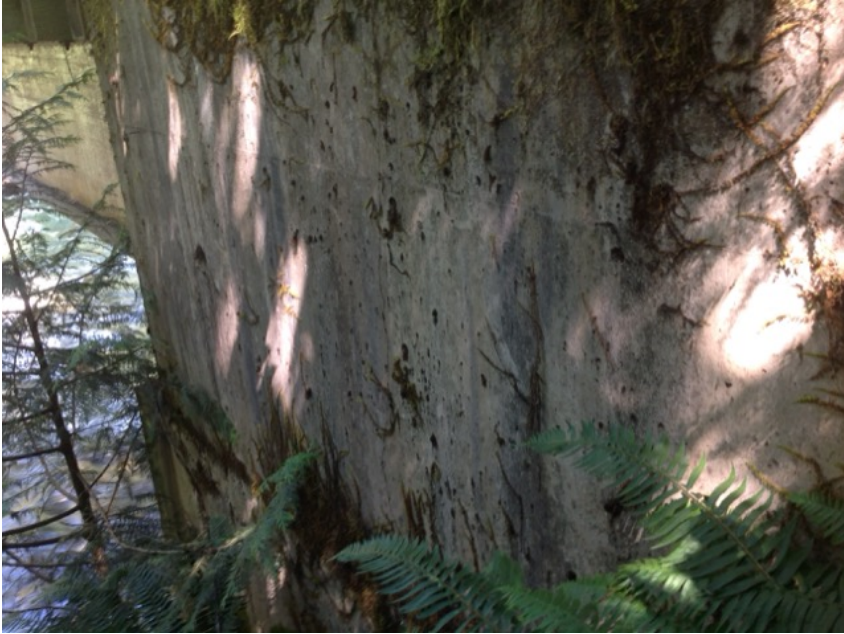
downstream left bank wing wall

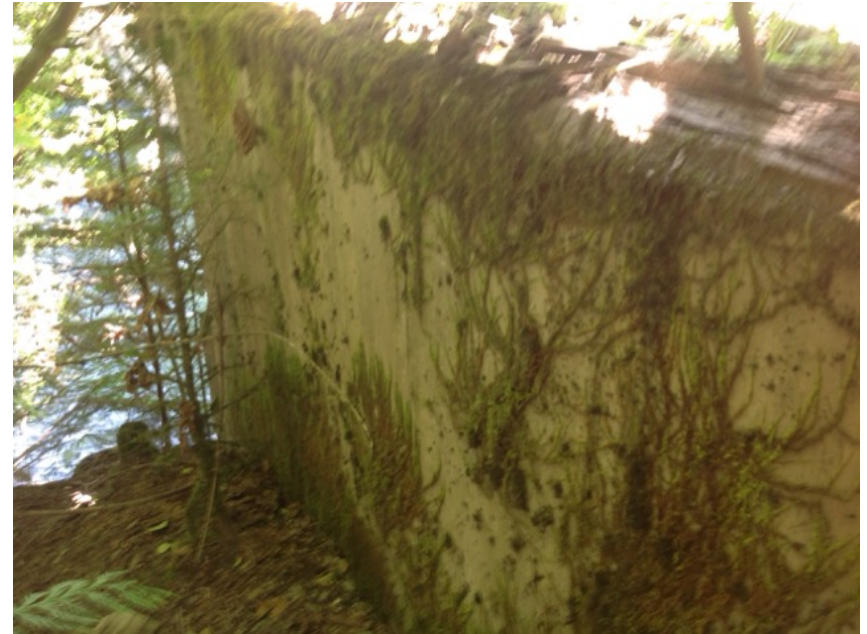
upstream right bank wing wall

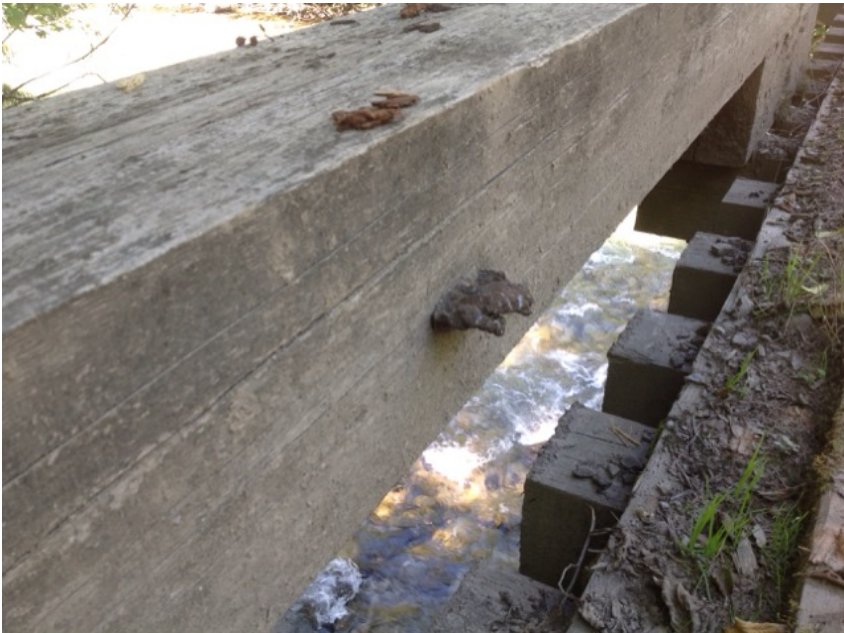
| Curb Rail/Blocks/Posts | Poor | rotting |

conk growing on guardrail

| Repair Item | Priority | Repair Description |
|---|---|---|
| 2 | High | replace guardrail |

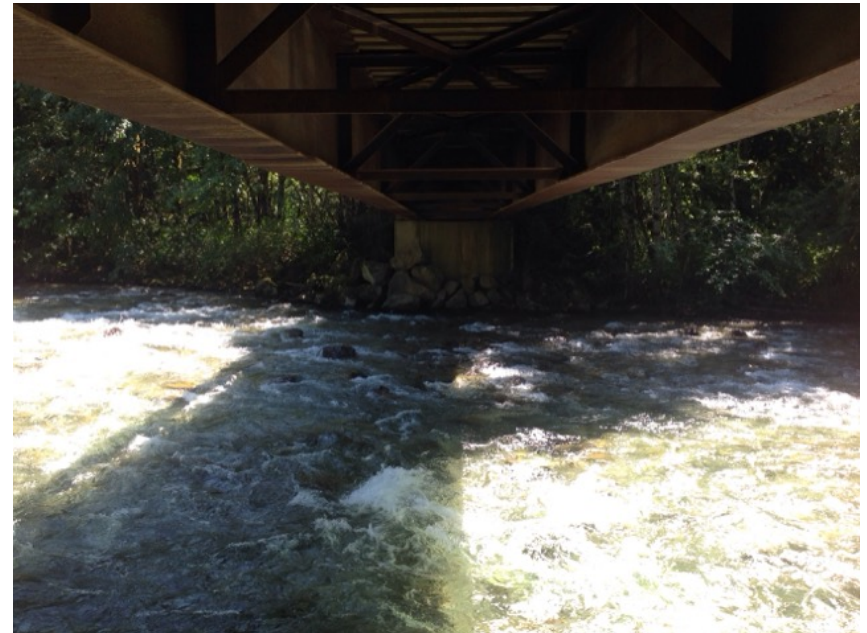
Left Bank Abutment when facing downstream

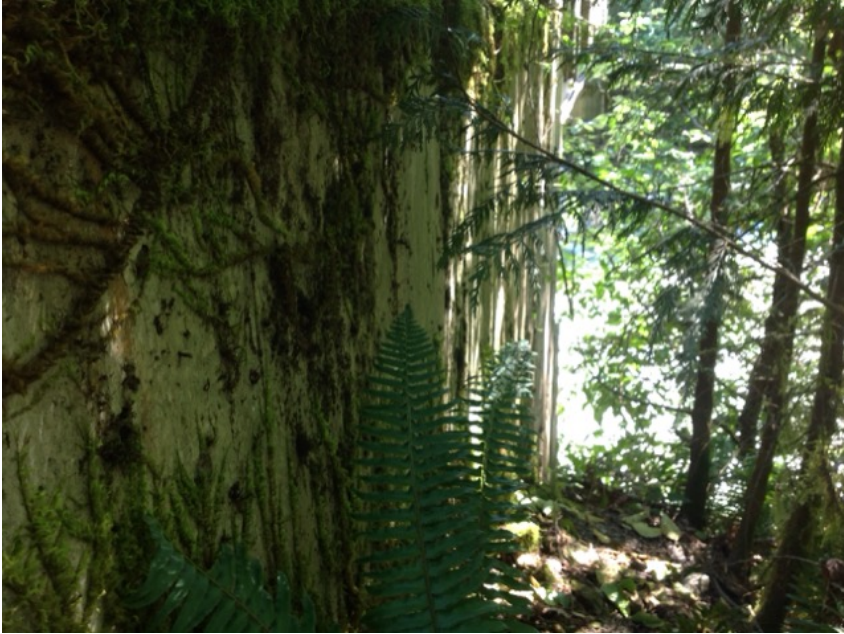
downstream right bank wing wall
