CK-2102

ROCKY POINT 0.2km

2016 Inspection

| Crossing Name | Sayers Creek | | |

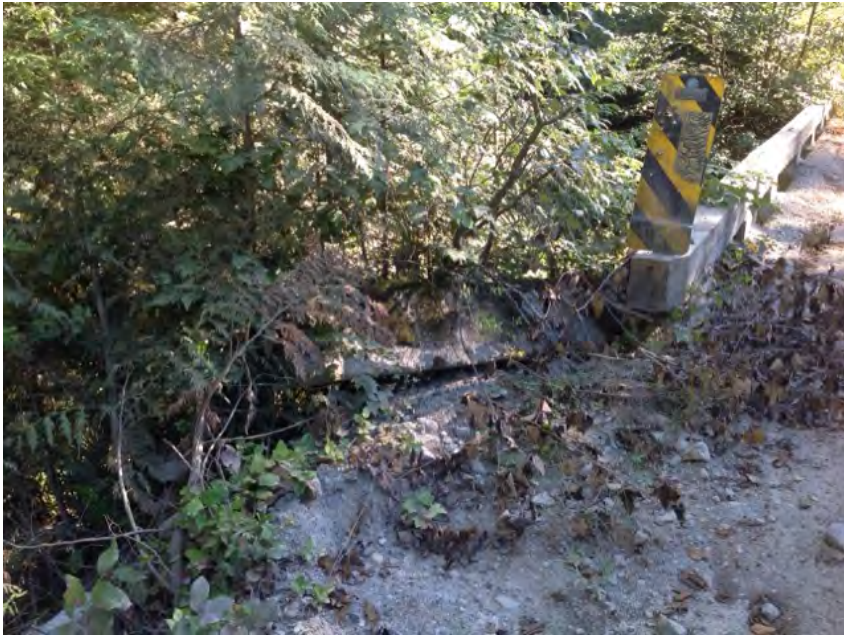
right bank upstream no post

| Repair Item | Priority | Repair Description |
|---|---|---|
| 1 | Medium | repair concrete no post alignment and brush approaches |

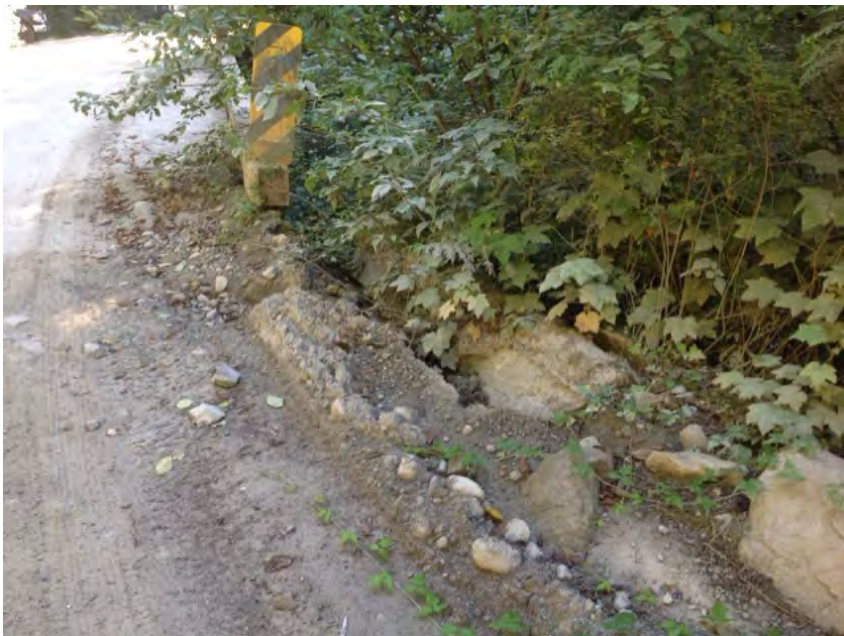
right bank downstream no post

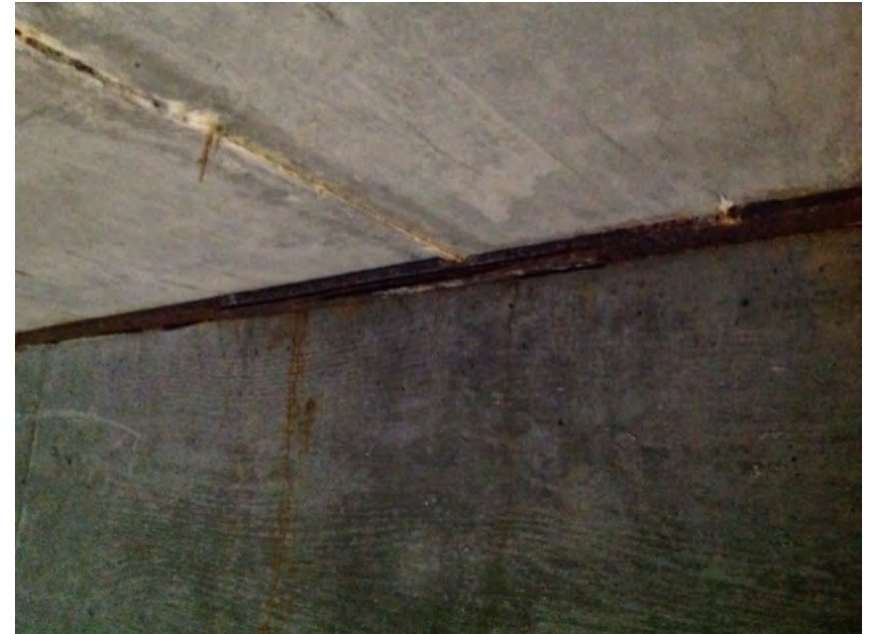
measurable section loss not anticipated based on limited extent of corrosion

Girders Fair some sections of steel delaminating

some delaminating of the top flange at deck joint

| Item | Monitor Description | Frequency |
|---|---|---|
| 1 | steel delamination | Routine Inspection |

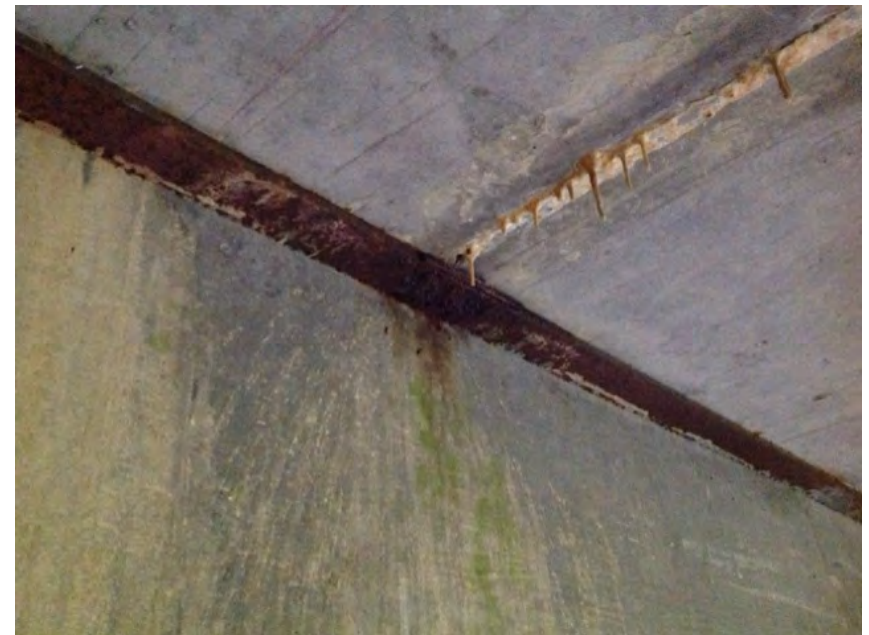
| Deck Joints | Fair | water getting through some grouted panel joints |

water getting through at deck joint

| Repair Item | Priority | Repair Description |
|---|---|---|
| 3 | Medium | seal all grouted panel joints |

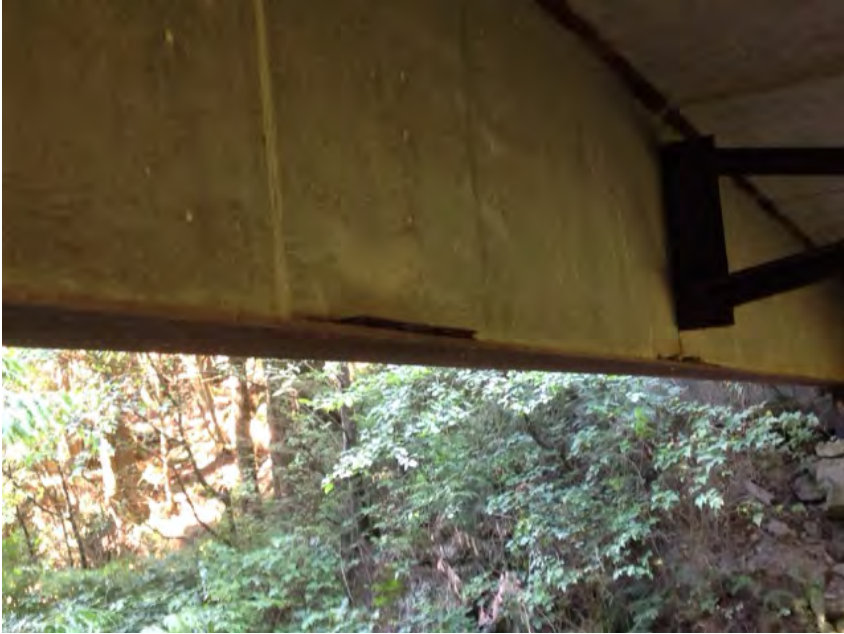
delaminating on bottom flange

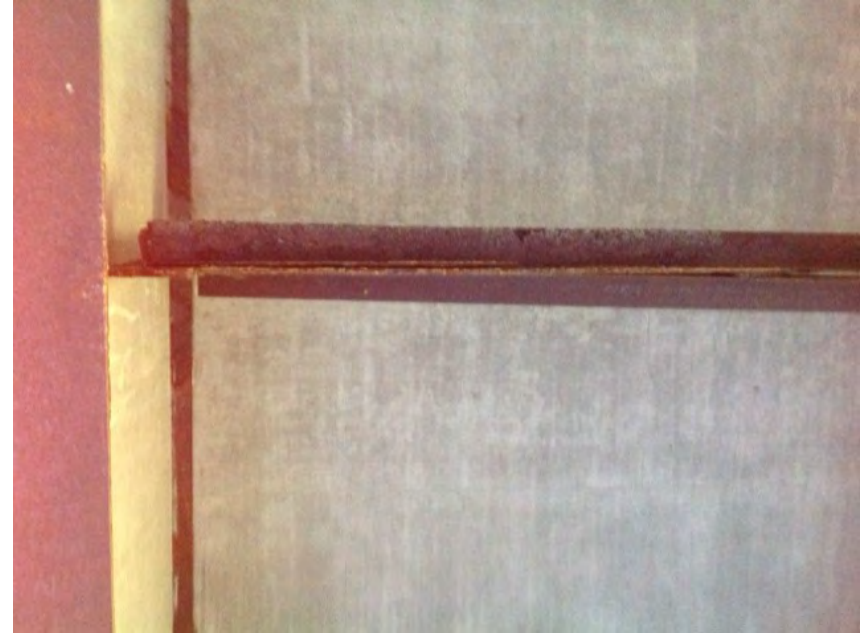
Diaphragms Fair 1 at center span

diaphragm delamination

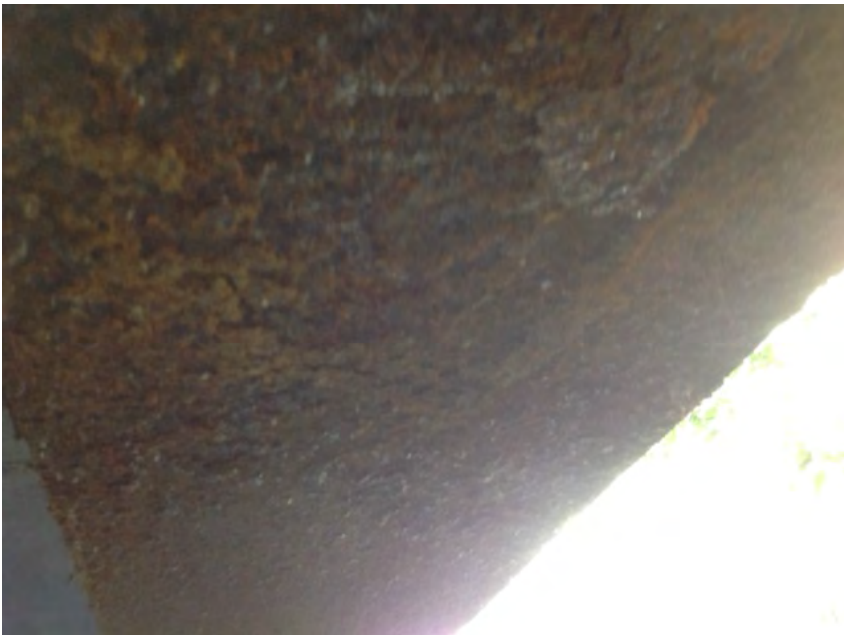
more delaminating on bottom flange
