CK-2108

HARRISON EAST 30.7km

2016 Inspection

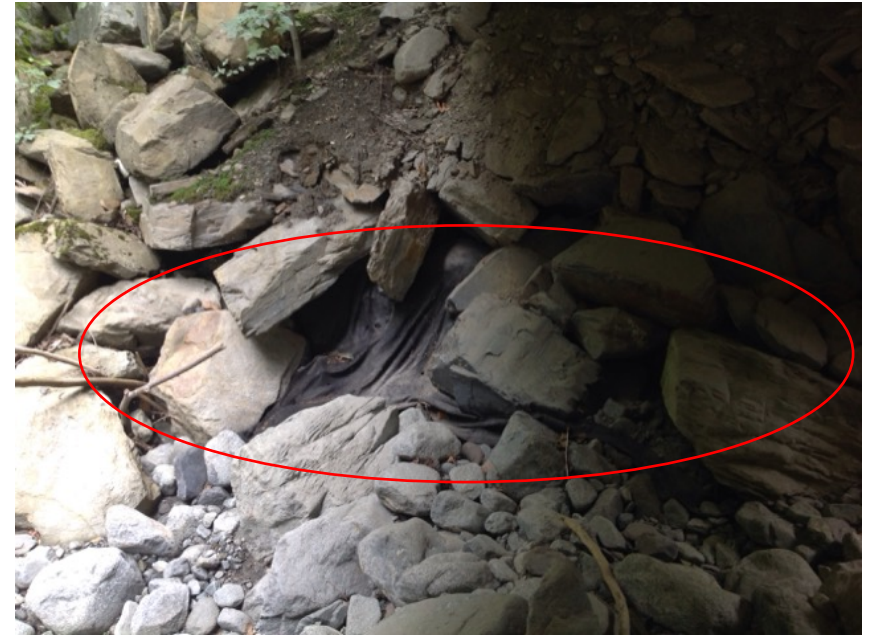
Riprap Fair scoured on right bank, additional req'd U/S left bank

riprap scour downstream right bank

The riprap is scouring on the right bank abutment and immediately upstream of the end of riprap on the left abutment. Both sections require additional riprap to help from further scour. Brush approaches by next spring prior to leaf out. Monitor stream aggradation at the inlet. Present load rating of L150 or 136 tonnes to continue.

| 1 | High | repair riprap at both banks |

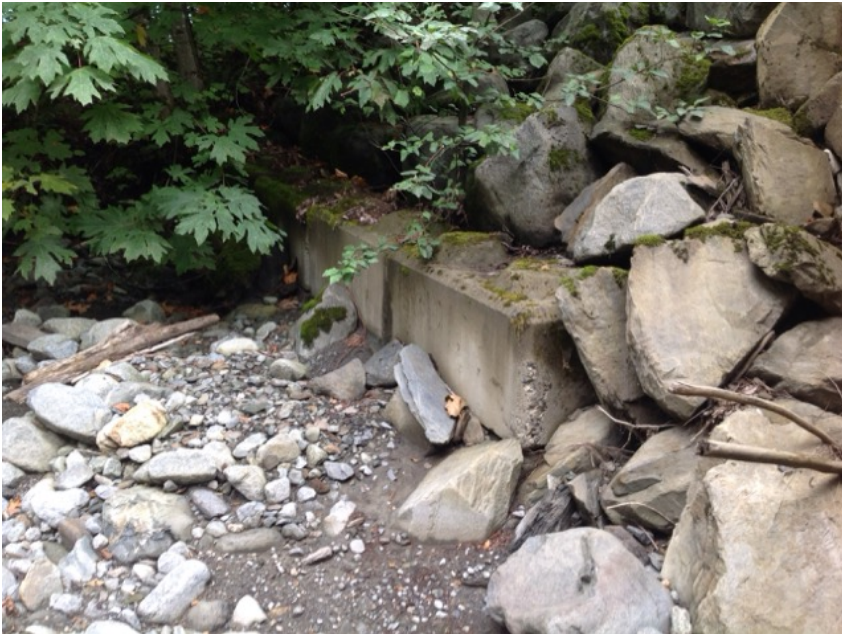
Wing Wall Good lock blocks on downstream right bank

downstream right bank wing wall

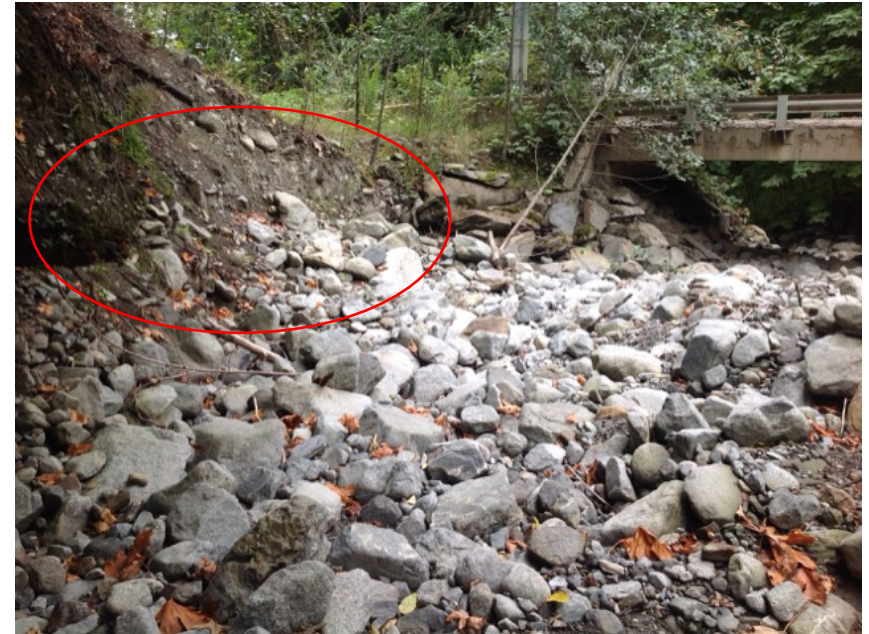
current hi flows are being directed towards left bank - behind riprap

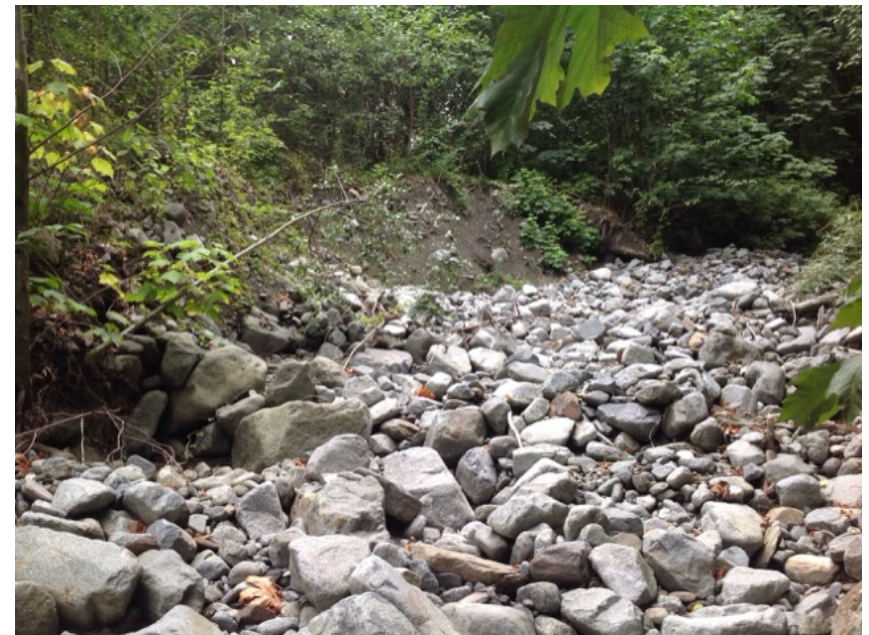
upstream from crossing - erodible banks
