CK-2110

HARRISON EAST 38.5km

2016 Inspection

| Crossing Name | Clear Creek (structure # 29) |

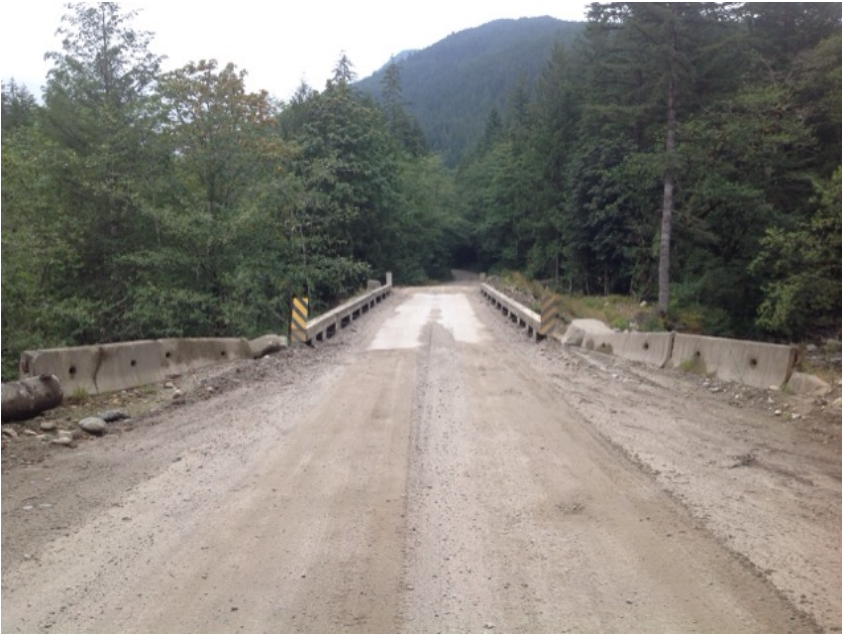
Approach from Left Bank when facing downstream

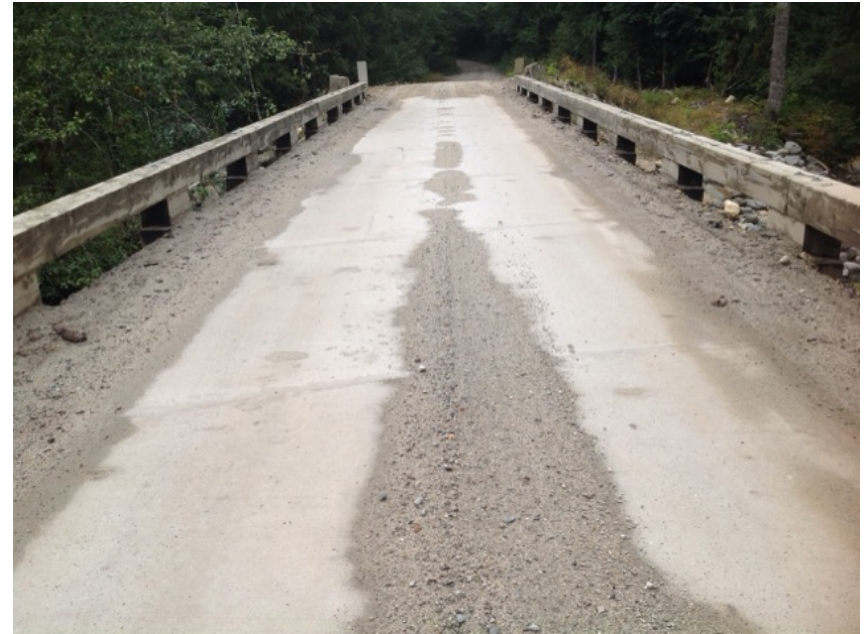
Deck

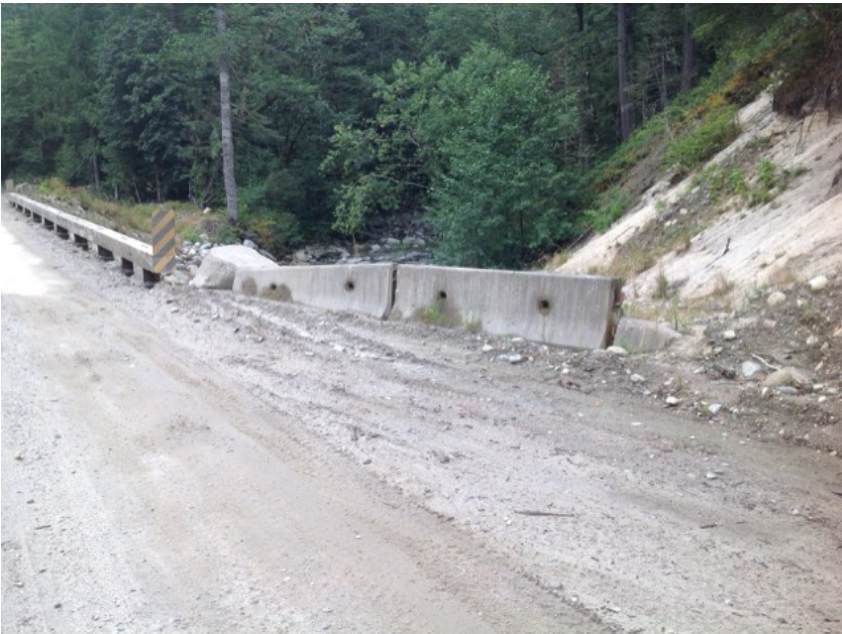
Fender Condition    Fair    wrong way

left bank concrete no posts pointing wrong way

Reinstall all concrete no post approach barriers so they are properly connected. Present load rating of L150 or 136 tonnes to continue.

| Repair Item | Priority | Repair Description |
|---|---|---|
| 1 | Medium | reinstall all concrete no post barriers correctly |

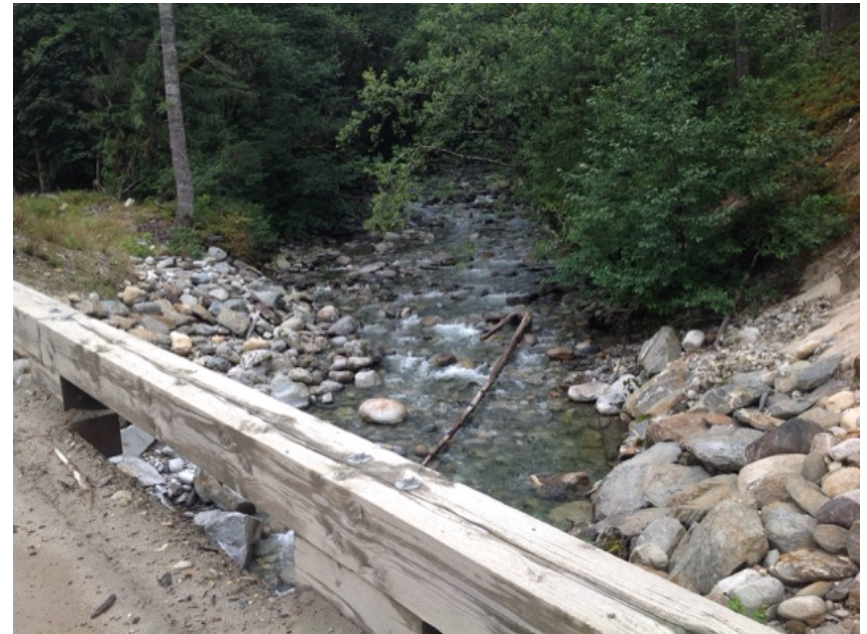
looking upstream from deck

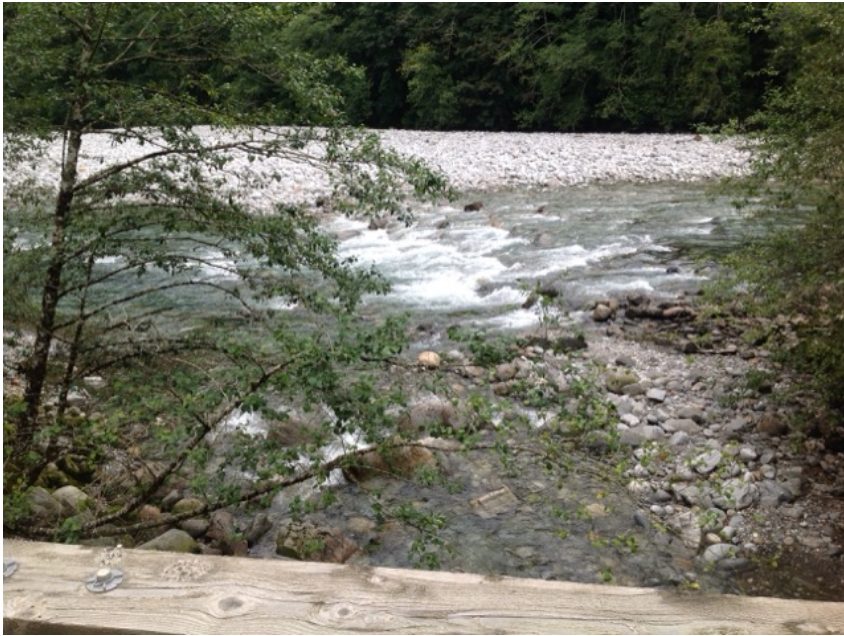
looking downstream from deck

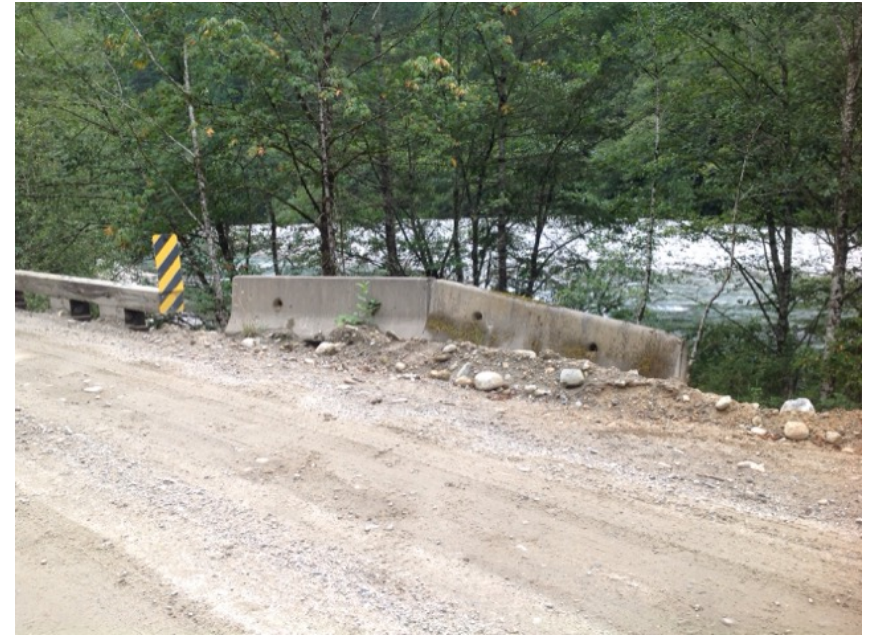
right bank downstream no post barriers

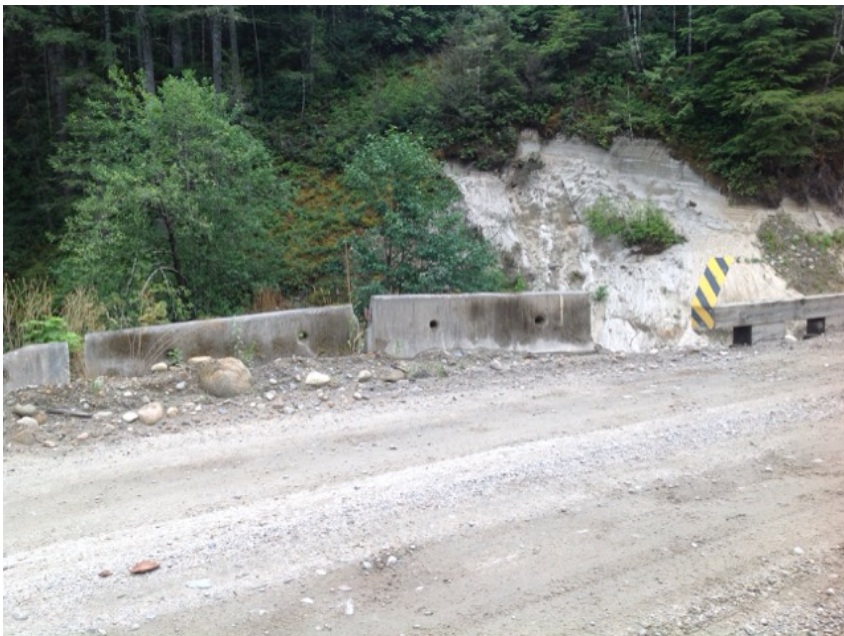
right bank upstream concrete no post barriers

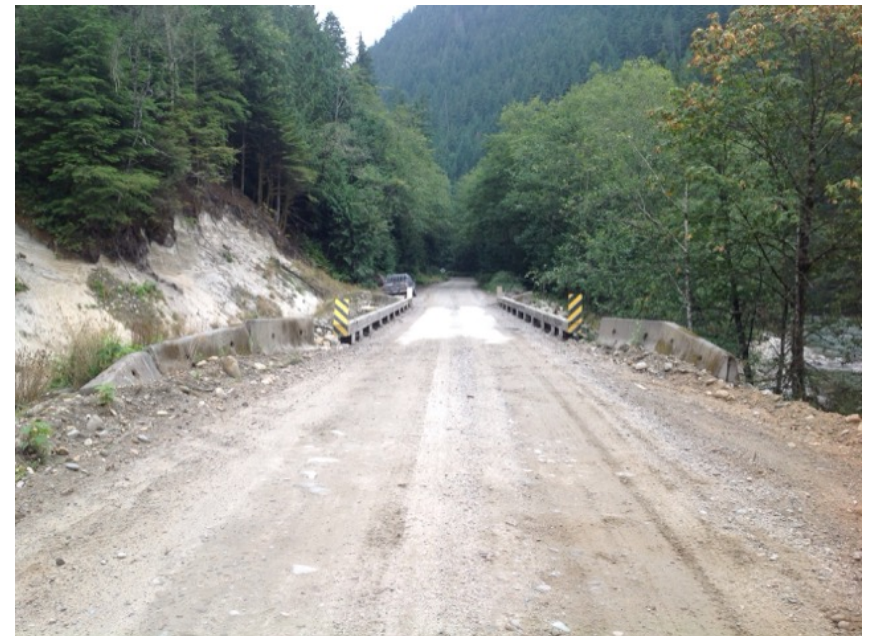
Approach from Right Bank when facing downstream

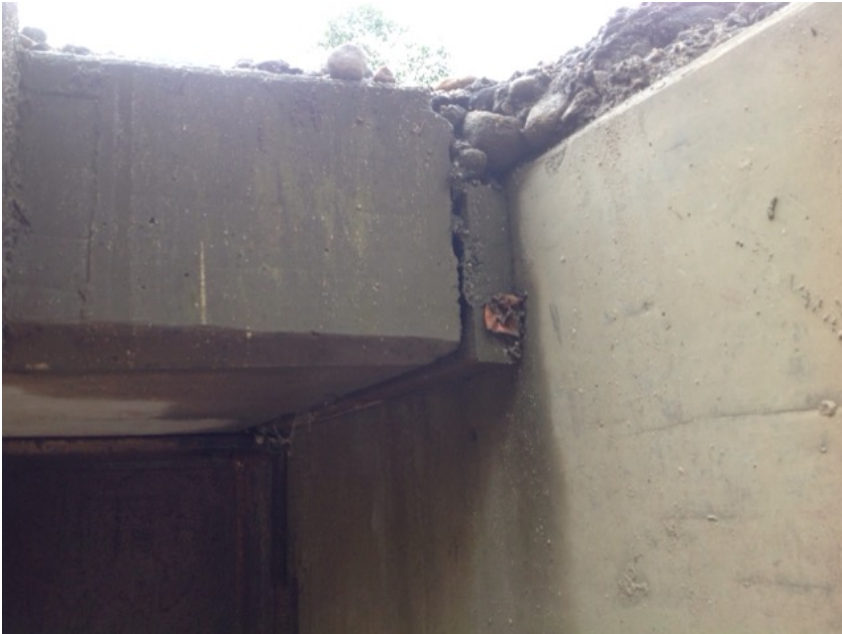
gap between right ballast wall and deck filled with treated 2x6

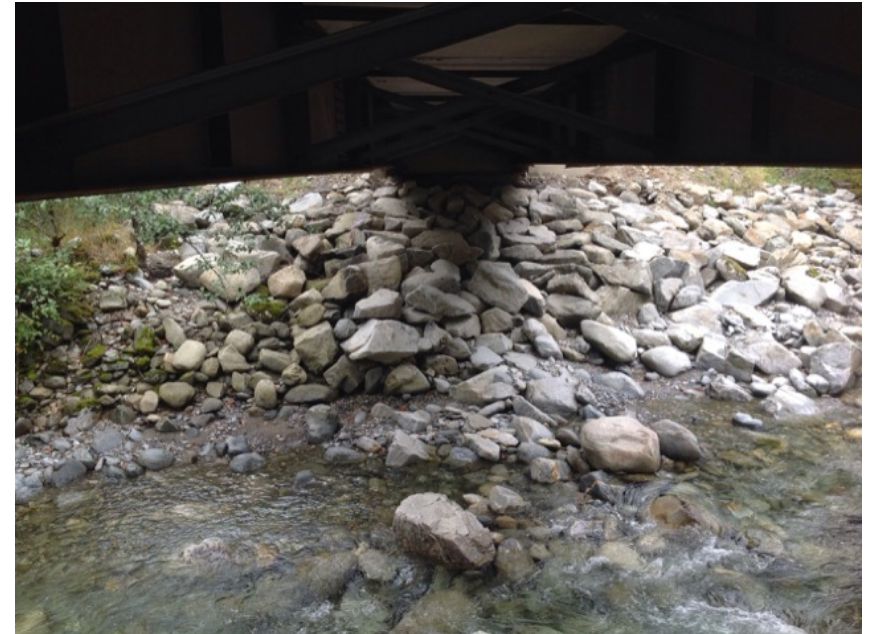
Right Bank Abutment when facing downstream

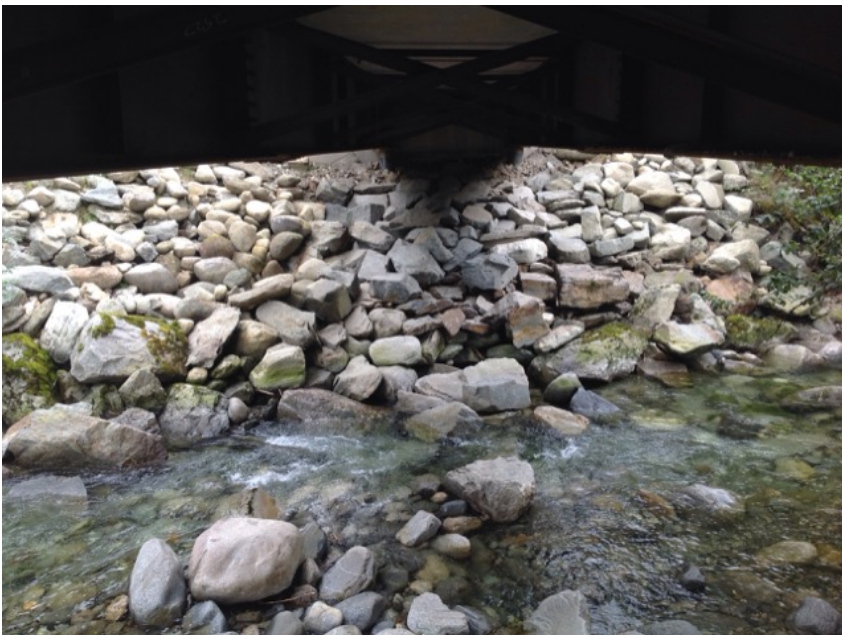
Left Bank Abutment when facing downstream
